## Survey Report:

# Fukuchiyama Line Train Derailment

Prepared by Editorial Office

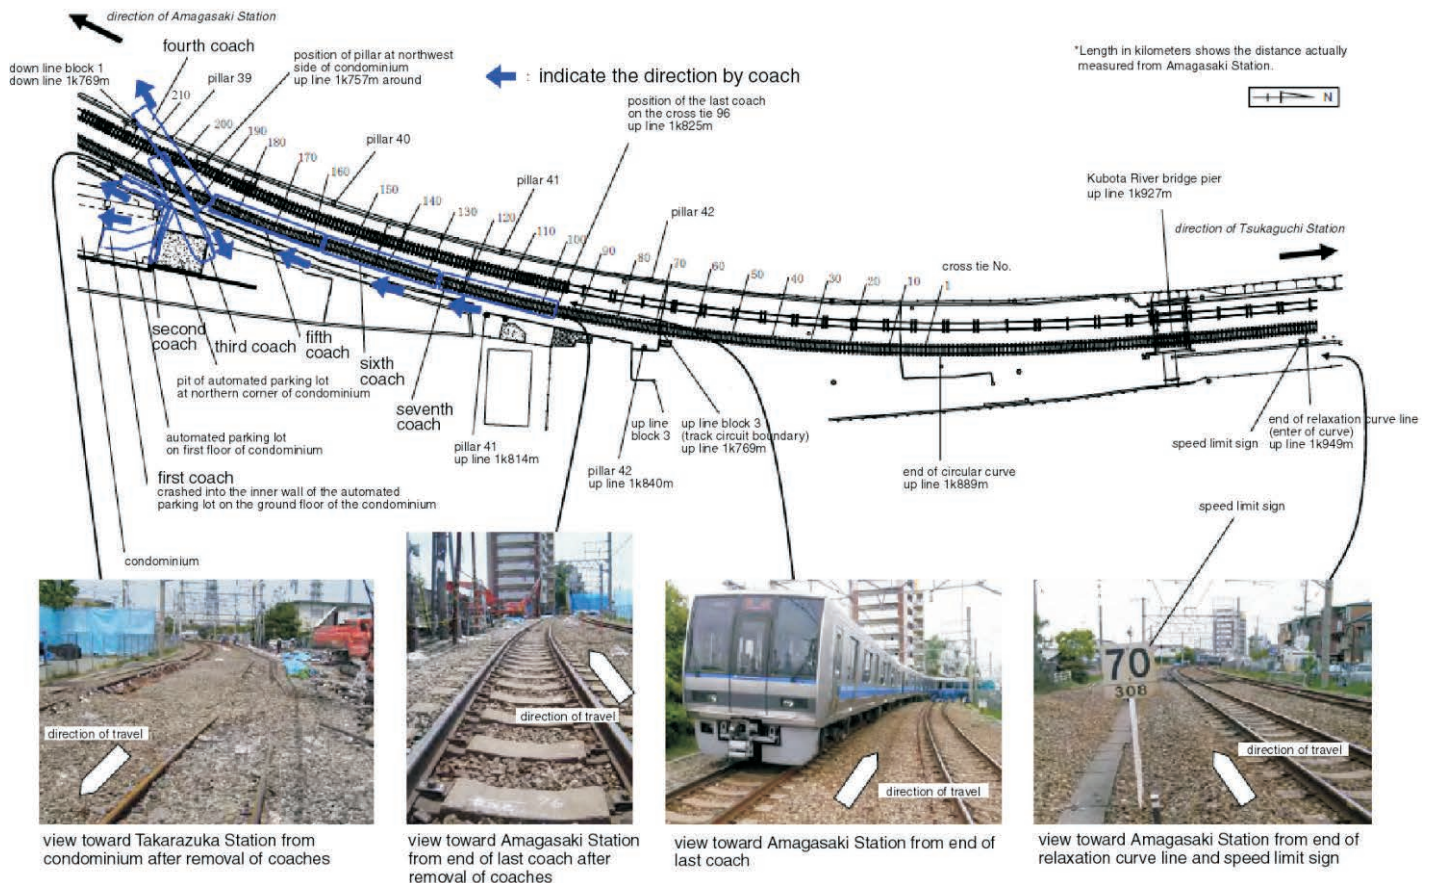
Fig. 3. Sketch map of derailment site.

The derailment occurred at 09:18 on April 25, 2005, on the West Japan Railway Fukuchiyama Line 1800 m from Amagasaki Station in the direction of Doshisha Station. The up (direction of Amagasaki Station) rapid express 5418 m passed Tsukagoshi Station at 09:18:27, 1min17s behind schedule. When the front of the train hit a point 1949 m from Amagasaki Station at a 304 m radius curve, it began to derail at 09:18:54 near pillar No.41 1814 m from Amagasaki Station (Figs. 1, 2, 3, 5).

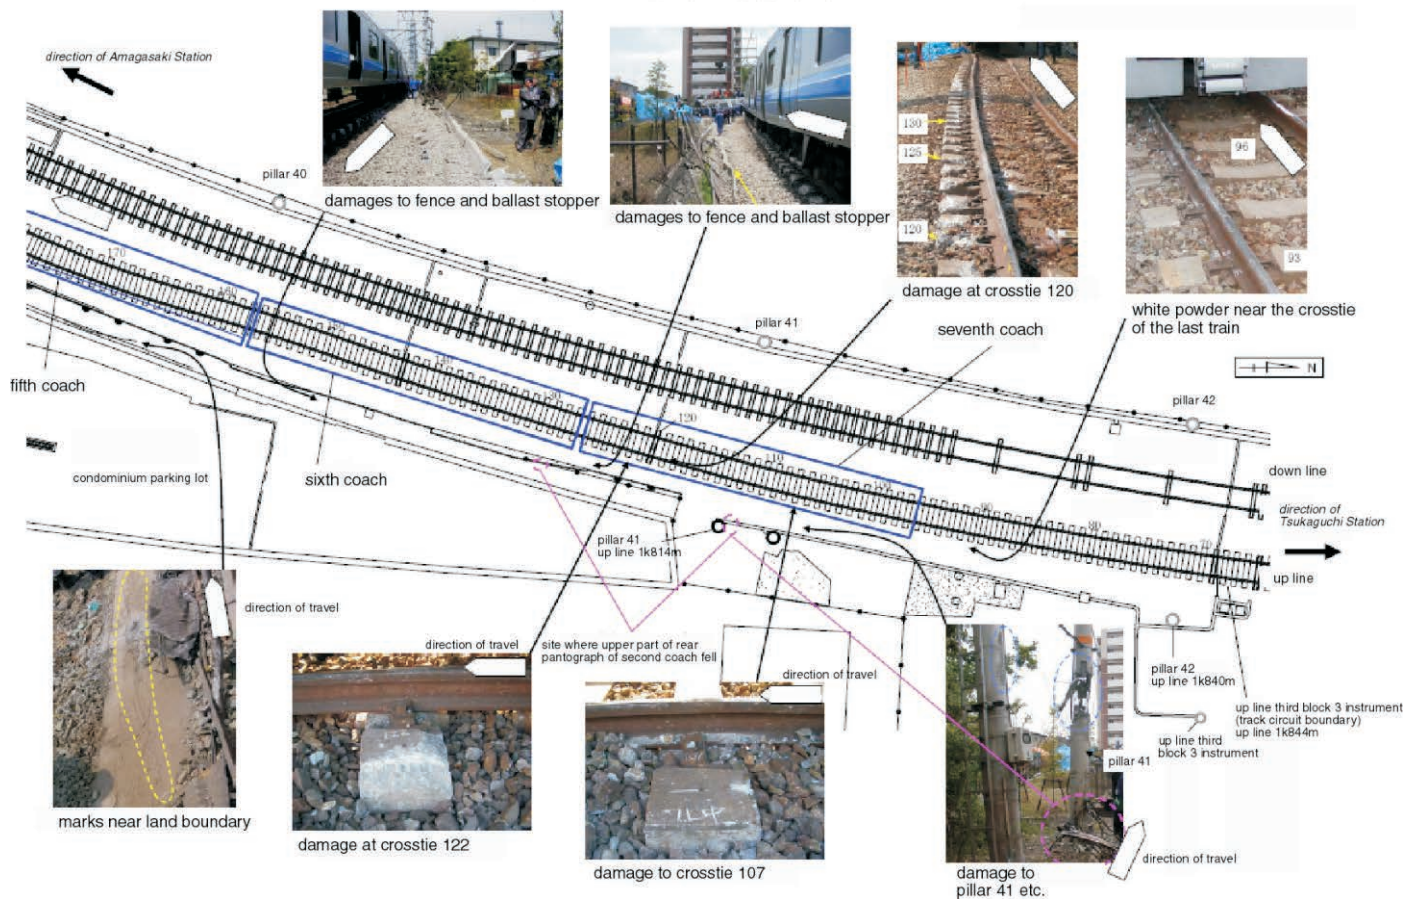
**Fig. 4.** Damage to railroad facilities.

Pillar No.41 at the left side of the track 1814 m from Amagasaki Station was broken off 2.7 m from the top level of the left side of the track.

Damage is shown in **Fig. 4**. White powder was observed on the top level of the left side of the track at 1828 m in the direction toward Amagasaki Station.

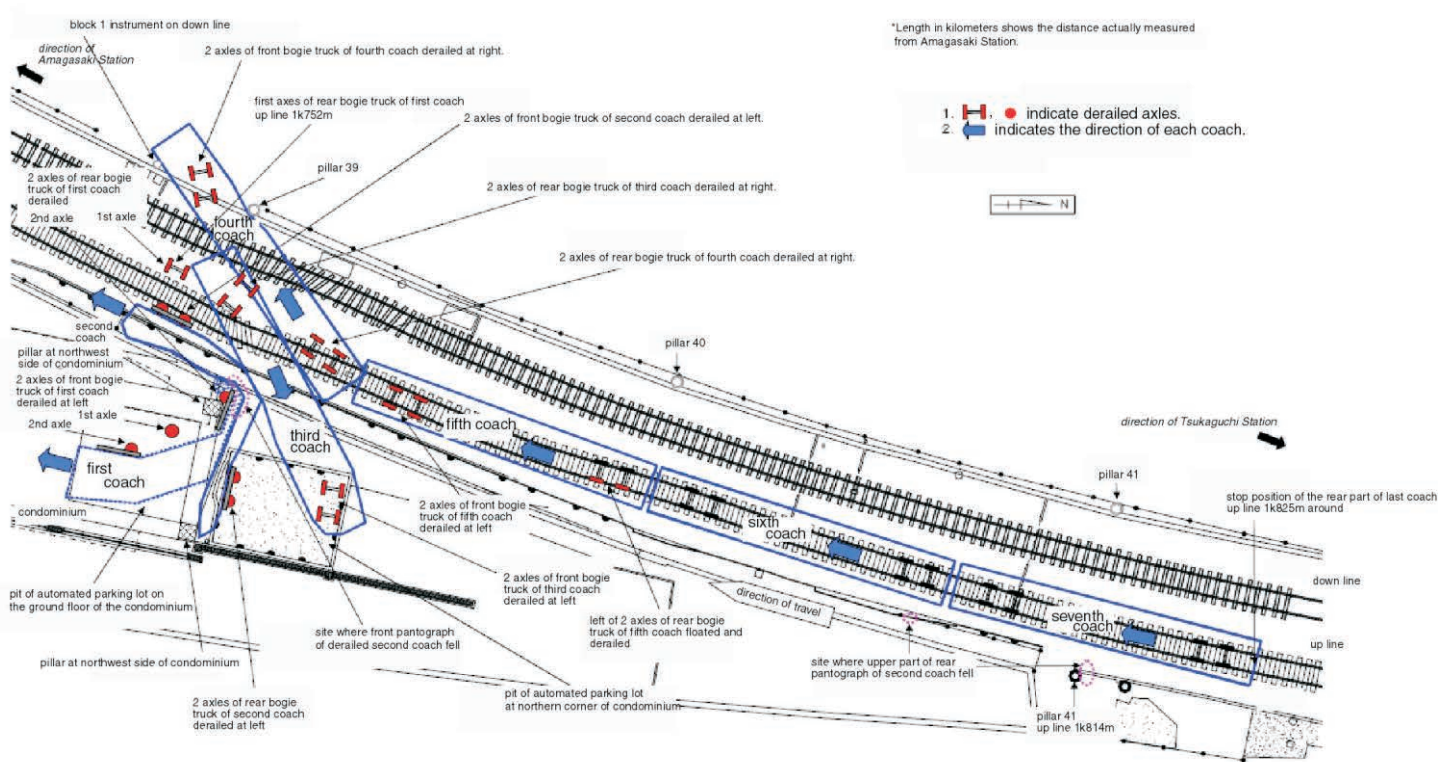
**Fig. 5.** Derailed coaches.

The first coach turned over, the front crashing into the wall of a condominium parking lot at the left side of the track and the lower rear of the coach crashing into a column northwest of the condominium. The left central section of the second coach crashed into a column northwest of the condominium, sandwiched between the rear of the first coach, with the left rear of the second coach crashing into a column northeast of the building.

The axles of the front bogie truck and all axles of the front bogie truck of the third coach were separated completely from the coach and thrown to the left of the railway tracks and the two axles of the rear bogie truck to the right (Fig. 5). All axles of the fourth coach were thrown to the right and two axles of the front bogie truck were thrown to the left, leaving the left wheels of the two axles of the rear bogie truck suspended in the air.

The sixth and seventh coaches did not derail. The rear of the train came to rest 1825 m from Amagasaki Station (Fig. 5).

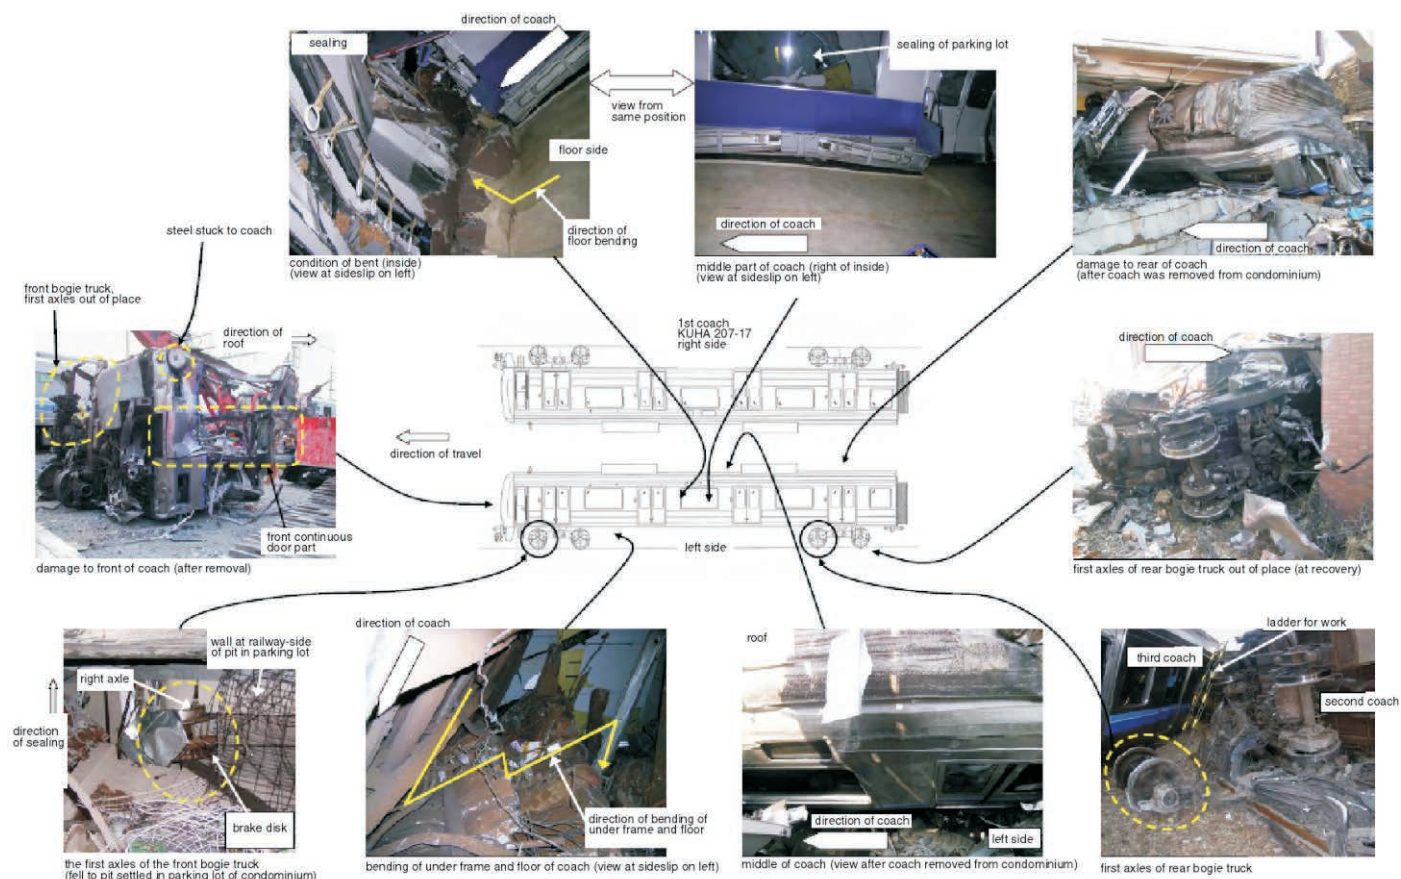
(a) first coach

The front (first) coach was turned over on its side and essentially demolished. A steel bar had pierced the front

of the coach at lower right. The first axle of the front bogie truck were separated from the truck itself and dropped onto the automatic parking lot at the ground floor of the condominium. The first axle of the rear bogie truck was also thrown from the bogie truck and dropped on the right side to the right of the track at 1752 m (**Figs. 5, 6(a)**)

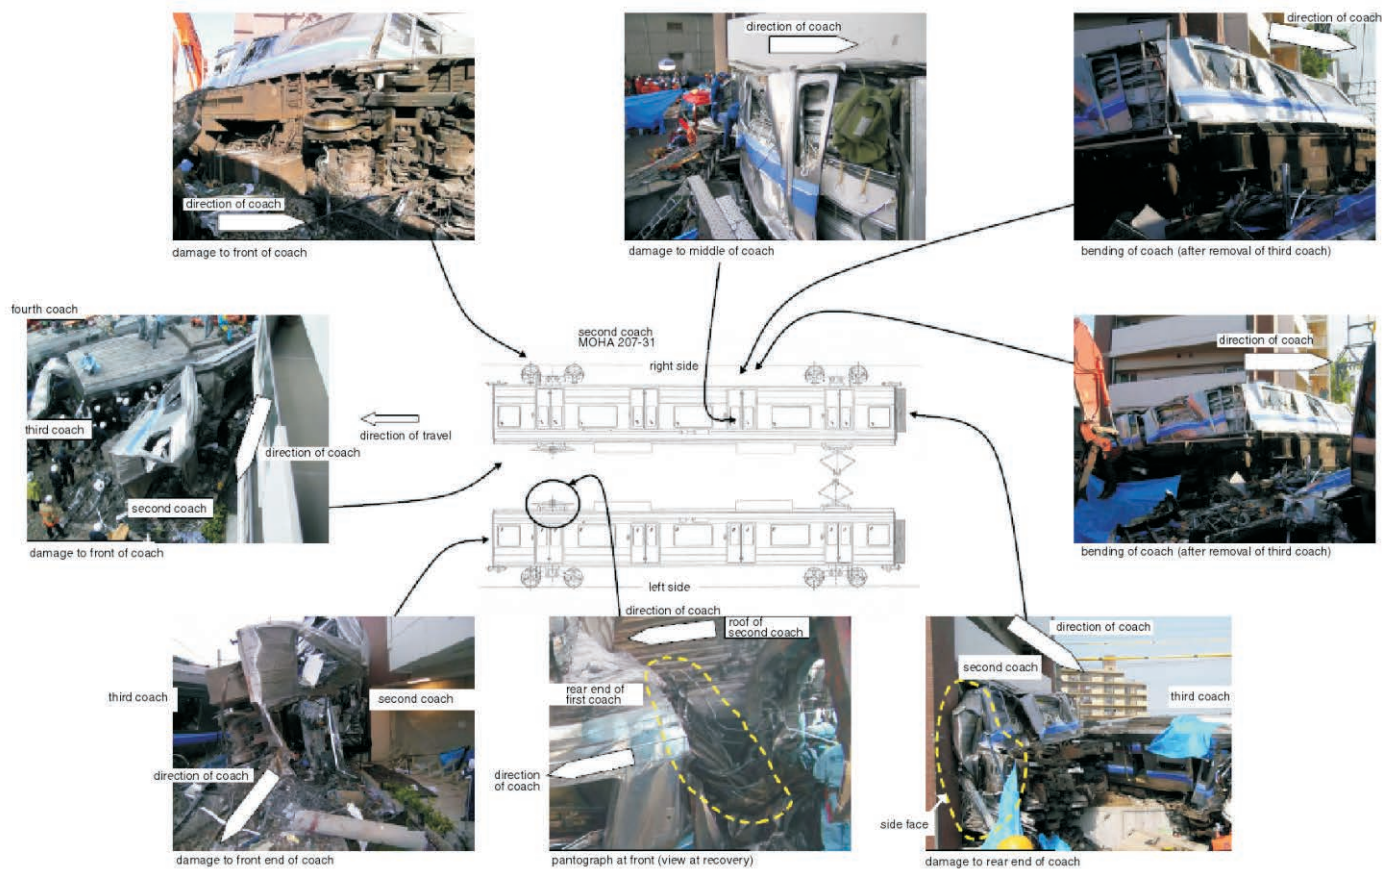
(b) second coach

The left side of the center of the second coach was crushed against a pillar northwest of the condominium, sandwiching the back of the first coach, and the rear left side was crushed against the northeast pillar of the condominium, catching it there.

The front pantograph was separated off body and fell to the ground between the first and second coaches. The rear pantograph fell near pillar No.41 (**Figs. 5, 6(b)**).

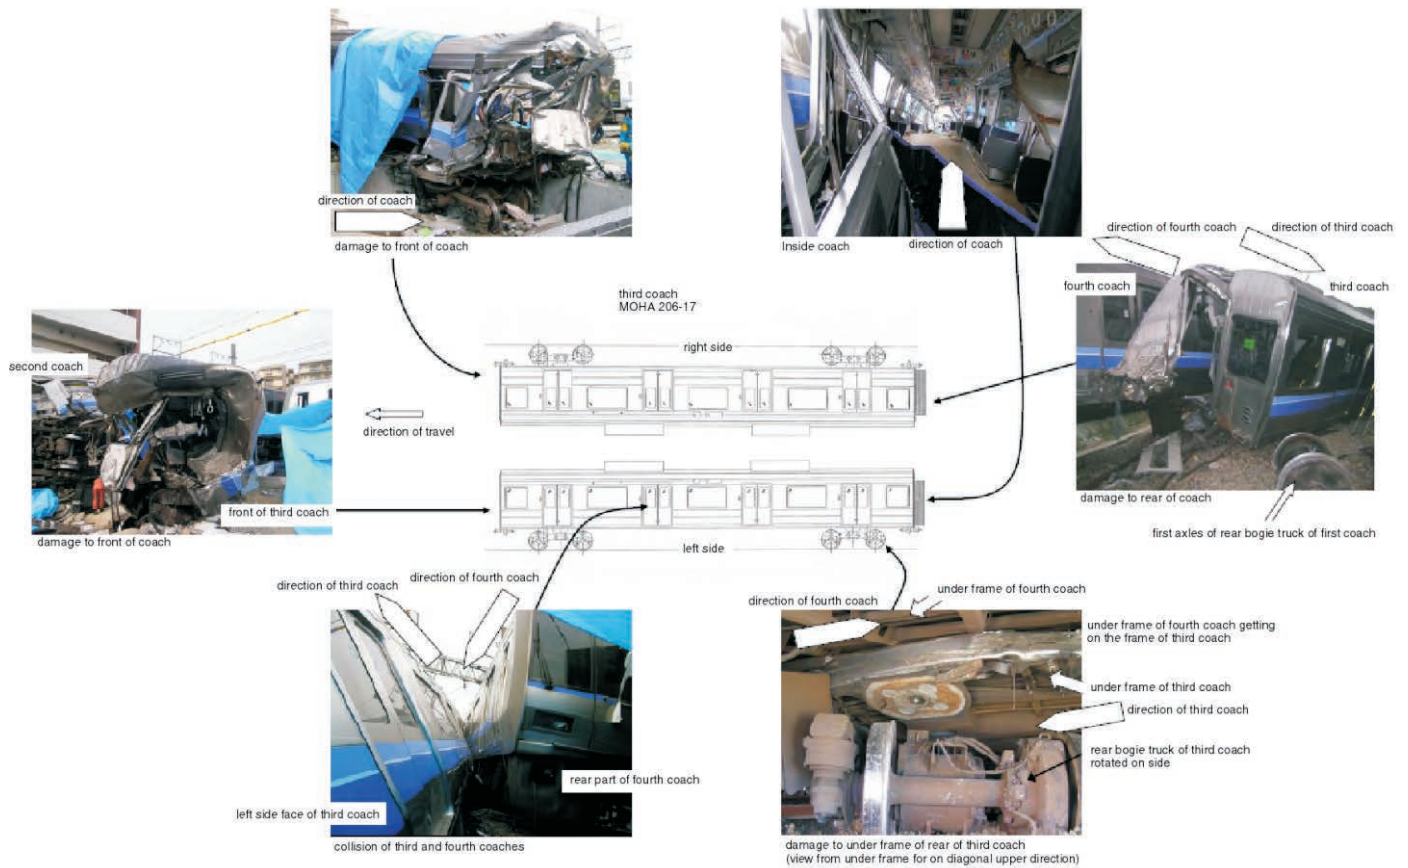
(c) third coach

The third coach was turned around in reverse against the direction of travel (**Fig. 5**) to block on the down line (direction of Tsukaguchi Station). The front and rear of the fourth coach were damaged and the frame was highly distorted (**Figs. 5, 6(c)**).

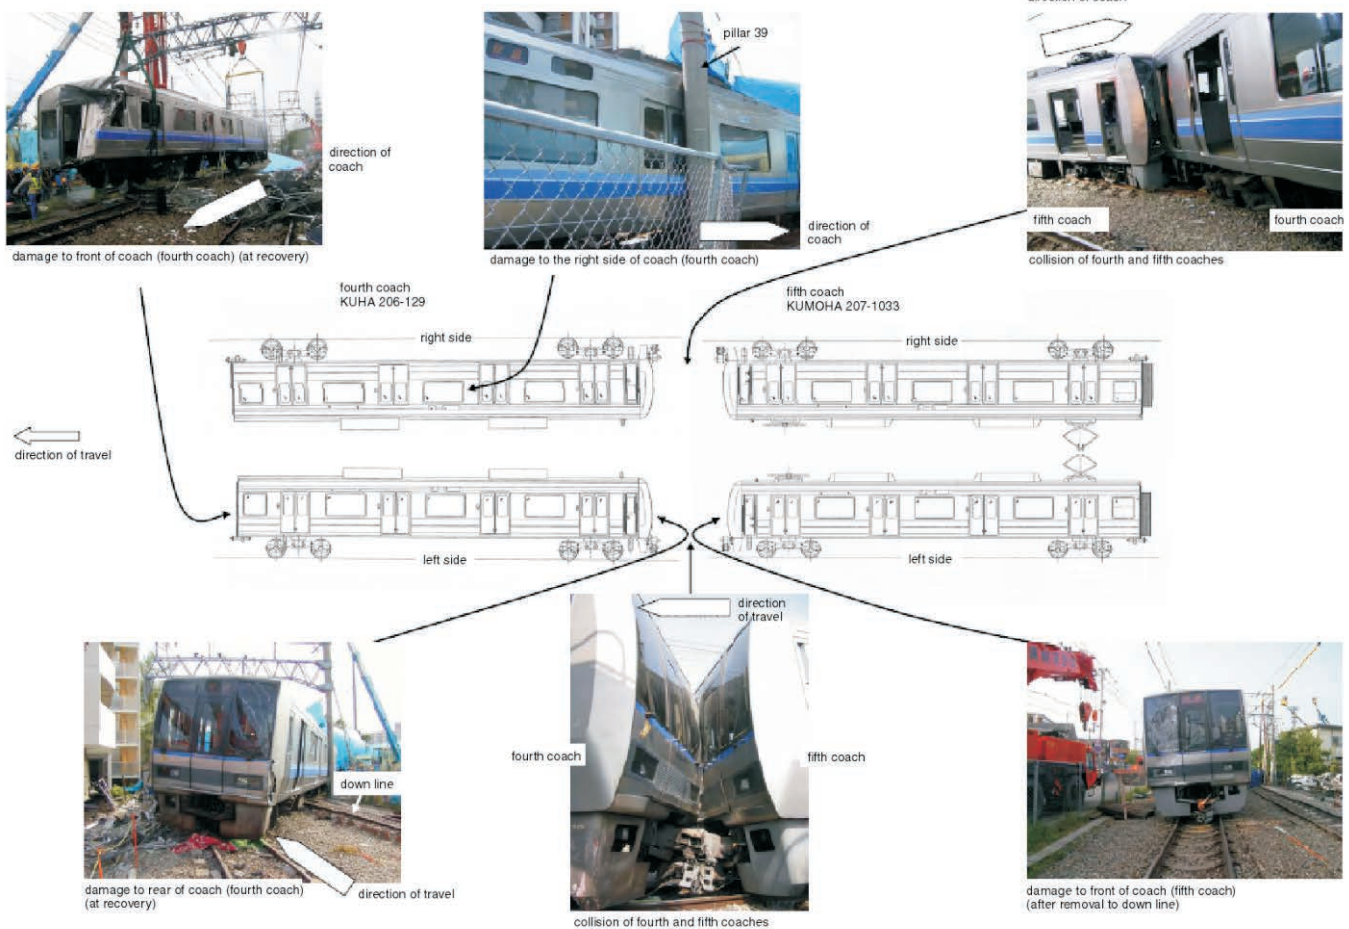
(d) fourth and fifth coaches

front damaged and the right side of the center rested against Pillar No.39, which it had damaged (**Figs. 5, 6(d)**).

The front coupler of the fifth coach was damaged (**Figs. 5, 6(d)**).

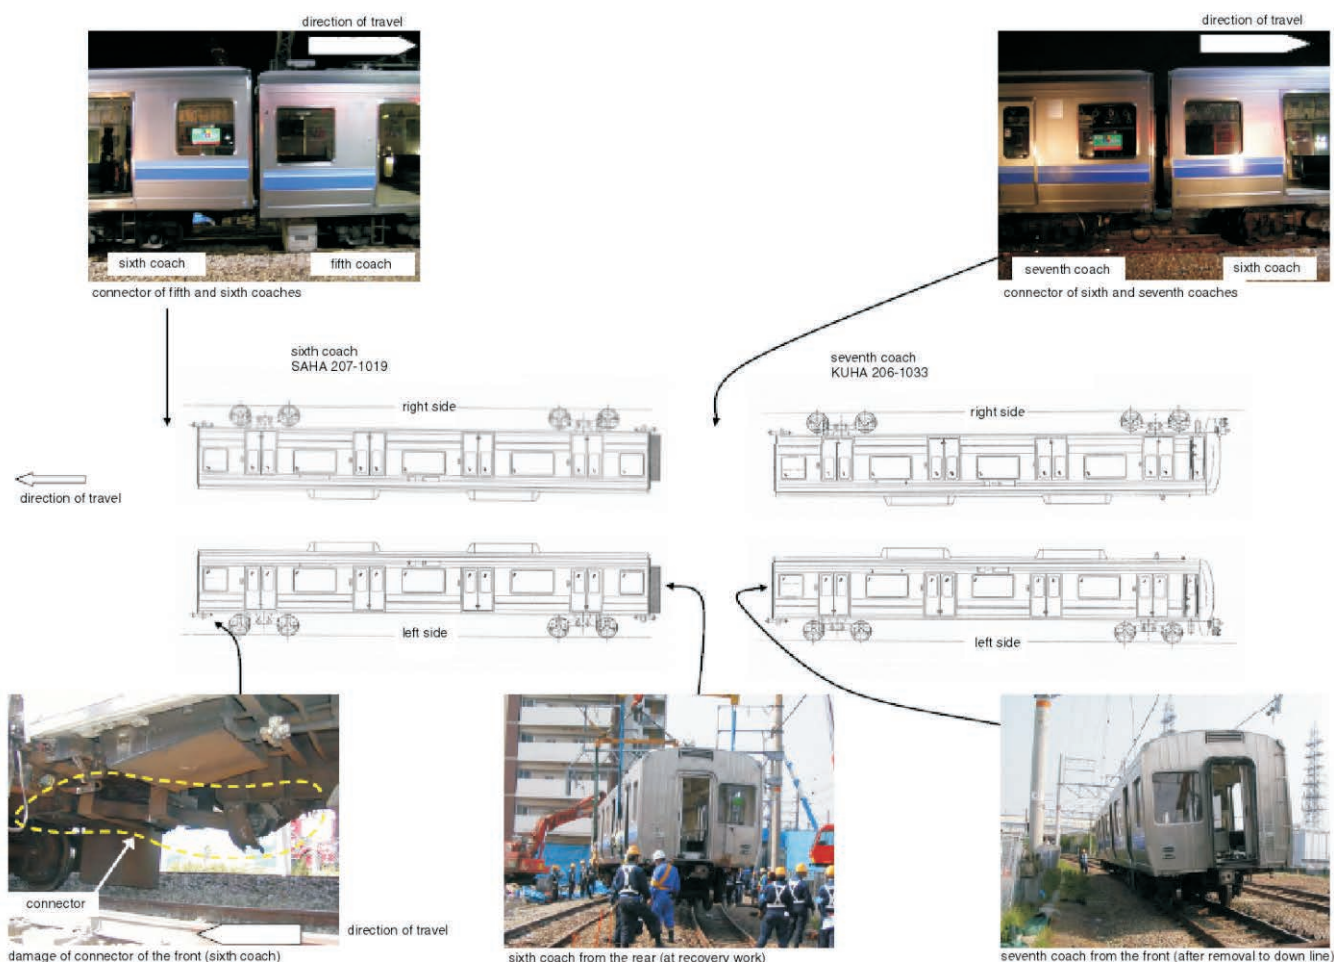
(e) sixth and seventh coaches

The front coupler of the sixth coach was damaged (**Figs. 5, 6(e)**).

No specific damage to the seventh coach was observed (**Figs. 5, 6(e)**).

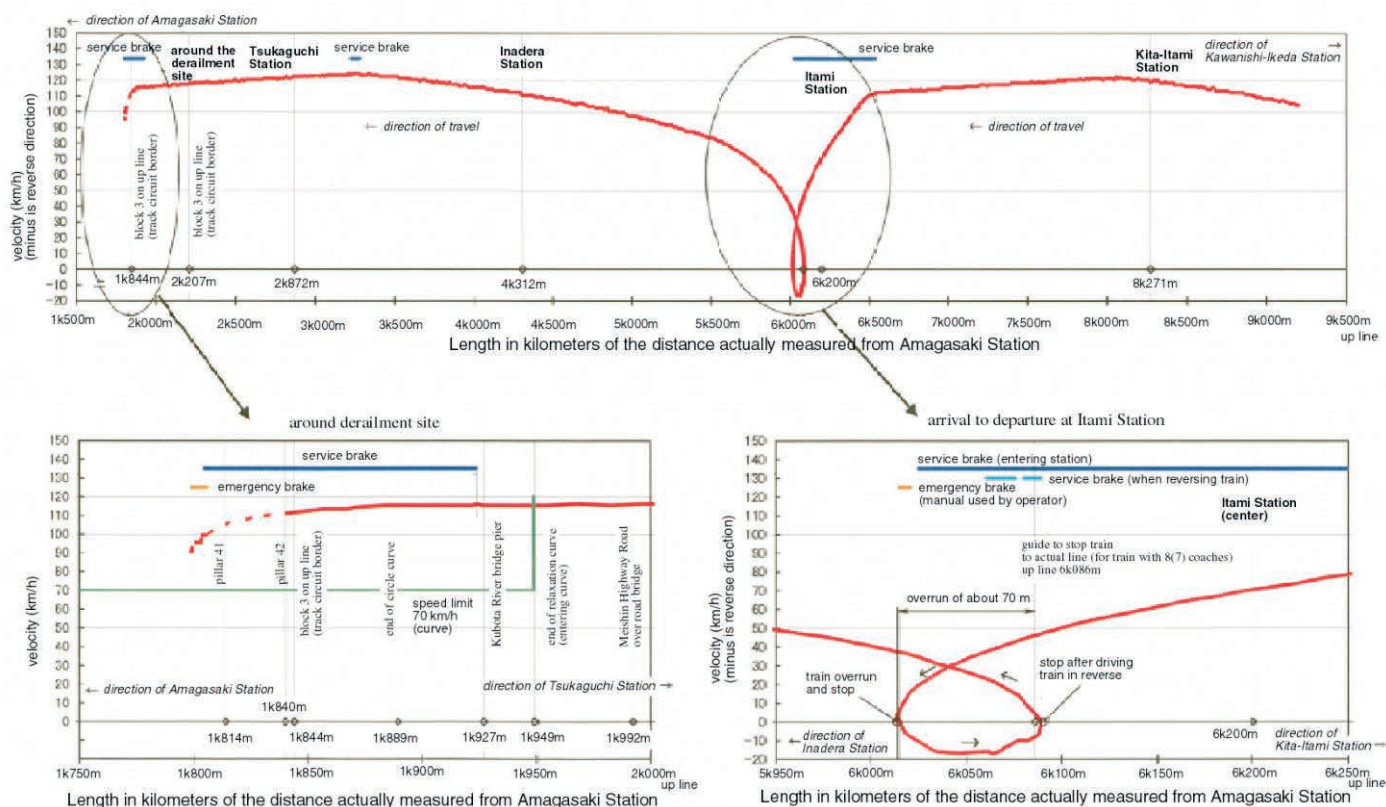
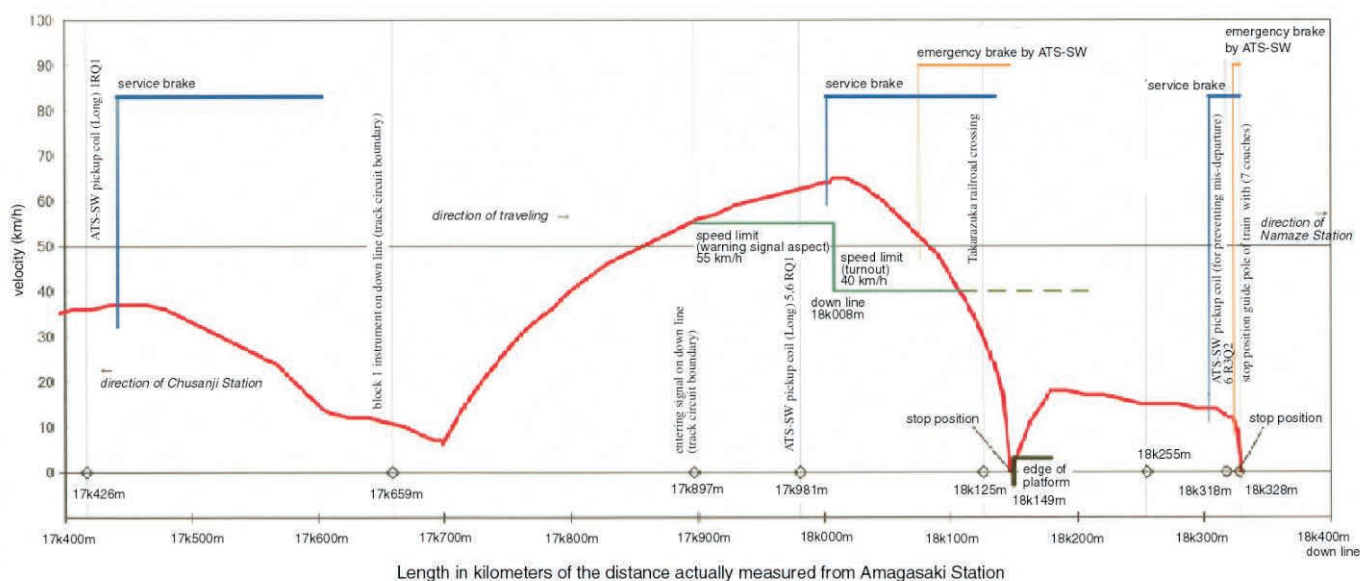
**Fig. 10.** Records recorded by ATS type equipment (rough estimate).

(a) Kita-Itami Station to accident site. This estimate is the ATS-P record from the first coach conducting approximate correction of wheel diameter and process time of location detection signal of ATS-P wayside coil.

(b) dead-head train arriving at Takarazuka Station. Unlike in (a), this estimate is not compensated for.

**Figure 10** indicates that the train overran the platform by 70 m and backed up at Itami Station. It also indicates that a regular braking signal was issued when the train entered the right curve 304 m in radius beginning from the up line (direction of Tsukaguchi Station) 1949 m traveling at over 110 km/h. ATS-SW emergency braking directives were issued twice when the train arrived at Takarazuka Station.

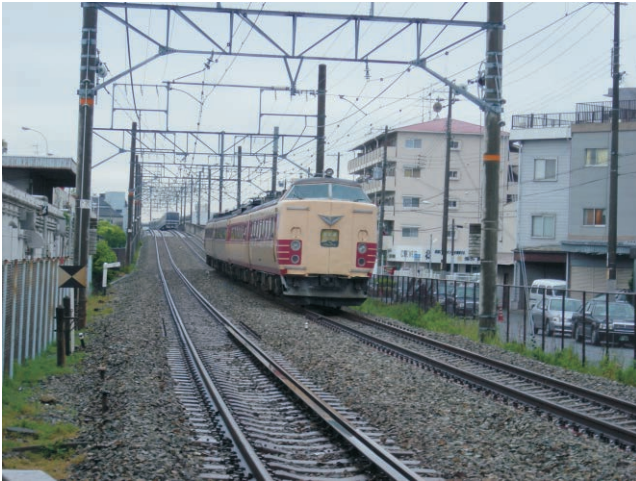
**Fig. 14.** Dead-head train, Limited Express No.3013M (Kita-Kinki No.3) traveling toward the derailment on the opposite track after the derailment (by courtesy of the Amagasaki Municipal Fire Department).

Just after the derailment, down line Limited Express No.3013M (Kita-Kinki No.3) was traveling toward the derailment on the opposite track, but the driver received no signals from the derailed train.
