Paper:

Damage to Seisho Bypass due to Storm Waves During Typhoon 0709

Takaaki Uda*, Toshiro San-nami**, and Toshinori Ishikawa*

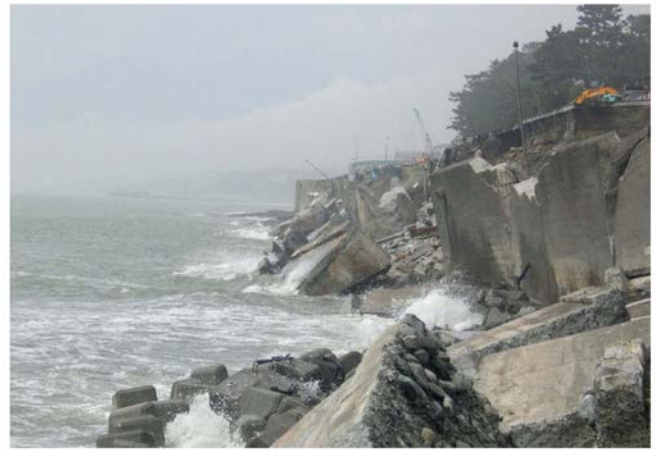
Fig. 4. Collapsed Seisho Bypass seawall, September 9, 2007.

We investigated highway damage and beach topography on September 9, 2007, immediately after the typhoon, and on October 8 (Fig. 4). The highway seawall was found to have tilted and collapsed and was being directly damaged by breaking waves. No beach was left in front of the collapsed seawall, which waves then traversed.

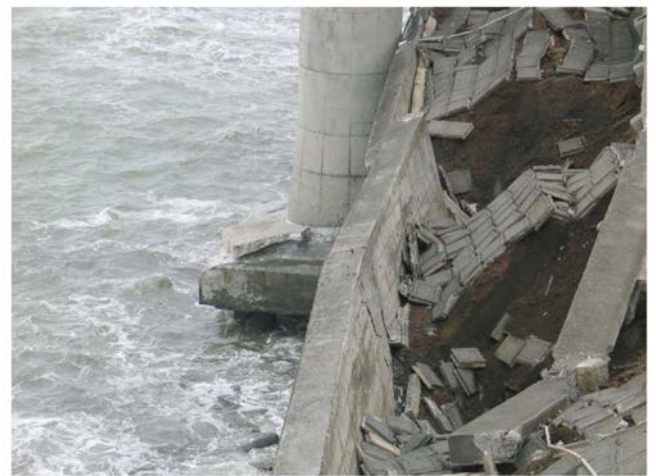
Fig. 5. Damaged Ginpa Bridge footing and tilted seawall, September 9, 2007.

The seawall leaned against the scoured pier of the Ginpa Bridge, which connects the highway to the Ninomiya Interchange (Fig. 5). All filler inside the sea-

wall had been removed by wave action and foundation piers under the bridge footing were exposed. Before the typhoon, this footing was buried under a sandy beach, which was eroded by at least 3 m during the typhoon, exposing the footing.

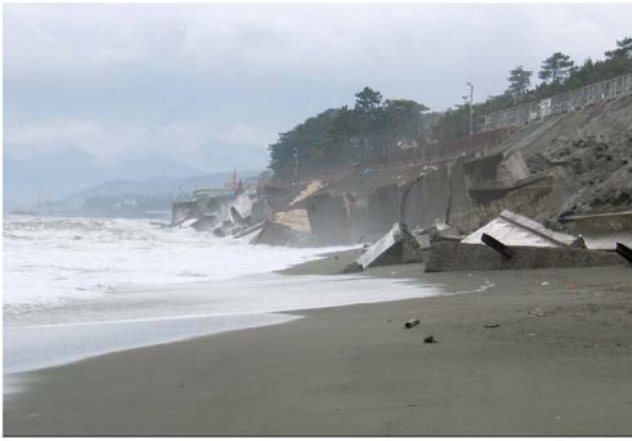
Fig. 6. Damaged highway and adjacent beach, October 8, 2007.

By October 8, 2007, (Fig. 6, east of damaged area) the seawall in front of the highway had collapsed and part of

the debris was buried under the beach. Beyond this site, waves broke directly on the collapsed seawall, indicating that the site had been severely eroded. Damage to the highway was greatest there.

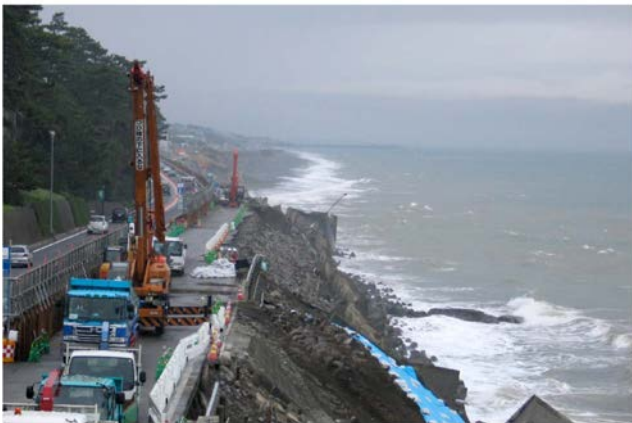
Fig. 7. Damaged Seisho Bypass seen from the top of the Ginpa Bridge looking east, October 8, 2007.

By October 8 (Fig. 7, top of the Ginpa Bridge looking east), the shoreline extending from Ohiso Port had retreated significantly landward east of the damaged area, resulting in seaward invasion of the damaged area (Fig. 8, west part of the damaged highway taken from the same location as Fig. 7. Circle: Kinpa Bridge). The beach under the bridge had been eroded entirely away. Riprap was temporarily placed along the coastline to rebuild the road.

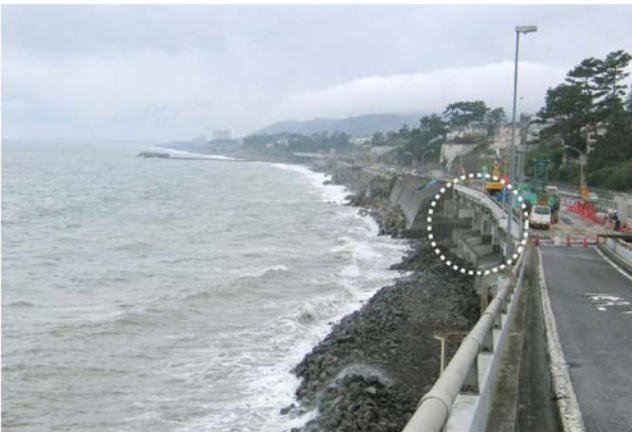
Fig. 8. Damaged Seisho Bypass seen from the top of the Ginpa Bridge looking west, October 8, 2007.

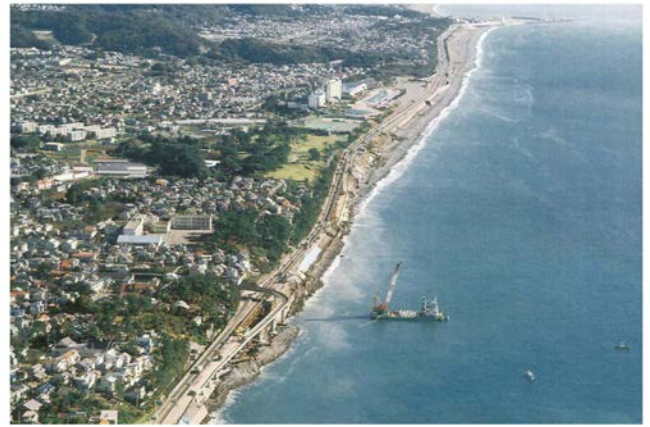
Fig. 9. Oblique aerial photograph of the damaged highway, November 13, 2007.

Although emergency repairs had been made to the damaged area by November 13, 2007 (Fig. 9), the shoreline extending west from Ohiso Port was interrupted east of the damaged site, and the foreshore in front of the damaged highway had completely disappeared. The extrapolated shoreline extending from Ohiso Port intersects the damaged highway, indicating that the damaged highway functioned as a groin against the longshore sand transport.

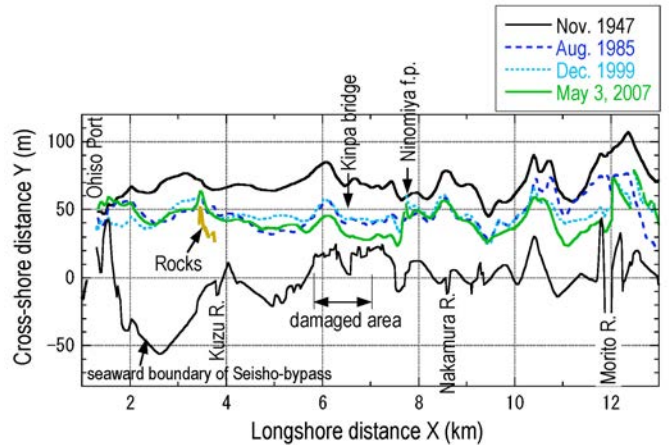
Fig. 10. Long-term pre-typhoon shoreline changes.

The foreshore width in 1947 averaged at least 20 m wider than in the reference year of 1999. By 1985, the shoreline had receded over the entire area except near Ohio Port, decreasing the foreshore width from 60 m in 1947 to 20 m in 1985 in front of the damaged area of the Seisho Bypass, making it increasingly vulnerable to wave

Between 1985 and 1999, the shoreline receded dramatically between the Morito River and 1 km east of it. By May 3, 2007, this extended to where the highway was damaged, east of the Ninomiya fishing port breakwater and east of the Morito River, where the shoreline had receded significantly since 1985. The foreshore width in front of the damaged highway had thus been reduced to 10 m, accelerating highway collapse.

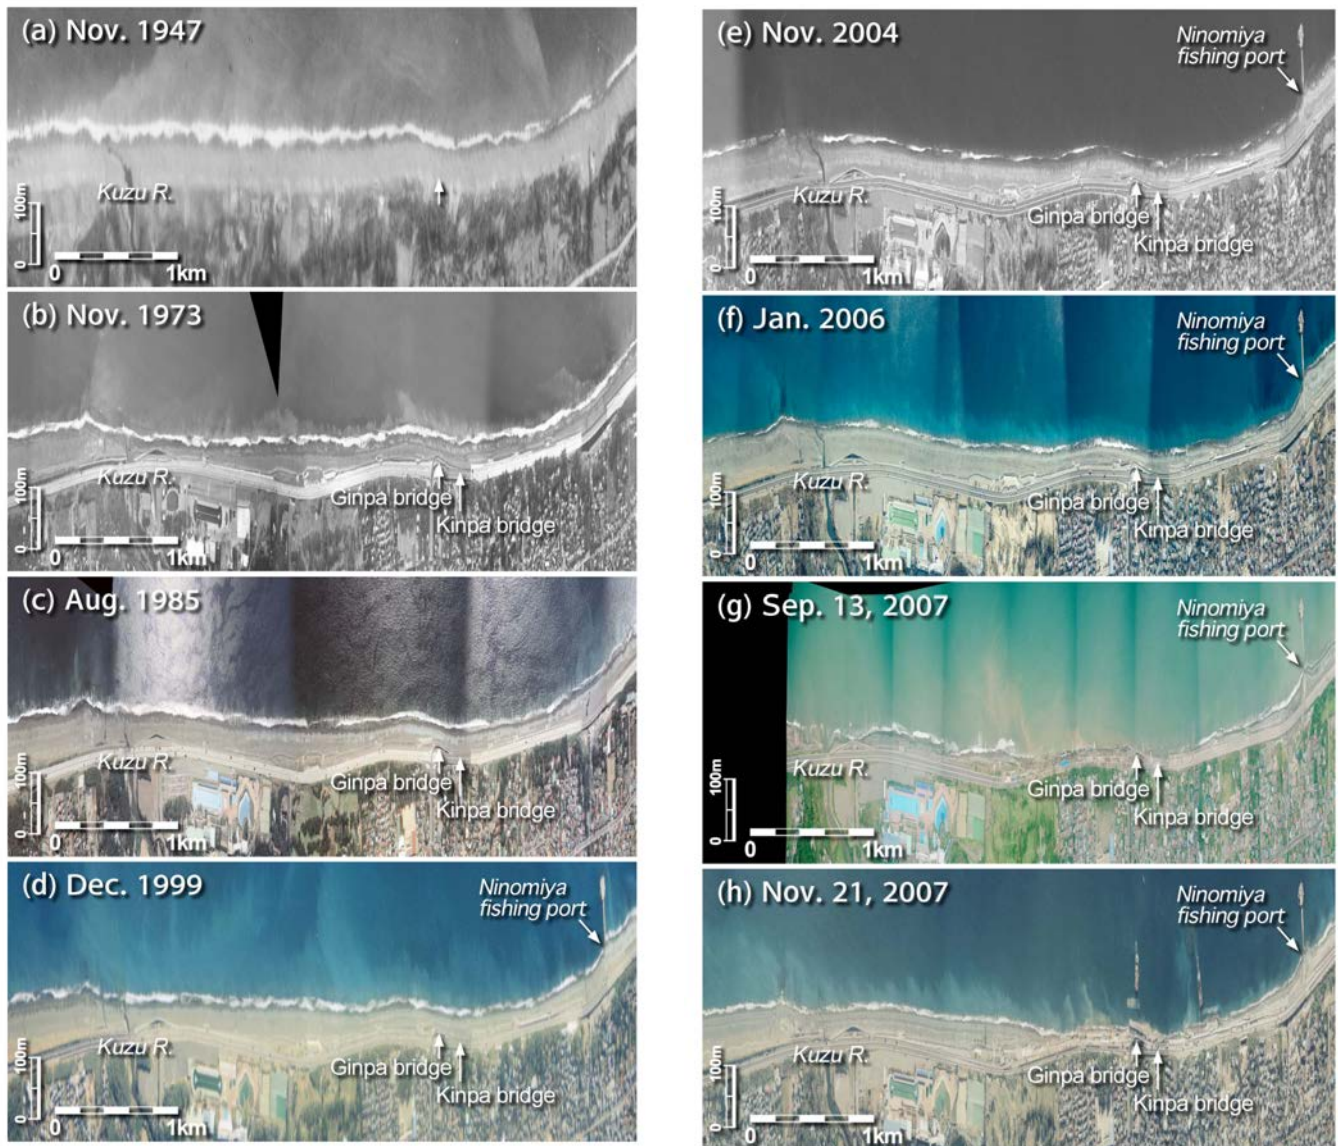
Fig. 11. Comparison of coastal changes in the damaged area using distorted aerial photographs.

In 1947 (**Fig. 11(a)**), the shoreline extended smoothly with an 80-m-wide foreshore, and a small shoreline projection where the Ginpa Bridge of the Seisho Bypass was later constructed (arrow, **Fig. 11(a)**). In 1973 (**Fig. 11(b)**), when the Seisho Bypass was under construction, the highway protruded seaward at two locations near the Kuzu River and the Ginpa Bridge as construction proceeded

along the projecting coastline. Highway construction along the backshore narrowed the beach, which had been 80 m wide in 1947. The Seisho Bypass was nearly completed in 1985 (Fig. 11(c)) and the Ninomiya fishing port breakwater was extended in 1999 (Fig. 11(d)). Although shoreline changes between the Kinpa Bridge and port were small compared to those in 1985, the beach in front of the Kinpa and Ginpa Bridges was narrow because of the projection of the highway itself, producing weak points lacking a sufficient buffer zone against waves.

The difference in the shoreline on both sides of the fishing port increased, and the foreshore on the east side was narrowed by 2004 (Fig. 11(e)), with the extension of the breakwater starting to block eastward longshore sand transport. The shoreline difference on both sides of the fishing port further increased, and the foreshore completely disappeared between the Ginpa Bridge and Ninomiya fishing port in 2006 (Fig. 11(f)).

On September 13, 2007, one week after the typhoon, the foreshore also disappeared around the Kuzu River and near the Ginpa and Kinpa Bridges, the debris of the collapsed highway was exposed to waves (Fig. 11(g)). In contrast, on the east side of the fishing port, the foreshore was wider and the shoreline had retreated on the west side compared to its location on January 7, 2006. These shoreline changes indicate that during Typhoon 0709, westward longshore sand transport was predominated, and part of shoreline changes was caused by the blockage of sand transport due to the breakwater. By November 2007, the foreshore had widened over an extensive area between the Kuzu River and the Ginpa Bridge (Fig. 11(h)), but the sandy beach in front of the Ginpa and Kinpa Bridges did not recover. With longshore sand transport blocked by the fishing port breakwater and no sandy beach left in front of the Ginpa and Kinpa Bridges, the only sand source for restoring the foreshore was from onshore sand transport, indicating that part of the sand was first transported offshore by storm waves, then transported to the foreshore by onshore sand transport during calm conditions. No sand remained in the damaged area and no sand source was left, preventing onshore sand transport.

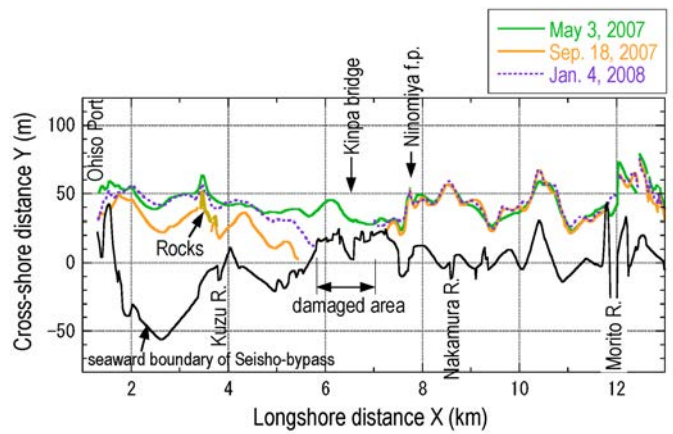
In a study of short-term shoreline changes around the damaged highway shown through the comparison of aerial photographs taken before and after the typhoon (Fig. 12), we found that the shoreline had retreated until May 2007 (Fig. 10). By September 18, soon after the typhoon, significant shoreline recession had occurred east of the fishing port, exposing the seawall protecting the highway for 1.9 km, and the shoreline receded up to 40 m in the damaged area. The shoreline between Ohiso Port and the damaged highway eroded by storm waves had recovered in part by January 4, 2008, with sand accumulating on the foreshore, as confirmed by on-site inspection, due to onshore sand transport after rapid erosion of the berm by storm waves.

Fig. 12. Short-term pre- and post-typhoon shoreline changes.

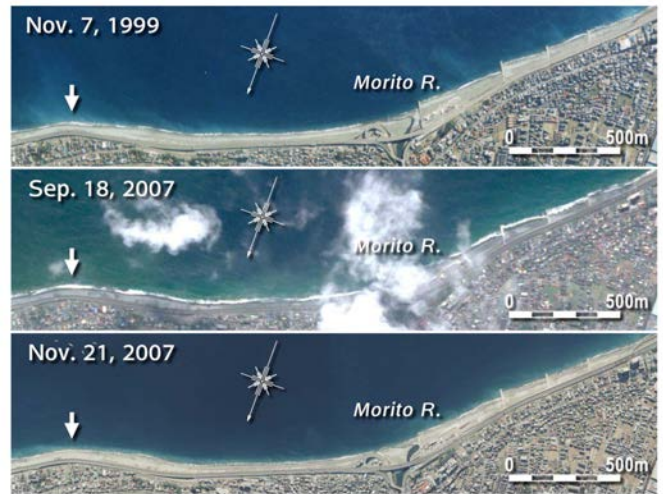
Fig. 13. Comparison of coastal changes around the Morito River.

Aerial photographs of the area around the Morito River in 1999 and 2007 (Fig. 13) shows how the shoreline extended smoothly alongshore in 1999, but had receded between the Morito River and the shoreline projection located 1.3 km east of the river by September 18, 2007, shortly after the storm (arrow, Fig. 13). The shoreline did not recover until November 21, 2007. Around the three groins located west of the Morito River, eastward longshore sand transport continued to predominate, since the shoreline advanced on the west side of the groins. Taking these facts into account, westward and eastward longshore sand transport must meet at the mouth of the Morito River, which should result in the shoreline advancing. In fact, however, this did not happen, indicating the possi-

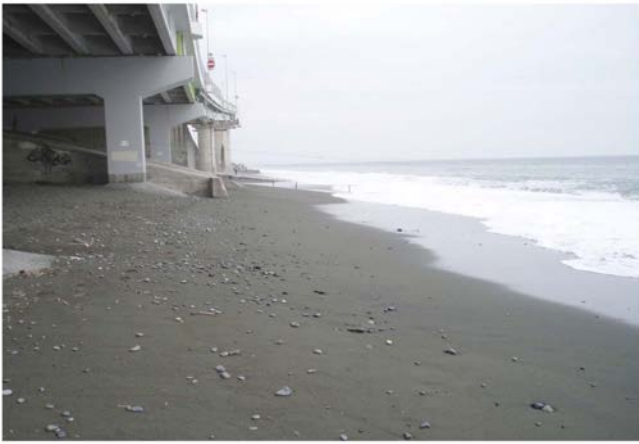
Fig. 14. 20-m-wide foreshore left under the Kinpa Bridge, September 4, 2007.

Near the Kinpa and Ginpa Bridges, which were both severely damaged, photographs of coastal conditions before the typhoon showed a 20-m-wide foreshore under the Kinpa Bridge on September 4, 2007, two days before the typhoon (**Fig. 14**). Similarly, on December 1, 2006 (**Fig. 15**), the base of the Ginpa Bridge was protected by concrete blocks on the shoreface, so the 20-m-wide foreshore in front of the bridge eroded after that time (pier denoted by an arrow, **Fig. 15**, the same as in **Fig. 5**).

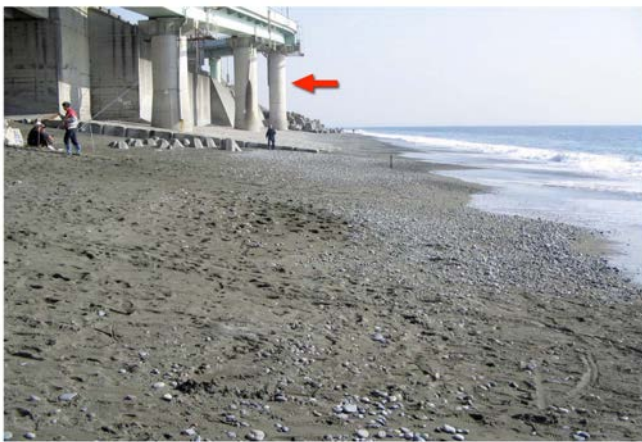
Fig. 15. Beach under the Ginpa Bridge, December 1, 2006.

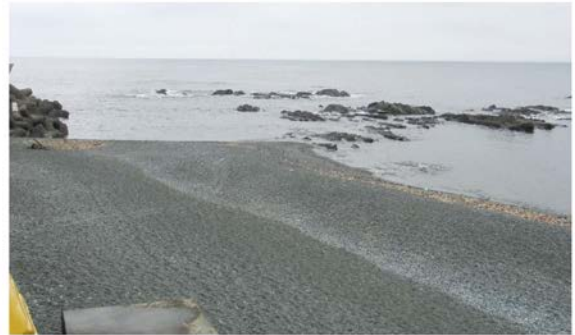
(a) July 2, 2007

Studies of beach changes before and after damage on the west side of the Ohiso Port breakwater, considered a fixed boundary for longshore sand transport, showed on July 2, 2007, that a salient had formed behind reefs next to the breakwater due to the deposition of gravel (**Fig. 16(a)**). By September 12 after the typhoon, gravel had been transported away, exposing the base of the rocks

Fig. 16. Comparison of beach conditions immediately west of Ohiso Port on July 2 and on September 12, 2007, after the typhoon.

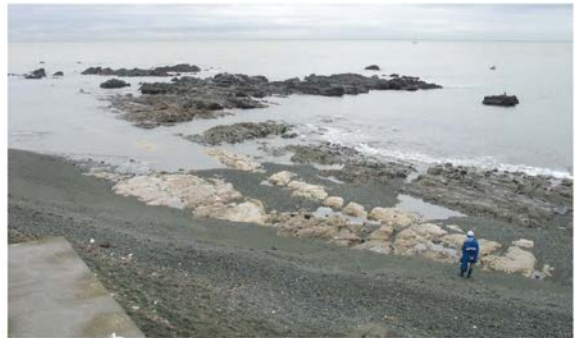
(b) September 12, 2007

(**Fig. 16(b)**). The base of the rocks was white in front of the berm, meaning that part of rocks had been buried under the gravel layer without exposure to ultraviolet light and wave action (Uda and Ishikawa, 2007), and black further seaward. This rock exposure was considered due to the movement of gravel by westward (rightward in the figure) longshore sand transport, because a long impermeable breakwater extends immediately east of this site.

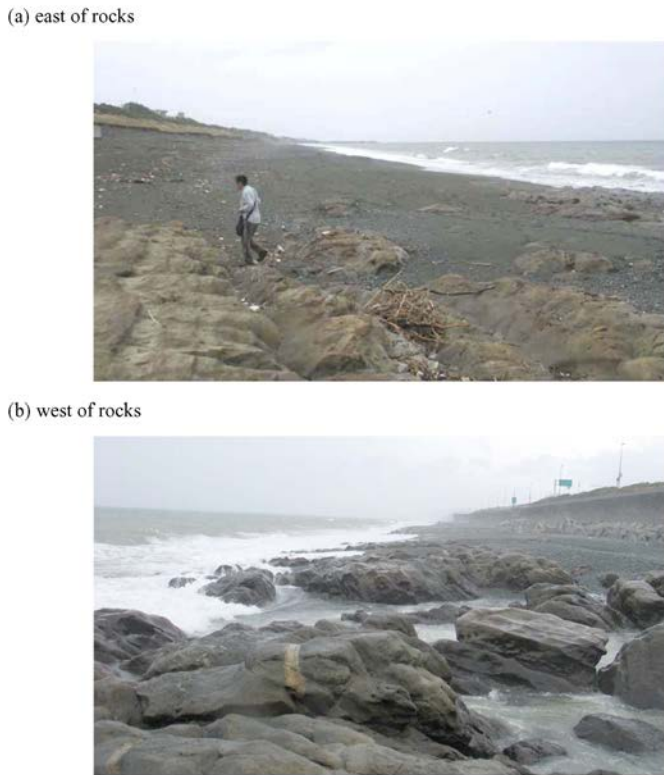
The base of rocks, which had long been buried under the sand layer, was exposed 270 m east of the Kuzu River. On the east side of these rocks, a berm had formed by October 8 due to sand deposition (**Fig. 17(a)**). On the west side, however, ground elevation was significantly lower, isolating individual rocks (**Fig. 17(b)**). Such asymmetrical beach changes, with sand accumulating on the east side and beach erosion on the west side, imply that westward longshore sand transport prevailed during the storm. Field observation on November 20 showed that sand reacumulated and buried the rocks (**Figs. 18(a)** and **18(b)**) suggesting that rapid landward sand transport occurred between October 8 and November 20 under calm wave conditions.

Fig. 17. Exposure of rocks east of the Kuzu River on October 8, 2007: (a) east of rocks and (b) west of rocks.

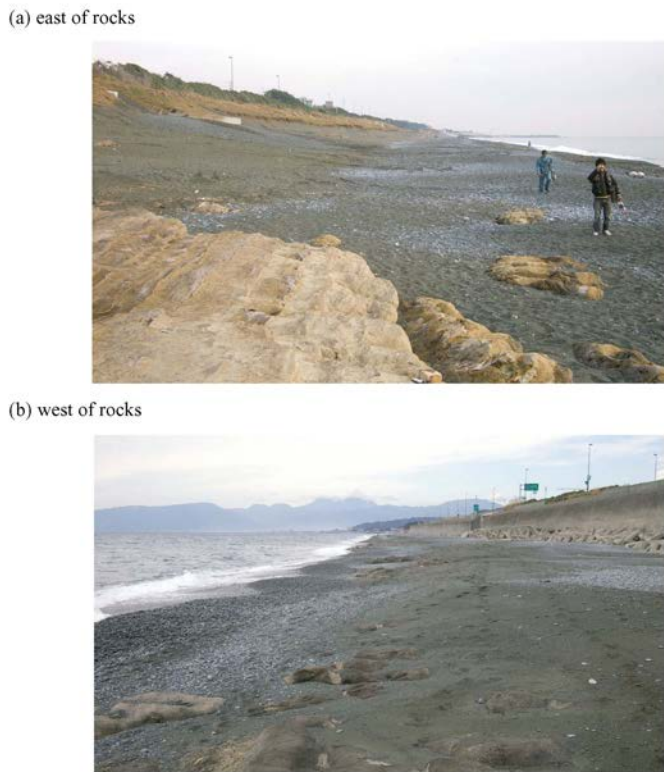
Fig. 18. Rocks recovered by sand accumulation on November 20, 2007: (a) east of rocks and (b) west of rocks.

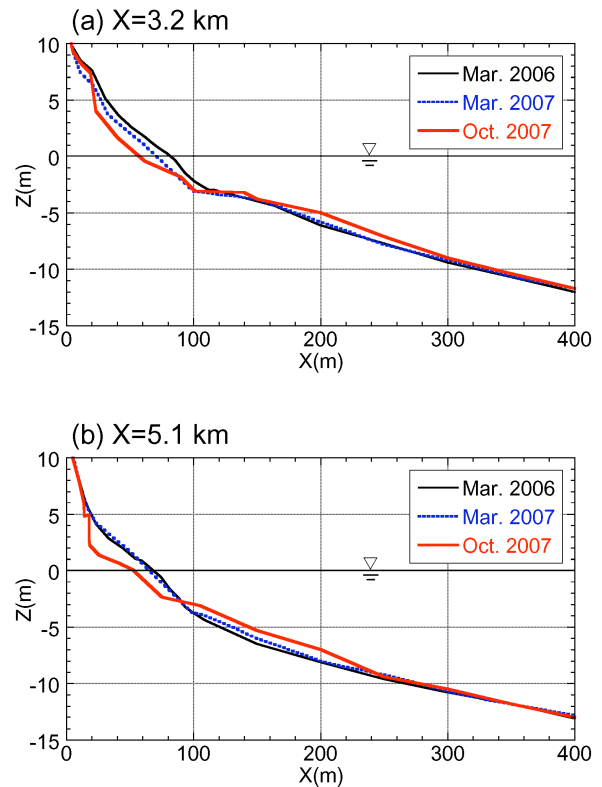
We studied changes in longitudinal profiles using seabed-sounding data taken before and after the typhoon (**Fig. 19(a)**, change in the longitudinal profile along survey line X=3.2 km near rocks east of the Kuzu River). The

Fig. 19. Change in longitudinal profiles along survey lines X=3.2 km and X=5.1 km.

foreshore was significantly eroded until October 2007 after the storm, and sand accumulated in the depth zone between -4 and -9 m. No beach changes were observed in the depth zone deeper than -9 m, however, implying that the depth of closure, h_c , of this coast is roughly -9 m. In the change in the longitudinal profile along survey line X=5.1 km, 700 m east of the damaged area (Fig. 19(b)), ground elevation was lowered 2.5 m on the foreshore, and eroded sand was transported offshore and deposited up to a depth of -9 m during the storm. These beach changes clearly show the occurrence of rapid seaward sand transport under storm conditions.

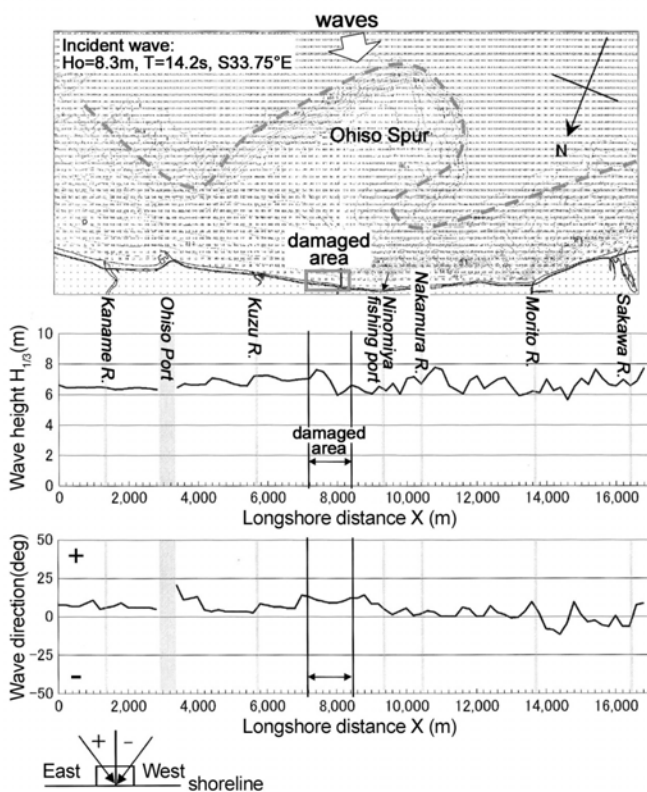
Fig. 20. Longshore distribution of predicted significant wave height and angle of incident waves.

assumed in the calculation, making westward longshore sand transport predominant in the area where the highway was damaged. In other areas, the wave direction varied resulting in spatial changes in the direction of longshore sand transport that differed with local conditions.

Because of the longshore distribution of the breaker angle, westward longshore sand transport generally predominated between Ohiso Port and the Morito River, whereas eastward longshore sand transport predominated west of

the Morito River. These features agree with results of shoreline change analysis. A larger wave incident angle causing large longshore sand transport was predicted in the damaged area. From this fact, the damaged area was considered to be significantly eroded, and around the Morito River where eastward and westward longshore sand transport meet, part of sand was considered to be transported offshore through the submarine canyon, causing a net sand loss.
