# Mechanoluminescent Testing as an Efficient Inspection Technique for the Management of Infrastructures

Akihito Yoshida\*, Linsheng Liu\*, Dong Tu\*,  
Shigenobu Kainuma\*,\*\* , and Chao-Nan Xu\*,\*\*\*,†

\*Advanced Manufacturing Research Institute, National Institute of Advanced Industrial Science and Technology  
Shuku-machi, Tosu, Saga 841-0052, Japan

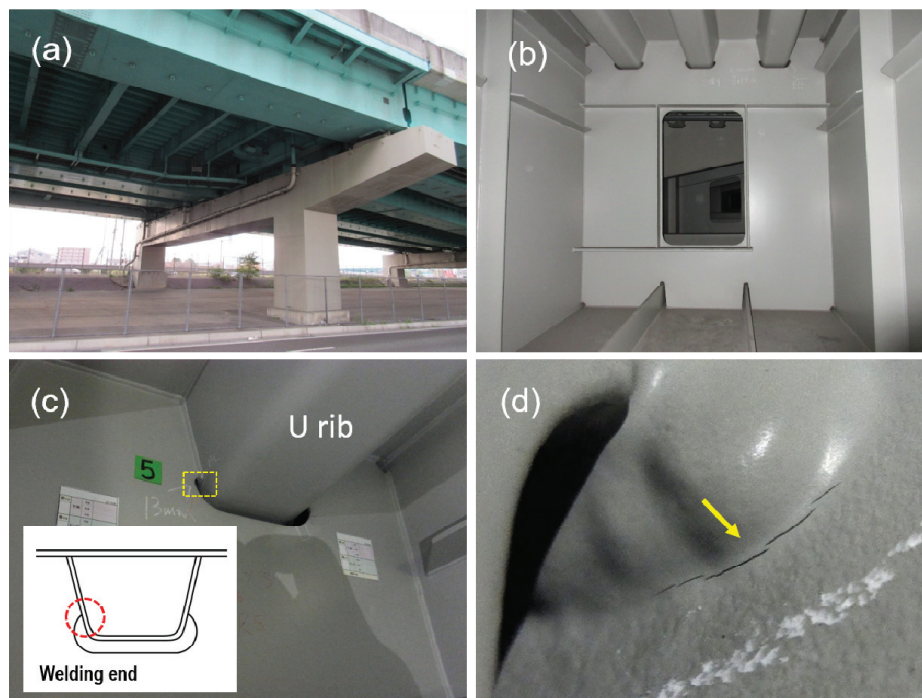
Preliminary visual inspection results on the box girder showed more than 300 cracks in the corrosion-proof coating (coating cracks) in the relevant section (two spans). In particular, many coating cracks were found at the turn around weld at the intersection of the U rib and the cross rib (**Figs. 2(c)** and **(d)**). It is conventionally known that complex deformation tends to occur locally owing to vehicle traffic around the intersection parts, which are subject to relatively higher stress concentration that leads to fatigue cracks [14,15]. Therefore, the authors selected the intersection of the U rib and the lateral rib, where fatigue cracks tend to occur, as the inspection target of this field testing. In principle, coating cracks do not necessarily mean fatigue cracks. It is difficult to judge the presence of latent fatigue cracks under coating cracks detected by visual inspection. The authors sought to judge the presence of fatigue cracks under corrosion-proof coating using the ML inspection technology.

**Fig. 2.** (a) Typical photo image of a highway bridge with box girders and (b) the inside of a steel box girder. (c) Test target area in this study. Inset shows a schematic illustration of a U rib. The rib connection area is marked with a red-dashed circle. (d) Enlarged image of the frame shown in (c). The film cracking is indicated with a yellow arrow.

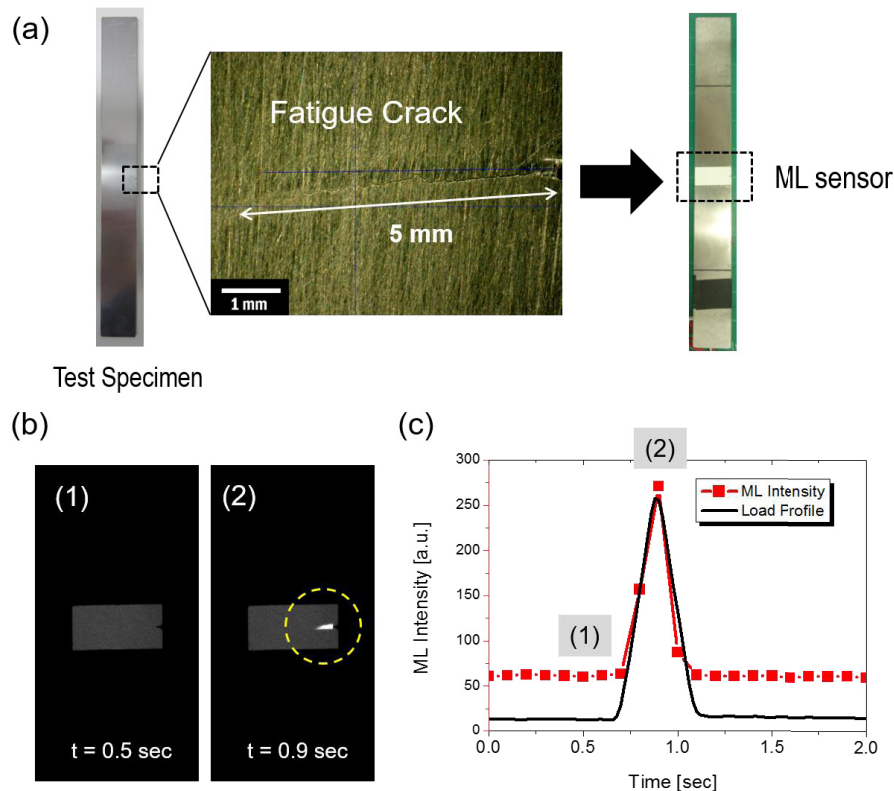
**Fig. 4.** Results of a preliminary experiment to visualize fatigue cracks. (a) Test specimen with a fatigue crack. (b) Images obtained at no-load (1) and on-load (2). (c) Time-dependent luminescent intensity in image (2) along with the load profile of tensile test.

were applied to cover the fatigue cracks (Fig. 4(a)). Tensile testing was performed using this specimen. Fig. 4(b) shows an example of an image obtained with the CCD camera system. Image (1) was obtained when no loads were applied, while Image (2) was obtained when loads were applied. Luminescence was detected on the right side of Image (2); the length and position of the luminescence correlate well with those of the fatigue crack. Fig. 4(c) shows chronological changes of luminescence intensity and load profiles during the tensile testing. The figure shows that luminescence in Image (2) resulted from the external load and thus was mechanoluminescence. The preliminary experiments indicated that fatigue cracks can be detected and identified by measuring mechanoluminescence from the ML sensor.

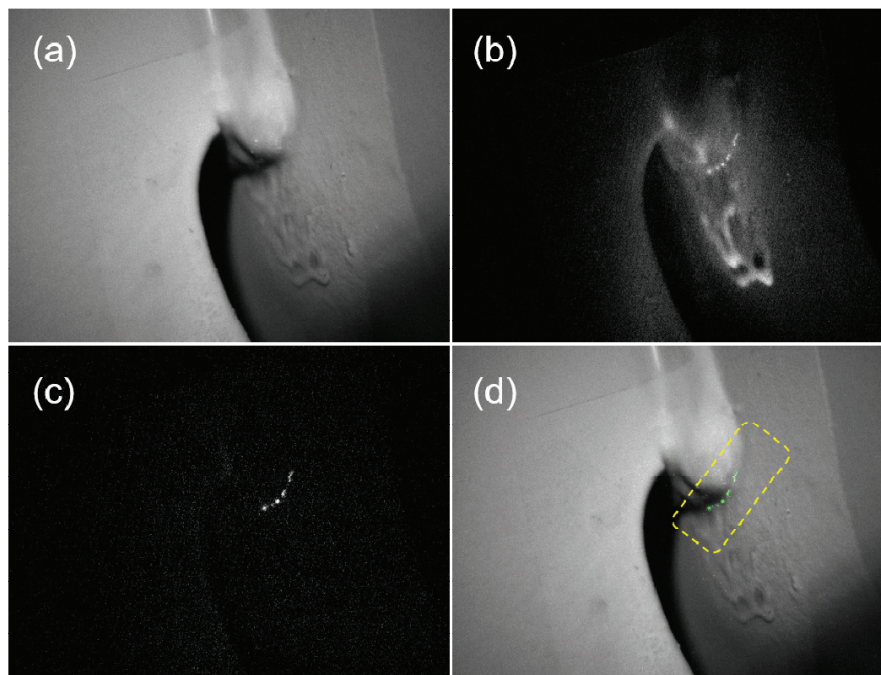
This section describes field testing results. Firstly, an example of actual ML detection in the testing is presented. Fig. 5 shows measurement results using the CCD camera system at an inspection point (denoted as T1). Fig. 5(a) is an image in a clear visual field around the rib intersection with the ML sensor implemented. Fig. 5(b) presents an image obtained when a vehicle load was applied. Note that the timing of loading owing to passing vehicles can be determined by the concurrent strain measurement. ML can be observed around the weld joint in the image. This luminescence is similar to that observed in the preliminary

**Fig. 5.** Typical images obtained by ML test for T1. (a) Bright-field image of test object. (b) ML image (on-load). (c) Image after eliminating noise components. (d) Composite image made by (a) and (c).

validation experiment (**Fig. 4(b)**), suggesting the presence of a fatigue crack. Images obtained during ML measurement usually contain a luminescence component called “afterglow” as noise, which is sometimes difficult to distinguish from ML. Therefore, **Fig. 5(c)** shows the extracted ML component by eliminating noise components through image processing. The figure includes discontinuous half-moon luminescence. In order to clarify ML, a composite image (**Fig. 5(d)**) was created by superposing the ML image in **Fig. 5(c)** on the image in clear visual field in **Fig. 5(a)**. In the figure, ML generated around the weld joint where a coating crack had been found, suggesting that the fatigue crack was due to abnormal stress concentration (generated fatigue crack). Similar results were obtained at several other inspection points.

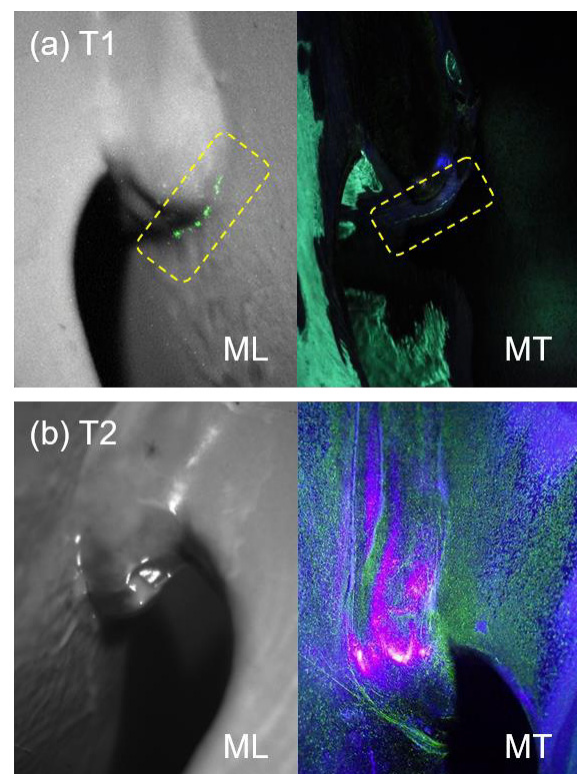
In order to evaluate the fatigue crack judgment based on ML images, MT inspection was performed after ML inspection. **Fig. 6(a)** shows the results of ML and MT inspections for the testing target T1. Here, the ML image on the left is the same as the composite image in **Fig. 5(d)**. In the MT image (right), a crack is shown in the linear magnetic powder pattern around the weld joint (yellow dashed frame). The position of the crack corresponds well to the position of ML in the ML image (left). In other words, the ML visualizes a latent crack inside the corrosion-proof coating, suggesting that the crack judgment of the ML inspection was valid.

Comparison results of both inspection methods with another test object (T2) are shown in **Fig. 6(b)**. In this case, no ML was observed in ML inspection, and no magnetic powder patterns that can be attributed to a fatigue

**Fig. 6.** Comparison of results by ML method (left) with MT method (right). (a) T1 and (b) T2.

crack were observed in MT inspection. In the two cases (T1 and T2), results of the two inspection methods accorded, indicating the high detection accuracy of the ML

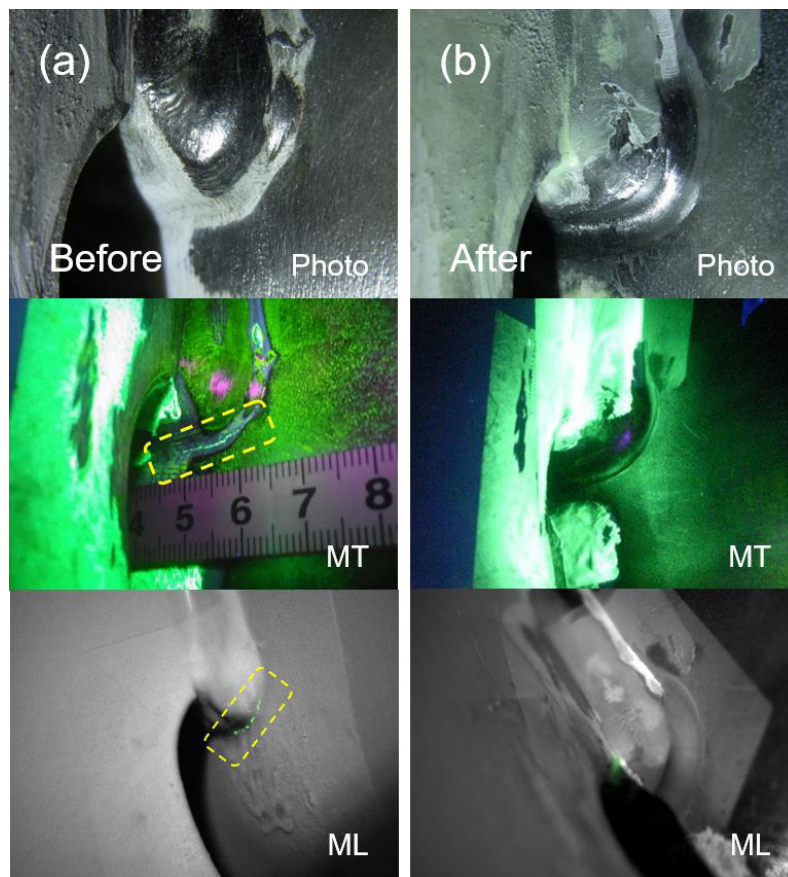
**Fig. 7.** Photos of MT and ML results for T1 (a) before and (b) after the grind process at the welding joint.

Investigation results of T1 were taken as an example. **Fig. 7** (top) presents pictures taken before and after crack removal using a grinder. During the process, the shape of the weld joint improved. MT inspection results obtained before and after the processing (**Fig. 7**, middle) show a magnetic powder pattern corresponding to a crack before the grinder processing, but not after the grinder processing. Therefore, the crack was removed based on the MT judgment criteria.

**Figure 7** (bottom) shows ML inspection results taken by the CCD camera system before and after the grinding work. These are composite images superimposing the ML images on the images in a clear visual field. Linear ML reflecting a crack observed before grinding work was removed after the processing and changed into a weak, broad luminescence image. The results indicate that removal of cracks can be judged using the ML inspection technique. The weak mechanoluminescence after processing resulted from stress concentration. Stress tends to concentrate at the target point (weld joint). ML that had been clearly observed at the weld joint was removed after processing in the other two points and changed into weak, broad luminescence distribution. From the above, the authors demonstrated that the ML technique can properly

Some fatigue cracks found in the ML inspection can easily be removed using a grinder or similar methods because short cracks are expected to have shallow depth. Steel structures can effectively and economically be maintained if damage, such as cracks, is detected by the above ML inspection method and promptly addressed. However, it is problematic that there are no criteria nor findings or technology to judge the effectiveness of processing and repair. With this in mind, it was considered that the ML inspection technique could evaluate the effects. Therefore, three cracks detected by the preceding ML inspection were removed with a grinder and then it was confirmed that there were no magnetic powder patterns due to cracks using the MT technique. Following this, an ML
