Survey Report:

# Landslide Investigation Results in Sapa Town, Lao Cai Province, Vietnam in December 2019

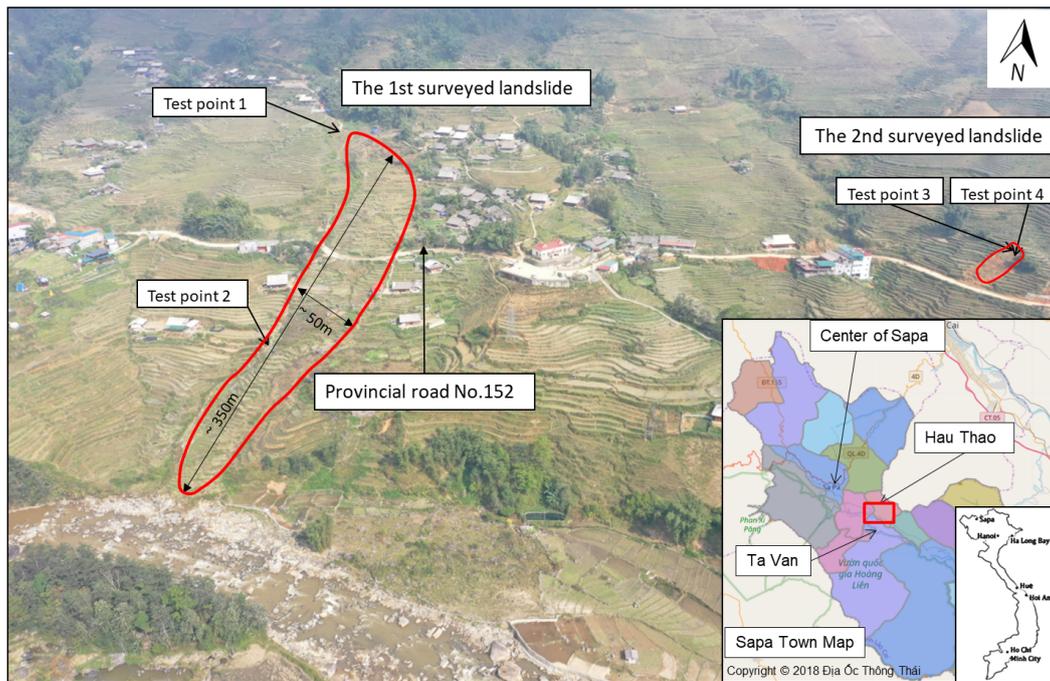
Fig. 1. The surveyed landslides site.

near the Sapa Ancient Rock Field, that extends across provincial road No.152 and has been going on for many years. There are also some smaller landslides occurred in 2019 due to rain. Some field experiments were conducted at four points in Fig. 1, whose coordinates listed in Table 1.

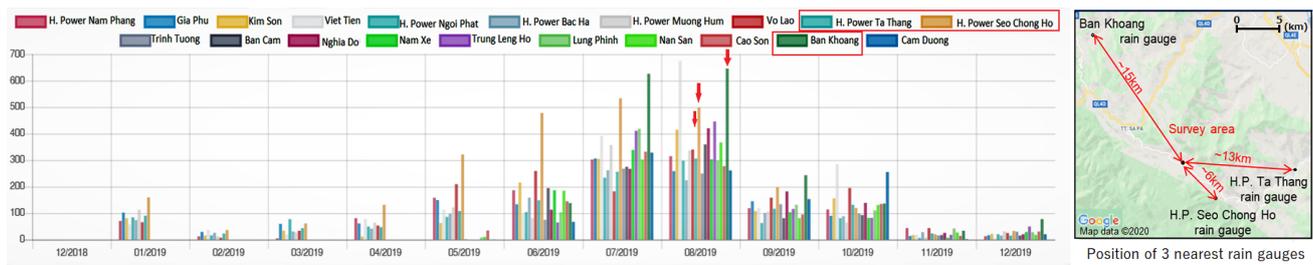
The highest daily rainfall in August of three rain gauges (4th August): 86.0 mm (H. P. Seo Chong Ho), 31.8 mm (H. P. Ta Thang), 114.0 mm (Ban Khoang)  
 The highest monthly rainfall of three rain gauges: 533.6 mm in H. P. Seo Chong Ho (July), 306.0 mm in H. P. Ta Thang (August), 645.4 mm in Ban Khoang (August)

**Fig. 2.** Rainfall data in 2019 of 20 rain gauges of Lao Cai province (mm).

from May to September, with the largest rainfall occurring in June, July, and August that accounts for around 80–85% of the total annual rainfall. For example, following the rainfall data referred from 20 rain gauges of Lao Cai Province in 2019 [12], the precipitation in June, July, and August are obviously much higher than that of the remaining months in the year (**Fig. 2**).

Specifically, the three nearest rain gauges from the investigation site are at Hydroelectric Power Seo Chong Ho (H. P. Seo Chong Ho), Hydroelectric Power Ta Thang (H. P. Ta Thang), and Ban Khoang (**Fig. 2(b)**). All of these rain gauges have high recorded rainfall data, which are depicted in **Fig. 2(a)** by the colors orange, dark teal, and dark green, respectively. The rainfall data of the Ban Khoang rain gauge (about 15 km from the surveyed site) are the highest, with the monthly amount being more than 600 mm in July and August 2019. The figures for the nearest rain gauge station, H. P. Seo Chong Ho, are the second largest, approximately 500 mm in June, July, and August of the year.

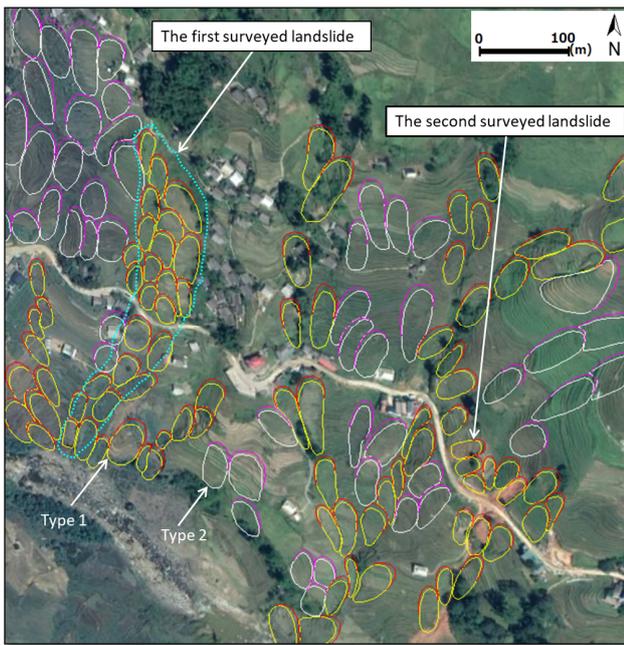
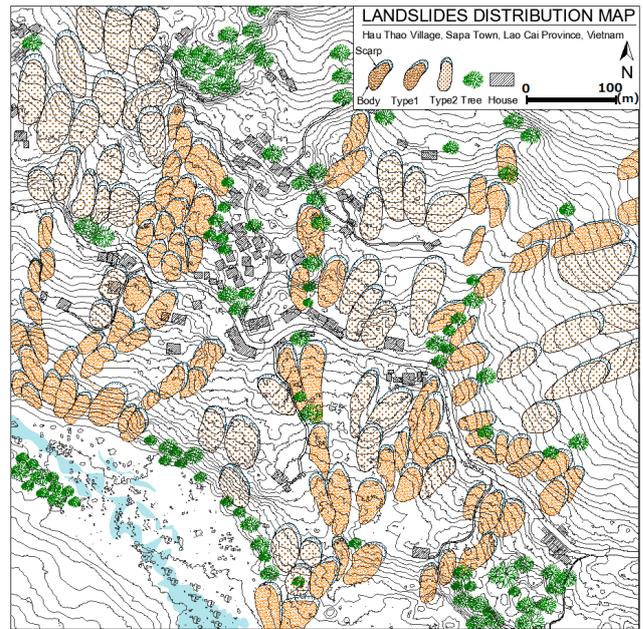
**Fig. 3.** A 700 × 700 m sized landslides distribution map.

We extracted such landforms from satellite images of Google Earth over time history and the UAV images taken in the investigation, some supposed slide blocks were sketched in a 700 m × 700 m area of the surveyed site. In such area, two types of landslide blocks are shown, type 1 is the landslide with clear signs of movement and type 2 is the proposed landslide with unclear signs of displacement (**Fig. 3(a)**). They are superimposed on a 1-m interval-contoured digital elevation model (DEM) map in order to create a landslides distribution map (**Fig. 3(b)**). It is indicated that there are various-sized landslides in this area however most of them are shallow in depth and small in scale. These landslides size ranged from 15 m × 35 m to

30 m × 70 m, and either formed independently with their own scarp and body or developed together to become a combined block. These potential sliding blocks are concentrated on terraced fields of both the positive and negative talus of the provincial road No.152, therefore, landslides in this area are prone to occur under triggered rain conditions. Two active landslides in this area were investigated.

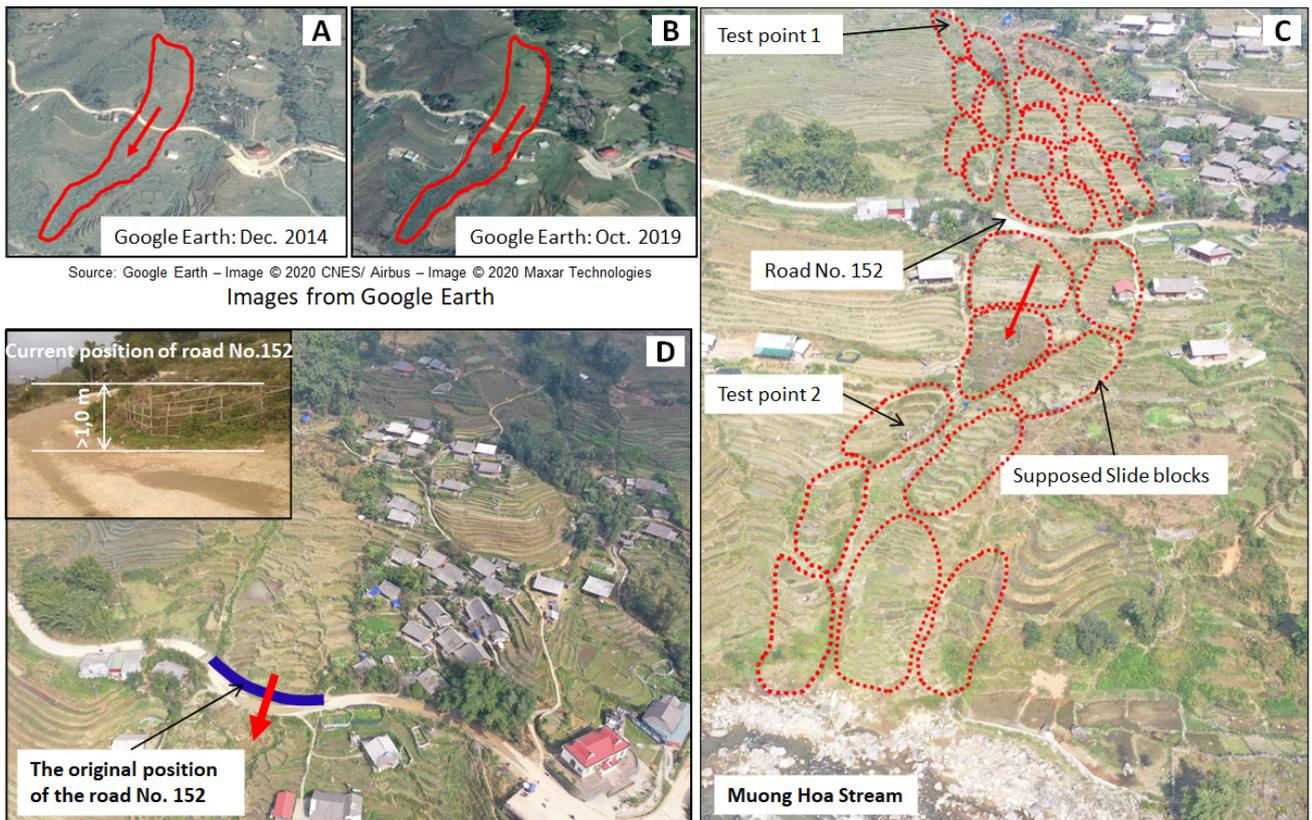
The first surveyed landslide is near the Sapa Ancient Rock Field, which is reported that there were about 200 stones of various dimensions concentrated in the area. Some of them have been found engraved with antique symbols and, therefore, it has been paid attention to by many scientists and tourists (**Fig. 4**).

This site is mainly composed of hillsides with terraced fields, geology made of dilute sand mixed macadam of reddish-brown, dark grey, and white-gray color. Its dimension is about 350 m long and 50 m wide (**Fig. 1**), extending from the positive talus, cut through the provincial road No.152 down to the Muong Hoa stream. It consists of small sliding blocks with dimensions from 15 m × 35 m to 30 m × 50 m (**Fig. 4C**).

The Google Earth Images in **Figs. 4A** and **B** do not clearly provide the movement of the sliding block in this site from 2014 to 2019. However, in recent years, the displacement of the provincial road No.152 in this area has been observed and it is reported that the landslide has been causing road displacement of more than 1 m in the vertical direction and around 6 to 8 m in the horizontal direction (**Fig. 4D**). It causes the road to be bent downwards to the negative talus, affecting the main traffic route connecting the local area with the surrounding regions. In addition, the weathering profile of marble in the depth of 5 to 7 m is considered to be the weak layer, along which a transitional landslide would typically occur in this area [8].

**Fig. 4.** The characteristics of the first surveyed landslide in Hau Thao commune.

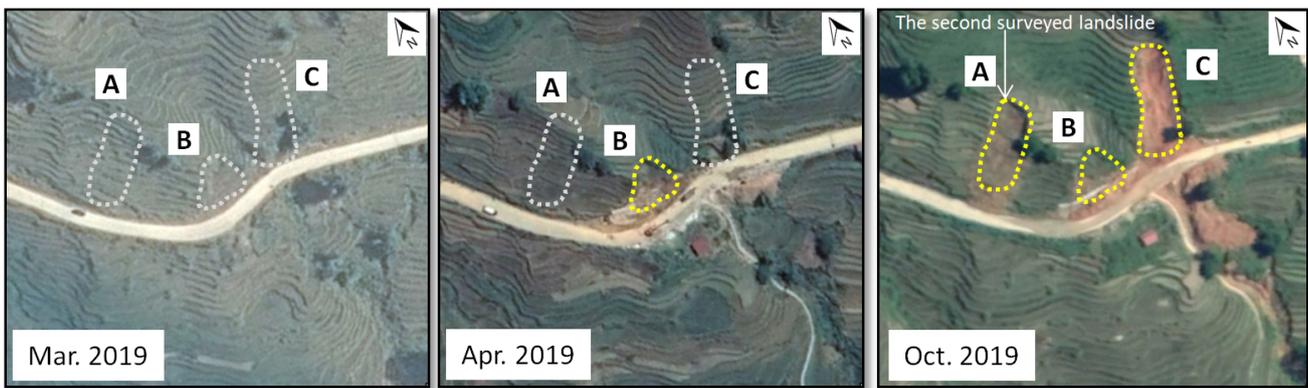
The second surveyed landslide is one of the translational landslides that occurred in 2019, located in Den Village, Hau Thao Commune, about 400 m southeast of the first one (**Fig. 5**). It is revealed that these three landslides occurred from April to October 2019, coinciding with the rainy season in the North of Vietnam. Site B is the smallest scale of approximately 20 × 20 m, appeared

Source: Google Earth© Image 2020 CNES/Airbus© Image 2020 Maxar Technologies  
**Fig. 5.** Images of an area in Den village, Hau Thao commune, Sapa town in 2019.

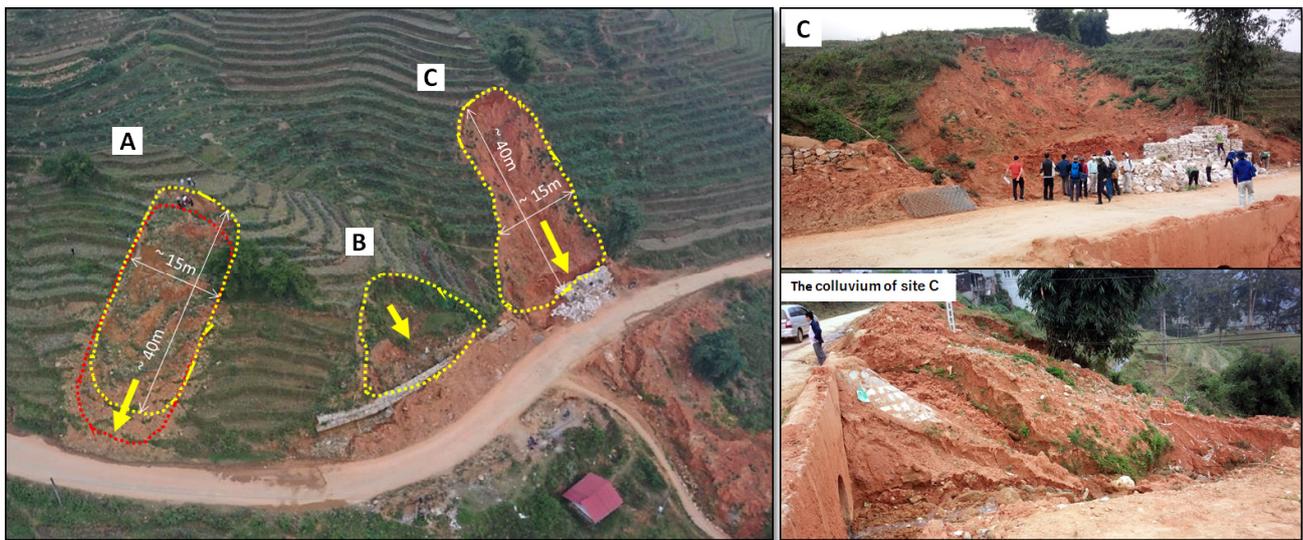
**Fig. 6.** Three landslides in Den Village, Hau Thao, Sapa in December, 2019.

in April. Besides this one, sites A and C are of similar dimensions, about 15 m wide and 40 m long, which occurred before October of that year (**Fig. 6(a)**). Meanwhile, according to local media, those were caused by the impact of typhoon No.3 (August 2019). Specifically, at about 9 AM on 5th August 2019, prolonged heavy rain of typhoon No.3 caused soil mass from the positive talus to slide to the provincial road 152, causing the death of a local resident, who was riding a motorbike through that place [13]. The incident was the result of continuous torrential rain that lasted for several days after a severe storm attacked Lao Cai province [2].

The daily rainfall of the H. P. Seo Chong Ho, H. P. Ta Thang, and Ban Khoang rain gauges on 4th August were so high, at 86.0 mm, 31.8 mm, and 114.0 mm, respectively (**Fig. 2**). Moreover, site C is deeper and steeper, and most of its colluvium was cleaned and eroded (**Fig. 6(b)**). By contrast, site A looks shallower, gentler slope, and most part of the landslide mass is still remaining. Com-

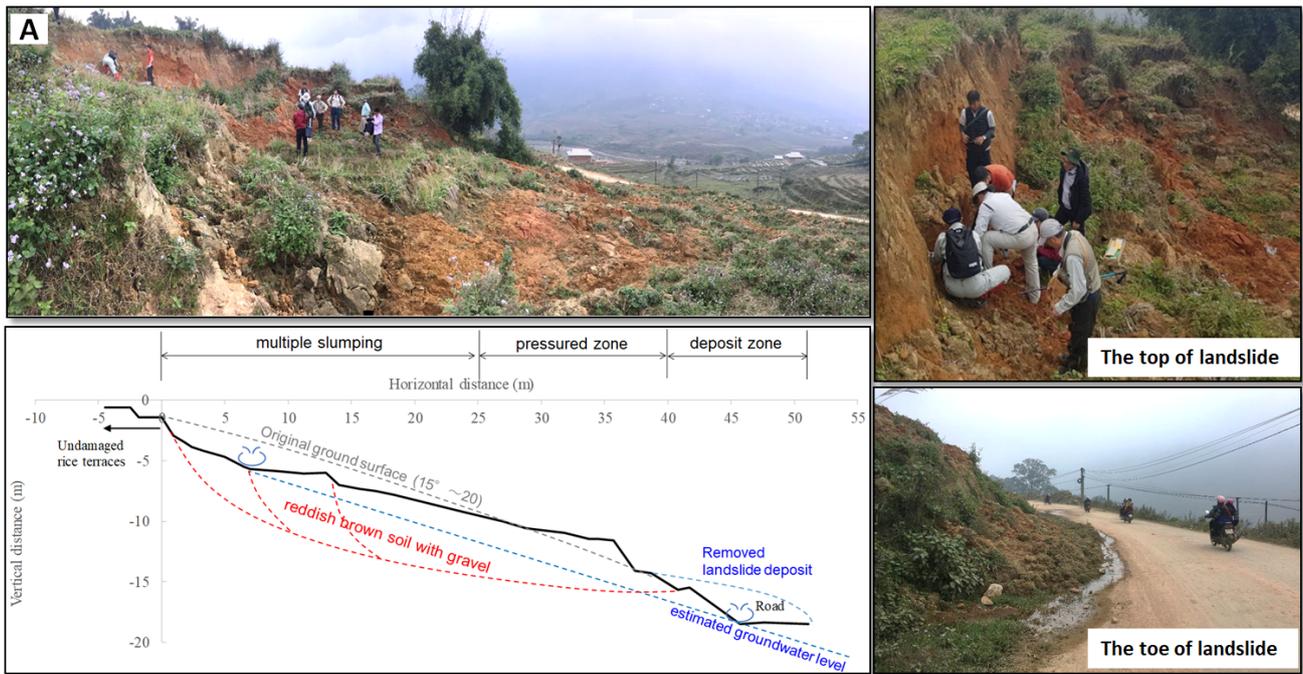
pared with the landslide phenomenon recognized around this area, site A is more typical. According to these characteristics, we decided to choose site A for additional field investigation, which is shown in **Fig. 7**. The depth of the main scarp of the landslide is approximately 3 m, and the average slope angle is about 15 to 20°. The collapsed soils are mainly reddish-brown, dark gray, clay mixed with gravel in the soft-plastic and semi-solid state. The weathered stone bedrock of this landslide is estimated to be in 5 to 7 m depth. This depth also coincides with the depth of the weathered soil layer indicated in the study by Giao and Hanh [8].

Fig. 7. Site A and its collapsed estimation.

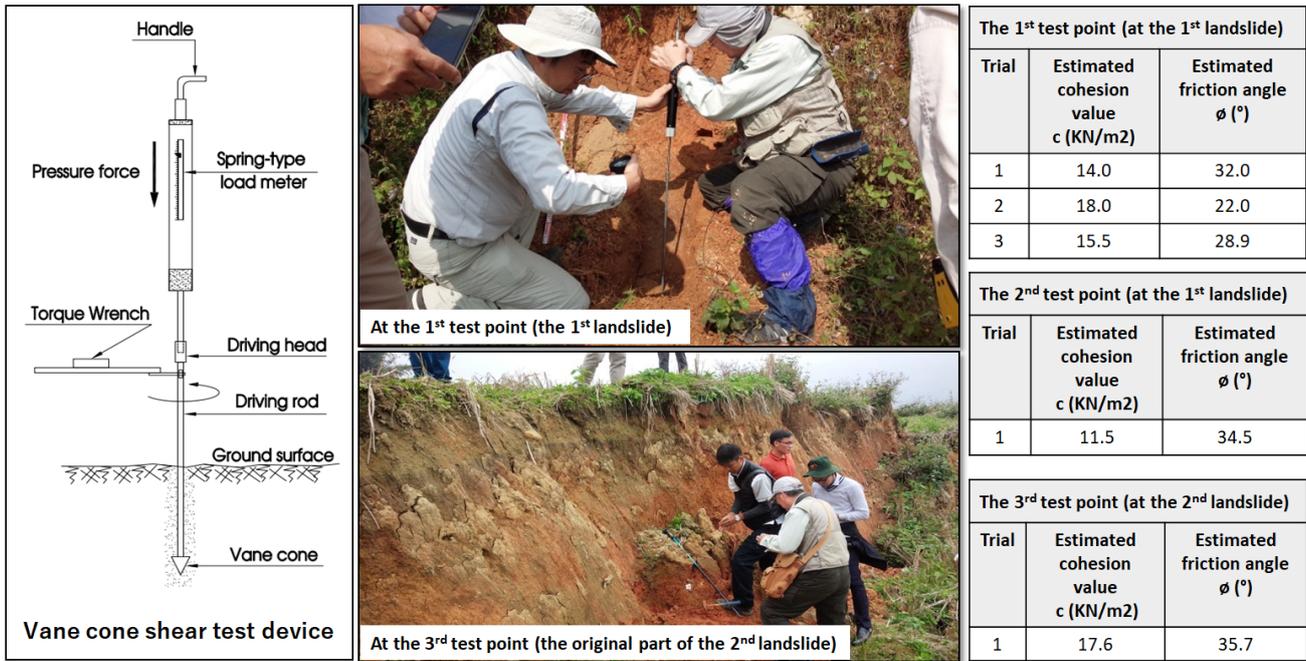
characteristics of the topsoil layer such as the depth, soil strength, slope, soil cohesion, and internal friction angle of the soil are to be investigated in detail. The investigation team uses a convenient and simple device, namely “soil layer strength measuring instrument” (*Dokenbou* in Japanese), developed by the Public Works Research Institute of Japan to evaluate cohesion values and internal friction angle of soil (Fig. 8). This instrument has a soil inspection rod, in which a vane cone is attached to the tip of the rod. The vane cone shear test is conducted by pushing the penetration vane cone into a target depth to keep the pressure force at a constant value and rotating it with a torque wrench to shear the soil, then the pressing force and rotation torque values are recorded. When doing each trial, the pressure force was kept constant in four levels of load (5000, 10000, 15000, 20000 cN). From the measured values, the soil cohesion  $c$ , and soil friction angle  $\phi$  can be easily estimated from the relationship between shear strength and stress of soil. The estimated values of each trial at some test points are depicted in Fig. 8.

Fig. 8. Vane cone shear test at field and results.

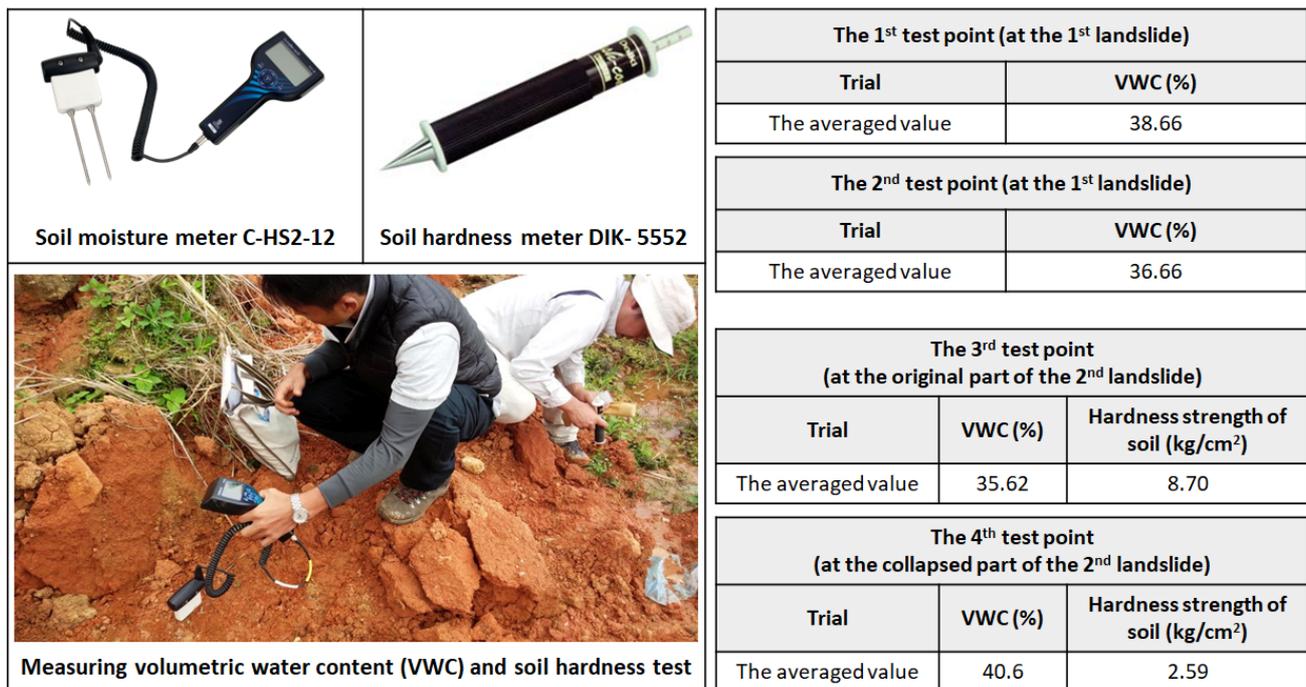
The soil moisture at four points was quantified by a compact and handy soil moisture meter C-HS2-12. This test was conducted in two points on the top-soil layer of the first landslide and in both the original and collapsed parts of the second one. The averaged values of volumetric water content are shown in Fig. 9. Besides that, hardness, one of the physical properties of soil, at the second landslide is measured by a Yamanaka soil hardness tester DIK-5552. When a cone is pressed perpendicular to the plane of the soil surface, both the depth of the conical force and the corresponding soil reaction (spring force) are measured as variables, and from these, the theoretical hardness value ( $\text{kg}/\text{cm}^2$ ) is calculated. The averaged

values of soil hardness at two test points are in Fig. 9.

In general, factors affecting slope failure due to rain-fall include: (1) an increased self-weight of the soil mass, (2) decreased strength of the ground owing to increased water content in the slope, and (3) an increased seepage force due to the elevated level of groundwater [14]. Although the estimated values of cohesion and friction angle at the time of the test are quite large (Fig. 8) and the volumetric water content values are also not high, about 40% (Fig. 9). However, at the time of the second landslide, the volumetric water content value was much higher as stated in the study by Tran et al. [2]. Besides that, this site surface was mainly covered by the terraced paddy which was in the growing season at the time of the collapse. Actually, the terrace fields often have contours to hold the surface water to retain on the soil surface longer for cultivation. Additionally, according to [12], there were scattered rains during July and August 2019 in Sapa, which possibly caused the cover soil layer above the impervious layer to be saturated at the time of the landslide. Therefore, this led to the decline in shear strength of soil, and thus landslides occurred. As can be seen in Fig. 9, the soil hardness strength of the collapsed part is also significantly smaller than that of the original part, with  $2.59 \text{ kg}/\text{cm}^2$  and  $8.7 \text{ kg}/\text{cm}^2$ , respectively.

Fig. 9. Volumetric water content of soil and soil hardness test and results.
