Damage in Ports due to the 2011 off the Pacific Coast of Tohoku Earthquake Tsunami

Takashi Tomita*, Taro Arikawa*, and Tadashi Asai**

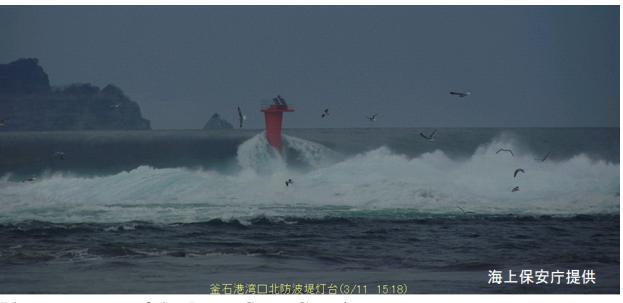
Fig. 2. Tsunami overflowing the breakwater of Kamaishi Bay.

ters 20 m deep. At the mouth of Kamaishi Bay, in fact, the tsunami exceeded 11.8 m in height estimated from an analysis of **Fig. 2**. Note that tsunami profiles observed by GPS-equipped buoys and open-sea seabed pressure gauges were also used to estimate the tsunami source inversely [3].

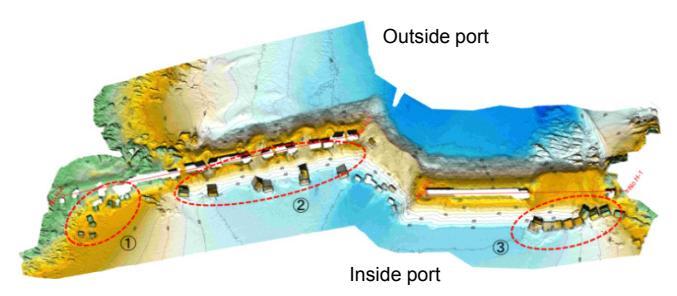
Fig. 3. Tsunami-distributed caissons of the breakwaters in Kamaishi Port, ①: Shallow water section of the north breakwater, ②: Deep water section of the north breakwater, and ③ Part of the south breakwater.

The tsunami damaged breakwaters at the mouth of Kamaishi Bay, where the maximum water depth was 63 m, as shown in **Figs. 3**, **4** and **5**. Because the bay coast had been severely damage by the 1933 Showa Sanriku tsunami and the 1960 Chilean tsunami, the tsunami breakwater had been built to reduce maximum tsunami inundation depth to less than 0.5 m, based on the highest tsunami recorded in the area following the 1896 Mw 8.5 Meiji Sanriku Earthquake. The design tsunami height was 5.0 m and

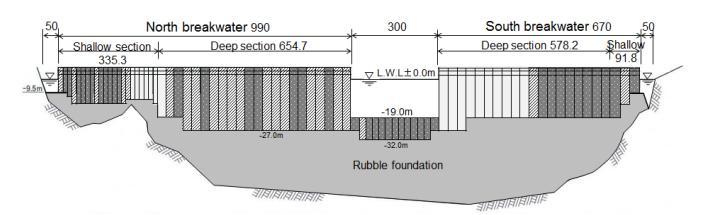
Fig. 4. Damaged caissons of the breakwaters in Kamaishi Port. White: No sever damage, Light gray: Inclined, and Dark gray: Displaced.

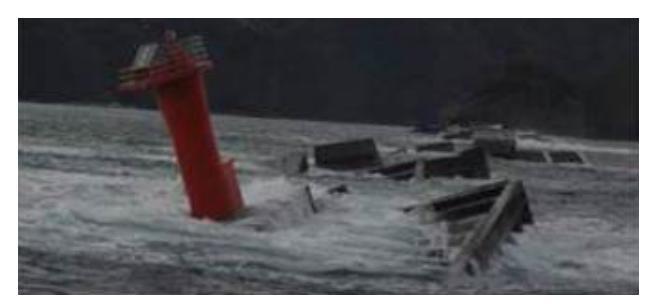
Fig. 5. Damaged north breakwater in Kamaishi Port.

the difference in water level between the front and back of the breakwater was considered to be 2.8 m. The 2011 tsunami, however, was over 11.8 m high and the water level difference between the front and back of the breakwater was over 6 m, resulting in heavy damage of the breakwater.

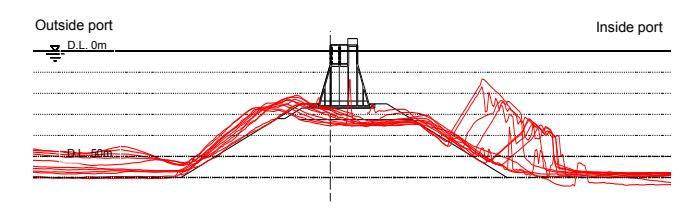
Fig. 8. Example of damaged section of breakwater in Kamaishi Port.

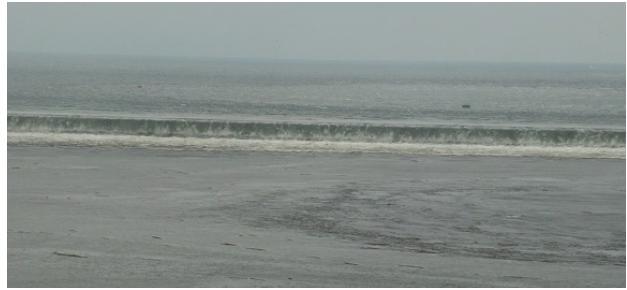
Fig. 10. Tsunami overflowing the central part of Hattaro north breakwater

Breakwaters at Hachinohe Port had been installed to ensure calm water when loading and unloading cargo, so breakwater resistance to tsunamis was not considered regarding its design. In the 2011 event, a tsunami approximately 8 m in height struck Hachinohe Port, according to tsunami water mark heights listed by the 2011 Tohoku Earthquake Tsunami Joint Survey Group [1]. All breakwaters suffered under the tsunami's impact. Breakwaters in the most offshore areas had almost no damage, because they were designed against high storm waves. Some of caissons at heads of the breakwaters had slid. In contrast, the wing and central parts of the Hattaro north breakwater were severely damaged, as shown in Fig. 9. It was confirmed that the tsunami overflowed the Hattaro north breakwater (Fig. 10) and other breakwaters inside the port.

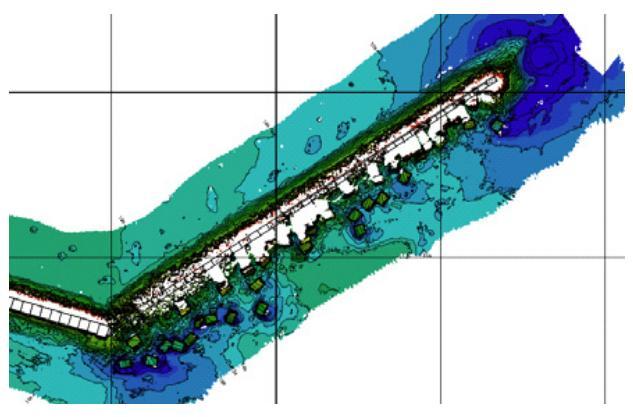
Fig. 11. Damaged wing part of Hattaro north breakwater.

At the 700 m long wing, caissons, wave absorbing blocks and rubble foundation had been destroyed. Many of the caissons had fallen over inside the port, as shown in **Fig. 11**, where a bathymetry survey had been conducted by the Tohoku Regional Bureau, MLIT, using narrow multibeam echo sounding. The maximum displaced

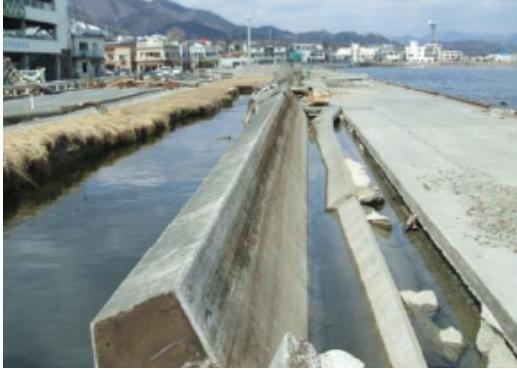
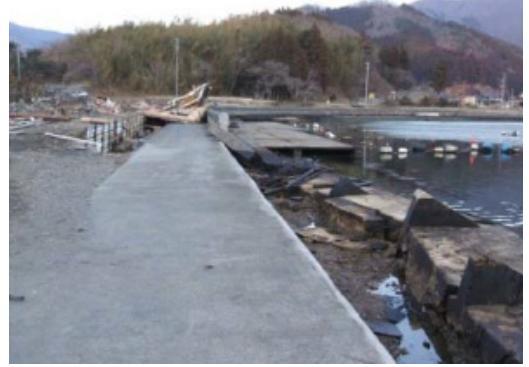
(a) Seawalls collapsed toward the landside

(b) Seawalls collapsed towards the seasideFig. 13. Seawalls damaged in Ofunato Port.

rapid tsunami waves caused no breakdown in main seawalls, which they overflowed, causing scouring failures at seawalls. Failures occurred both during the rushing tsunami phase and during the receding tsunami phase, as shown in **Fig. 15**.

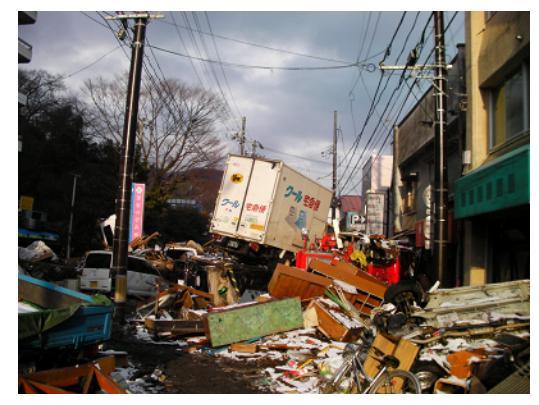
Fig. 16. Kamaishi City in the disaster aftermath.

The tsunami destroyed houses, which resulted in debris. In addition, many cars floated along both on land and at sea. At the time that the tsunami hit, residents said that traffic jams occurred on roads in Sendai City and Ishinomaki City. **Fig. 16** shows the state of Kamaishi City in the disaster aftermath.

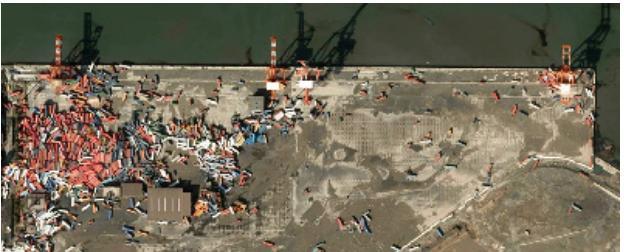
Fig. 17. Containers displaced by the tsunami in Sendai-Shiogama Port.

Containers in ports were displaced, especially in Sendai-Shiogama Port, where approximately 2,000 floated (**Fig. 17**). In Hachinohe Port, 700 containers were displaced as shown in **Fig. 18**. The first positive tsunami was 2.3 high in observed water level records at the port tide station of Hachinohe and caused enough inundation for a container chassis to be soaked at approximately 1 m in depth, and therefore some containers were knocked down and displaced. The second tsunami wave, which was the highest in Hachinohe Port, carried many containers out to sea. The observed height of the second tsunami wave was 4.5 m at the port tide station, and watermark height measured at the container wharf in the posttsunami field survey was 2.9 m above the ground surface.

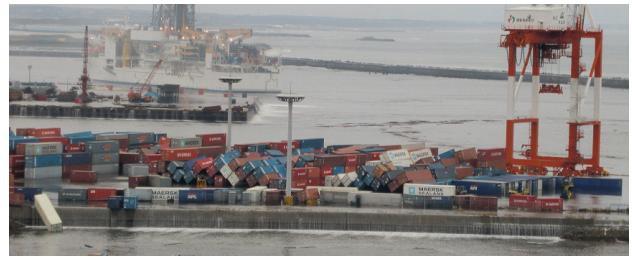
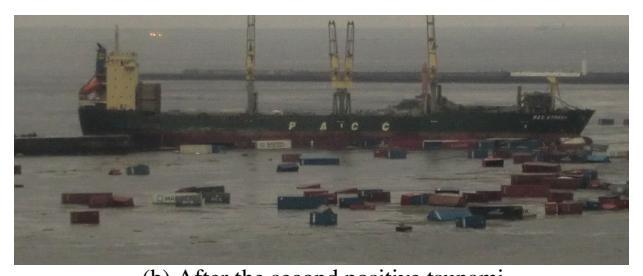
(a) After the first positive tsunami

(b) After the second positive tsunamiPhoto courtesy of Tohoku Grain Terminal Co. Ltd.Fig. 18. Containers displaced by the tsunami in Hachinohe Port.

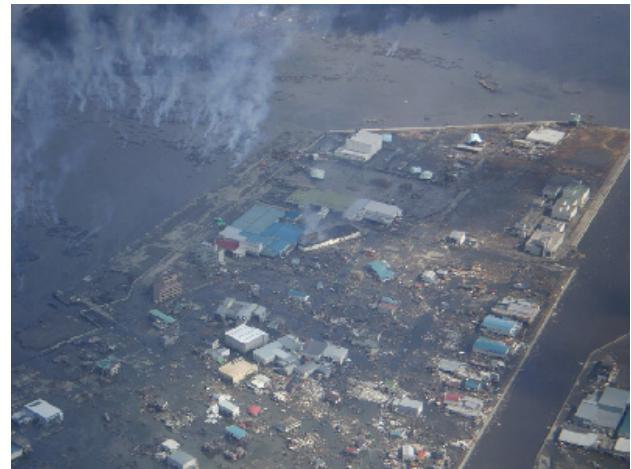
From some of the oil tanks carried away by the tsunami, oil leaked and caused fires in flammable debris. **Fig. 19** shows burned-out Kesennuma Port, including displaced oil tanks.

Fig. 19. Fire accident in Kesennuma Port.

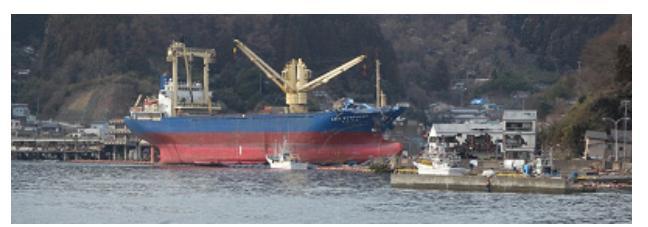
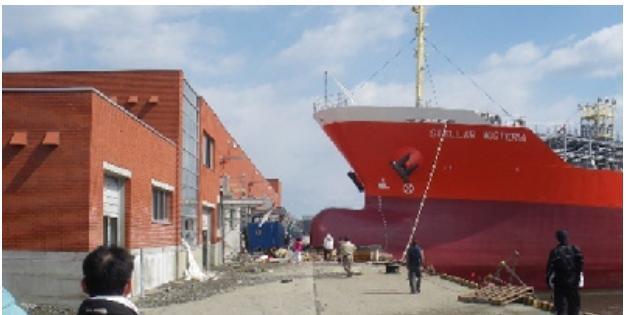
Many ships and boats were also displaced by the A cargo carrier landed in Kamaishi Port tsunami. (Fig. 20(a)) because the inundation depth was 8 m and deeper than the ship's 7.2 m draft. If the inundation depth had been shallower than this draft, the vessel would have collided with the quay wall and other obstructions. Fig. 20(b) shows the collision of a chemical tanker whose draft was 8.7 m in Hachinohe Port, where the inundation depth was 3 m. Some vessels were displaced with carrying cargo handling equipment such as buckets because electrical power failures due to seismic motion prevented equipment from being removed from vessels that were being unloaded. Fig. 21 shows unloading equipment damaged when carried away by a ship displaced by the tsunami. Equipment was also damaged by tsunami wave forces and collisions with tsunami debris, such as tsunami-displaced vessels.

(a) Cargo carrier with the draft of 7.2 m (Inundation depth of 8 m)

Photo courtesy of Hachinohe City (b) Chemical tanker with the draft of 8.7 m (Inundation depth of 3 m) Fig. 20. Damaged vessels by the tsunami.

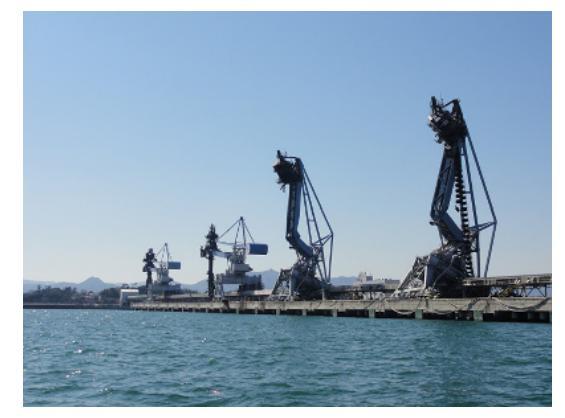
Fig. 21. Damaged loading and unloading equipment in Soma Port.

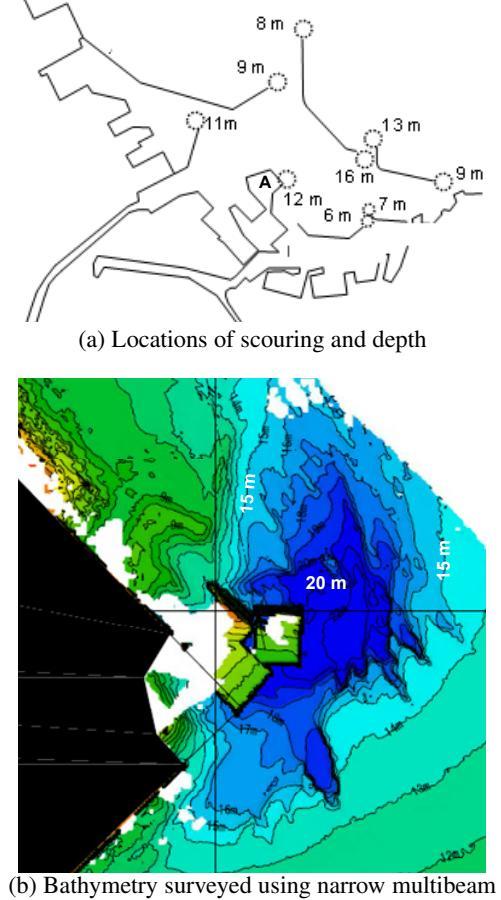
Figure 22 shows the locations of scouring and its depth, which is the difference in water depth surveyed by multibeam echo sounding after the tsunami from that of navigation chart. Since scouring occurred at the tips of breakwaters and quays, especially in openings between breakwaters, tsunami-induced currents and eddies probably generated it. **Fig. 23** shows missing caissons at a corner of a port island (Point A). Three caissons forming the corner were moved to a hole due to scouring whose depth was 12 m. Scouring around the structure is responsible for damage of the structure.

echo sounding at Point A Fig. 22. Tsunami-induced scouring in Hachinohe Port.

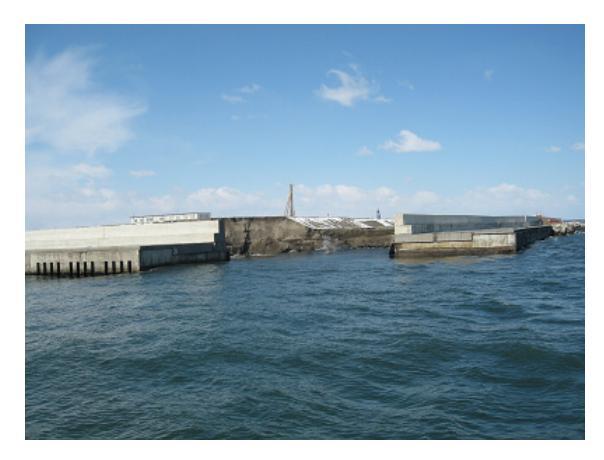
Fig. 23. Missing caisson corners at a port island due to scouring.

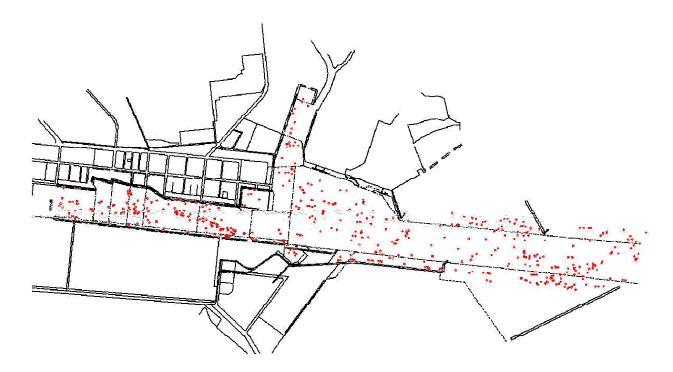
Fig. 32. Scattered tsunami-induced debris on the seabed at Sendai-Shiogama Port.

In Sendai-Shiogama Port, various kinds of debris were caused by the tsunami impact. Some of these were carried out to sea by the tsunami, sank and were scattered on port sea beds of the port. Dots in **Fig. 32** indicate locations where debris was collected from the seabed in Sendai area of Sendai-Shiogama Port. The number of locations was 531, including 335 containers and 26 cars. They were obstacles to navigation in the transport of emergency supplies and in ensuring national and global supply chains in the disaster aftermath. It took about 80 days to collect most debris from the seabed. In addition to developing methods for collecting debris, measures to minimize the debris carried out to sea are also needed to increase port resiliency. Guardrails and wind shelters were effective in trapping cars and boats going out to sea in the 2011 event.
