Flooding Along Oda River Due to the Western Japan Heavy Rain in 2018

Keywords: flood, inundation, Oda River, Western Japan heavy rain

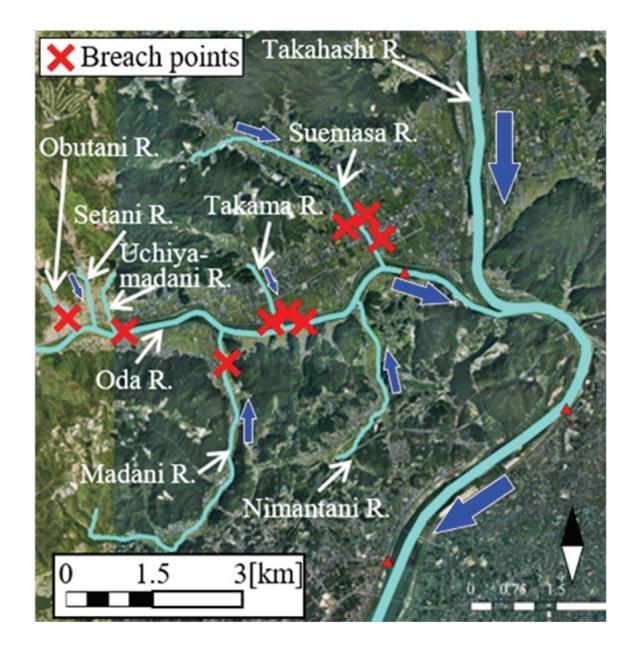
A map of and detailed information on the dike breach points along Oda River and its tributaries are shown in **Fig. 5** and **Table 1**, respectively. The data on dike height, breach width, and breach height (= dike height – bed height) in the table were sourced from the investigation commission on dikes along Oda River of the Takahashi river system [11]. The estimated breach time was determined based on the testimonies of residents and image data from mass media. Although the damage to dikes along Obutani River was not considered as dike breach by the investigation commission [11], this location was added to the dike breaches in this paper in light of the erosion of the dike on the field.

It can be seen from **Table 1** that there were two dike breaches along Oda River at the 3.4 kp and 6.4 kp points,

Fig. 5. Dike breach points in the lower reaches of Oda River and its tributaries.

which were located on the left side of the river and at the downstream side of the confluences with its tributaries. The point of dike breach at 3.4 kp was located at the downstream side of the confluence with Takama River and that at 6.4 kp at the downstream side of the confluence with Uchivamadani River. The breach width was 92 m and 54 m at the 3.4 kp and 6.4 kp points, respectively. For the tributaries of Oda River, there were three points of dike breach along Suemasa River (0.4 kp on the left side, 0.7 kp on the left side, and 0.7 kp on the right side), two points along Takama River (0.0 kp on the left side and 0.1 kp on the right side), one point along Madani River (0.5 kp on the left side), and one point along Obutani River (0.1 kp on the right side). In total, the dikes were breached at two points along the main river and seven points along its tributaries. The breach width varied, ranging from 20 m at the 0.0 kp on the left side along Takama River to 110 m at the 0.7 kp point on the left side and 150 m at the 0.7 kp point on the right side of Suemasa River.

From the estimated breach times, it can be seen that the right side of Takama River at the 0.1 kp point was breached first at around 11:30–12:00 pm on July 6, followed by the right side of Suemasa River at the 0.7 kp point at about 0:00 on July 7. Next, the left side of Oda River at the 3.4 kp point was breached at around 3:00–3:30 am on July 7, followed by the left side of Suemasa River at the 0.4 kp and 0.7 kp points at around 7 am the same day. For the other breach points, except the one along Obutani River, for which the estimated breach time is not available, it is supposed that the dikes were breached before dawn on July 7 based on the testimonies of residents and the surrounding state of inundation. The dikes were thus breached one after another over time, but it is important to note that a dike breach

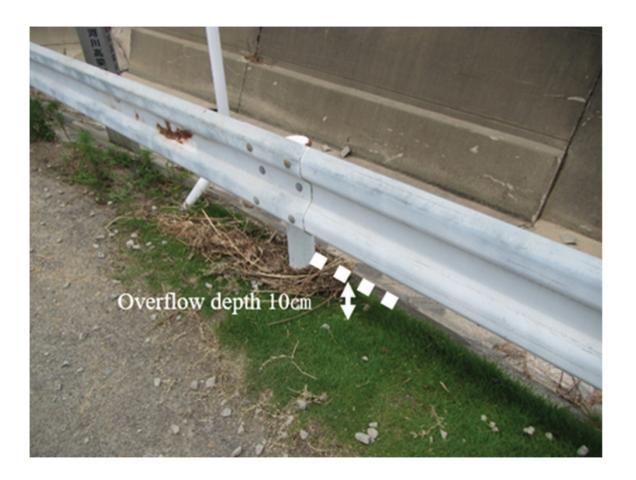
Fig. 6. Situation of overflow near the right side of Takama River at the 0.1 kp point.

A main factor of dike breach was overflow, according to the investigation commission [11]. **Fig. 6** shows a flood mark on a dike crest near the right side of Takama River at the 0.1 kp point. Although the overflow depth is 10 cm, as can be seen, a mark of overflow can be recognized.

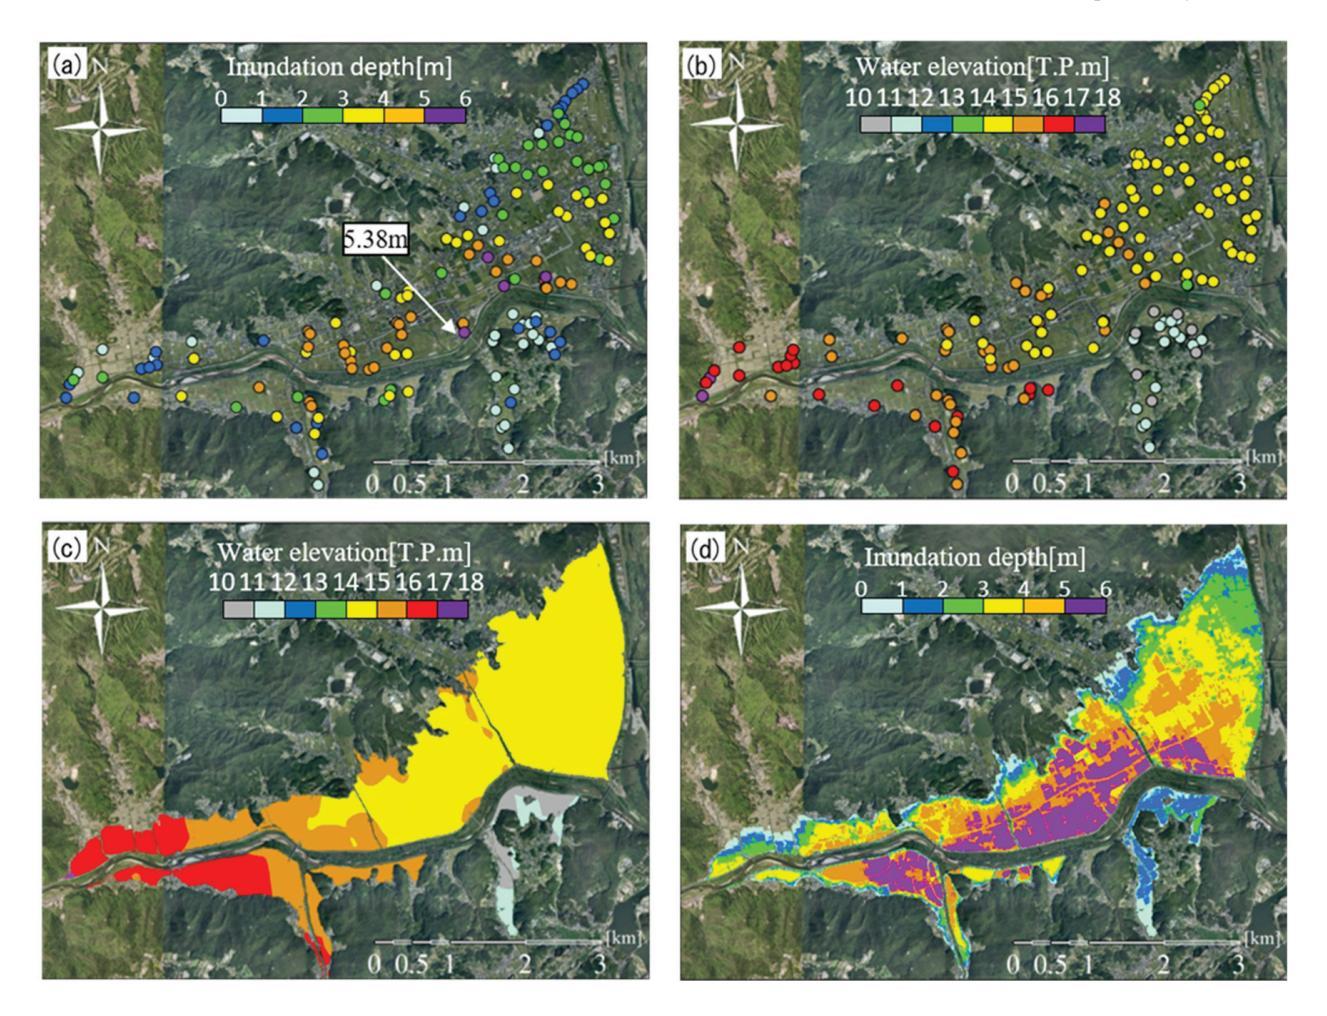
The measured values of inundation depth and height (flood level) obtained from the survey on flood mark are shown in **Figs. 7(a)** and **(b)** to illustrate the state of inundation. **Fig. 7(a)** shows that the area on the north (left) side of Oda River was widely inundated and points to an inundation depth exceeding 5 m were found all over this area. On the other hand, on the south (right) side of Oda River, the range of inundation was narrower than that on the north side, and inundation occurred mainly around the tributaries, with an inundation depth exceeding 4 m

recorded along Madani River. The maximum value of inundation depth recorded in this survey was 5.38 m on the north side of Oda River.

Similarly, Fig. 7(b) on inundation height shows that on the north (left) side of Oda River, the values were higher in the west and lower in the east. The magnitude relation that upper reaches are larger than lower reaches is applied as in the case of riverbed height. Therefore, it can be generally understood that the flood flow moves from west to east. However, on the south (right) side of Oda River, the flood level was higher locally around Madani River and at other locations, but no distinctive tendency can be recognized regarding the upper and lower reaches of the river. This indicates that the inundation of flood water on the south side of Oda River occurred locally as a result of overflow around the tributaries, Madani River and Nimantani River. The lower locations of dikes on the right side of Oda River and the flood flow dose are not linked because of the topographical factor.

An aerial map of inundation depth was drawn using point data on inundation depth. Fig. 7(c) shows the contour of the inundation height, which was generated by interpolating point data on inundation height, as Sayama and Takara [12] did. For this purpose, natural neighbor interpolation of ArcGIS 10.3 was used. Fig. 7(d) shows the contour of inundation depth, which was generated by subtracting the altitude data, obtained using DEM, from the obtained inundation height. From this figure, it can be understood that an inundation depth exceeding 5 m occurred along 1 km in the north-south direction and 3.5 km in the east-west direction on the north side of Oda River. A major part of the inundated area on the north side had an inundation depth exceeding 3 m. However, it can be seen that on the south side of Oda River, the inundation depth exceeded 5 m around Madani River. The values of inundation depth are generally measured by supposing the road surface as the ground level. However, the area with

Fig. 7. State of inundation along Oda River (measured values of inundation depth (a), measured values of inundation height (b), contour of inundation height (c), and contour of inundation depth (d)).

an inundation depth of over 5 m on the north and south sides was extensive, since rice paddy fields are at a lower level than the road surface.

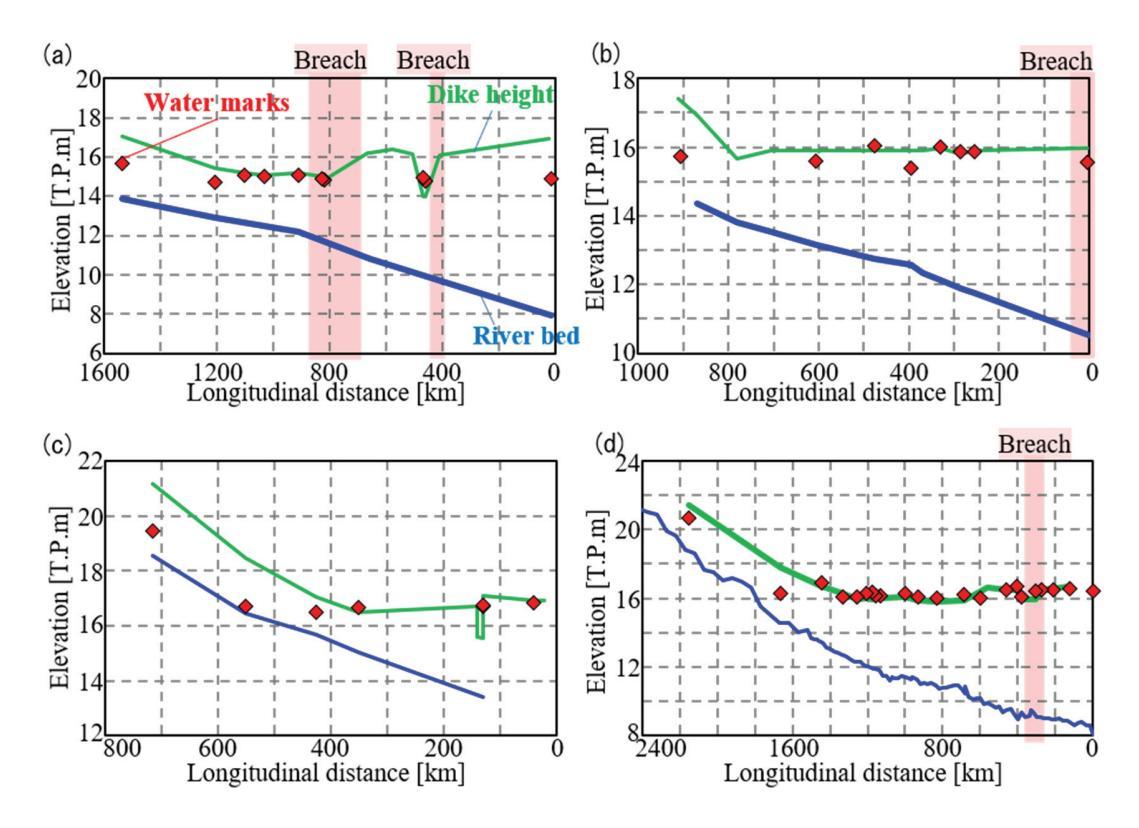
The longitudinal distribution of the elevation of flood marks in the river channels of the tributaries is shown in **Fig. 8** to illustrate how the flow regime influenced the inundation. The figure shows the findings for the four Oda tributaries of Suemasa River, Takama River, Uchiyamadani River, and Madani River. The longitudinal distribution of dike height and riverbed height are also shown. It can be seen from **Fig. 8** that in Suemasa River, the flood mark shifted almost horizontally in a section beginning from its confluence with Oda River and extending to a point about 1.1 km upward. The horizontal flood level was influenced by backwaters from Oda River. A simi-

Fig. 8. Longitudinal distribution of elevation of flood marks and dike height in tributaries (Suemasa River (a), Takama River (b), Uchiyamadani River (c), and Madani River (d)).

lar tendency is seen in the other three tributaries. Such sections with an almost horizontal level of flood mark can be seen for 600–800 m in Takama River, about 400 m in Uchiyamadani River, and about 1,400 m in Madani River. It can be understood that the flood mark water level exceeded the dike height at some locations, causing overflow. For example, in Suemasa River, overflow occurred at a point about 0.8 km upward from the confluence with Oda River, where dike height was lower. It is supposed that the dike height is lower at a point about 0.4 km upward because of an intersection with a road, which triggered a dike breach.

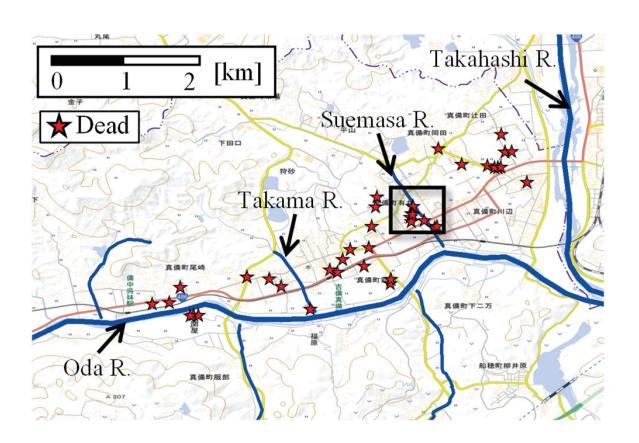
Fig. 9. Locations where persons died in Mabi Town. Square with black line is the range of Fig. 10.

The locations of the houses in Mabi Town (41 houses in all) where 51 persons died because of the flood disaster are shown in **Fig. 9**. The figure shows 38 houses in the disaster area on the left (north) side of Oda River where 47 persons died, and three houses on the right (south) side where four persons died. Specifically, there are 7 houses on the west side of Takama River, 19 between Takama River and Suemasa River, and 12 on the east side of Suemasa River. The number of houses between Takama River and Suemasa River, where the Yata and Arii districts of Mabi Town are located, is remarkably high. Thus, human damage was higher on the left side of Oda River, though the damage was concentrated not near the river, but near the shelter located on the north side of the area.

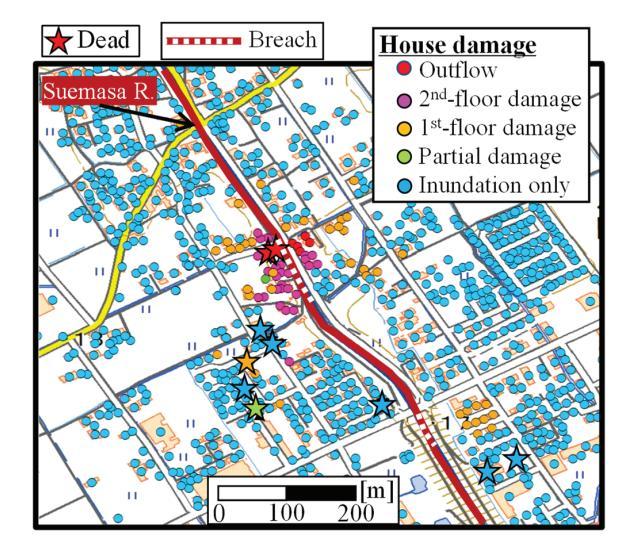
The state of house damage near the points of dike breach and the locations where human damage occurred are shown in **Fig. 10**. In this figure, the extent of house damage is represented by different colored circles, and the locations where human damage occurred are indicated with a star symbol whose color follows the same criteria as those of the circle. It can be seen from **Fig. 10** that in the vicinity of the dike breach at the 0.7 kp point in Suemasa River, there were cases of houses that were "washed away" or suffered "damage to the first floor" or "damage to the second floor," but the majority of house damage was placed in the "only inundation" category. At the locations where human damage occurred, only two

Fig. 10. Relation between the situation on house damage and that on human damage around points of dike breach in Suemasa River.

houses were placed in the "washed away" category, one house in the "damage to the first floor" category, one house "partly damaged," and six houses in the "only inundation" category. Thus, it can be seen that the extent of house damage was relatively small compared to human damage in what is a significantly different scenario from the case of sediment disaster in the mountains.

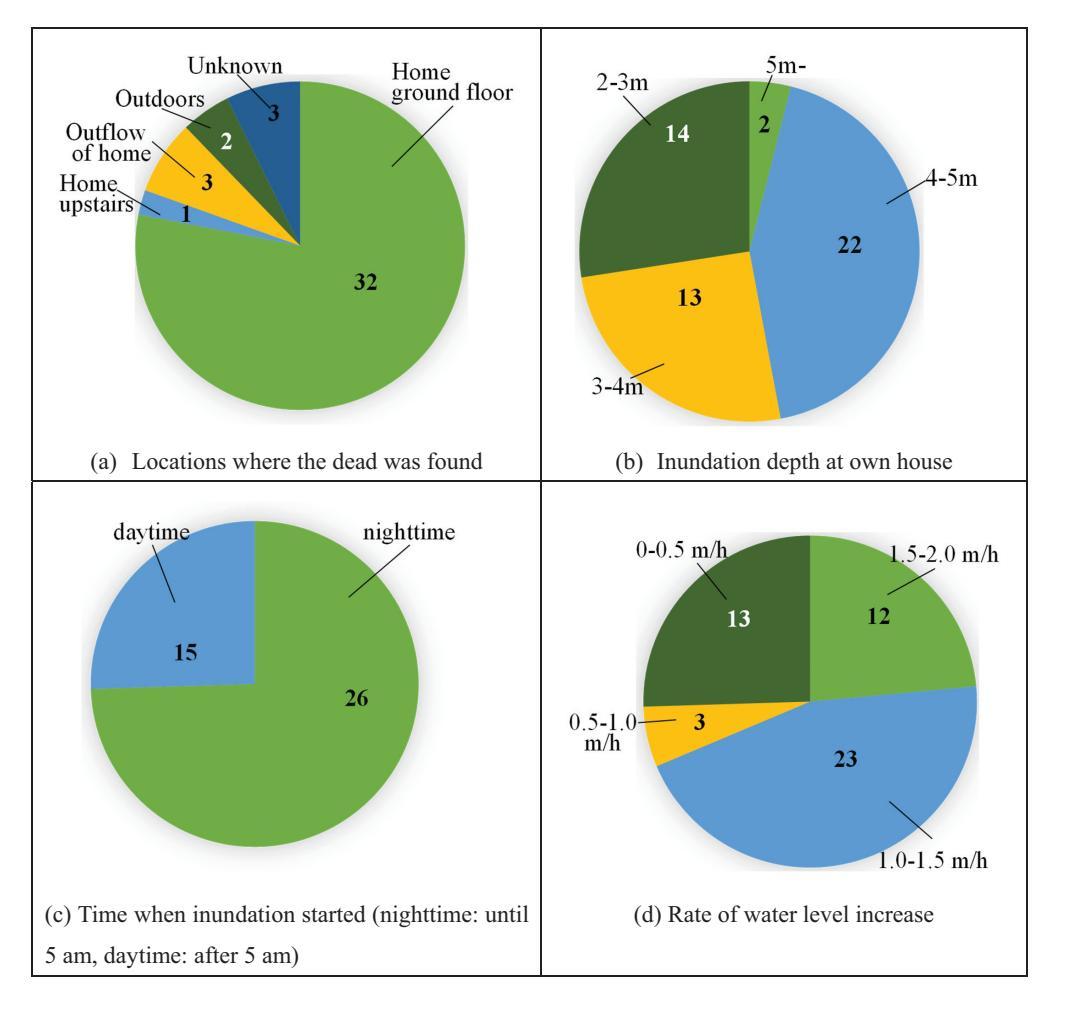
To shed light on the characteristics of human damage, the findings on the location where the dead were found and the state of home inundation (i.e., inundation depth, time when inundation started, and rate of water level increase) are shown in Fig. 11. The inundation depth and the time when inundation started were calculated from the findings of the field survey, while the rate of the increase in water level was calculated from the simulation on inundation of flood water in Mabi Town, which was carried out separately based on the authors' model [14]. According to the findings, 44 persons were found dead in their own houses, with 43 of them found on the first floor. The locations of the two houses (nearly 5% of the total), which were washed away, were in the vicinity of the dike breach points on the right side of Suemasa River and on the left side of Takama River. As mentioned above, the inundation, rather than the washing away of houses, had a significant influence on human damage.

In terms of inundation depth at home, 37 persons, or nearly 73% of all dead people, suffered inundation with a depth of 3 m or more, indicating submergence of the first floor, and 24 persons suffered inundation with a depth of 4 m or more. This finding highlights the difficulty in vertical evacuation. The remaining 14 persons (27% of all dead people) experienced an inundation depth ranging from 2 m to 3 m, indicating submergence of a large part of the first floor. For 38 persons (75%), inundation started at night when the dike was breached along Oda River. However, for 13 persons (25%), inundation started at daytime. Therefore, human damage occurred both at night and during day, indicating that the damage was triggered regardless of the time when inundation started. Furthermore, the water level rose at a rate of 1 m/h or more at the houses of 35 persons, which was significantly higher than the maximum rate of water level increase of 0.5 m/h in the flooded area of Kinugawa River during the Kanto and Tohoku heavy rain in 2015 [15].

About 80% of the dead were found on the first floor, of whom those who had lived in a one-story house and those in a two-story house accounted for 50% each, indicating how difficult even vertical evacuation was. The findings appear to be related to the considerable inundation depth and high rate of water level increase, in addition to the fact that 45 persons, the majority of the deceased, were those aged 65 years or more.

Fig. 11. Summary of characteristics of human damage (Unit: people).
