Survey Report:

Damage and Height Distribution of Sumatra Earthquake-Tsunami of December 26, 2004, in Banda Aceh City and its Environs

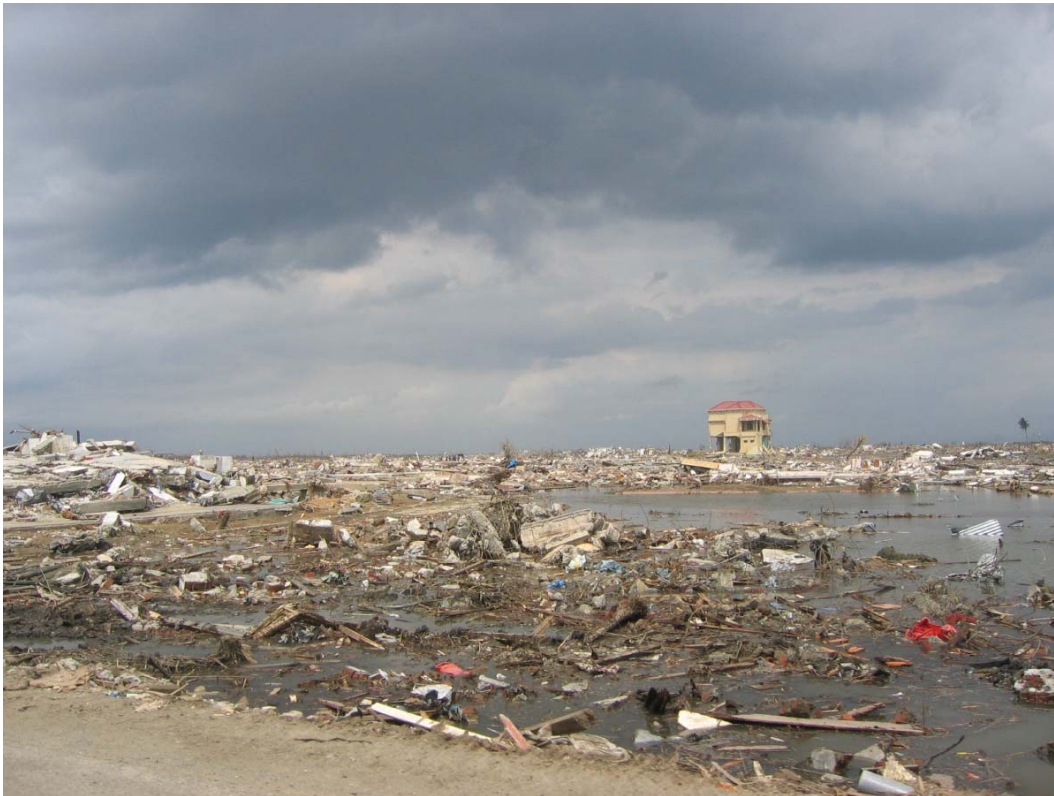
Fig. 1. Residential area near harbor. Almost all houses in the residential area about 2 km from the coast were swept away.

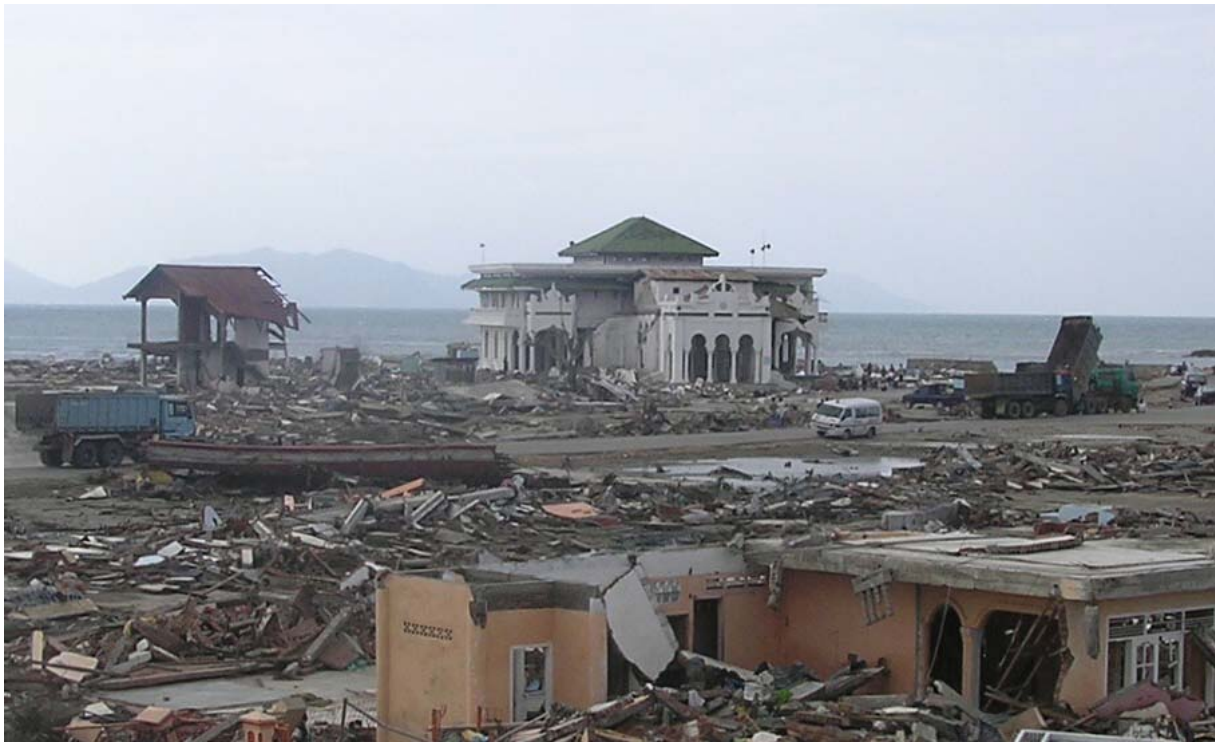
Fig. 2. Baiturrahim Mosque at Ulee Lheue Port.

At Ulee Lheue Port (**Fig. 2**), only the Baiturrahim Mosque still had its roof, and most other buildings had been entirely destroyed. Seawater rising to the front of the Mosque (in the direction of Mecca), broke through the front walls and rose to the upper door sill on the second floor. We found that seawater had risen to 11.95 meters above MSL. The second wave rose to the handrail on the second floor – a height of 8.35 m.

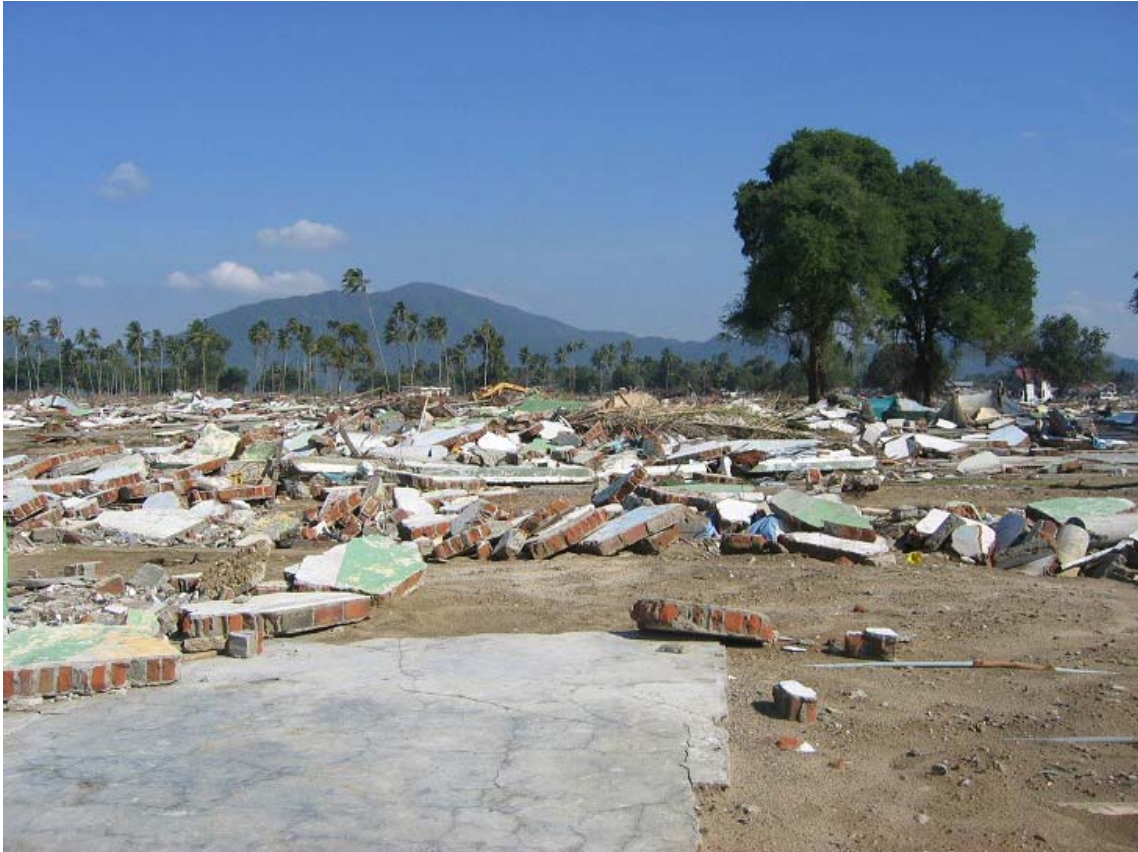
Fig. 4. Lhoknga Village on the west coast about 7 km southwest of central Banda Aceh. Only one house remained, that of Mr. Julpikar, near the right here.

Figure 4 shows Lhoknga, where comparatively rich people had lived in concrete or brick houses, all of which were entirely destroyed except for one behind the ridge

of a coastal dune. It was not hit by a direct wave and so was not swept away. We measured the water mark inside of this house near the floor of the second storey: seawater had risen 12.42 meters above MSL.

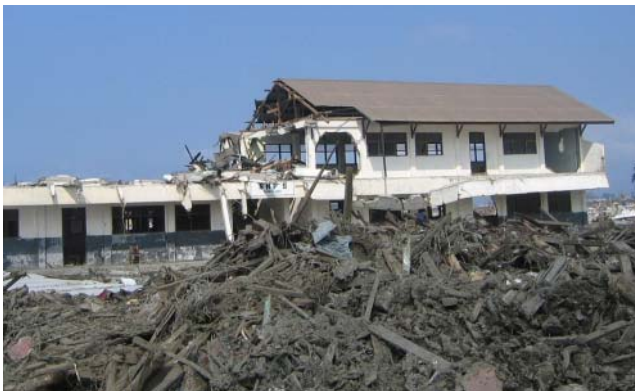
Banda Aceh Junior High School No.5 (**Fig. 3**) located about 1 km from the shore was houses in a steel-reinforced concrete building not easily washed away. The left side of the second floor, however, had been carried away by the tsunami current. The seawater had risen to 50 cm above the ceiling boards of the second floor, which was measured at 9.0 meters above MSL.

Fig. 3. Damage to Banda Aceh Junior High School No.5 building.

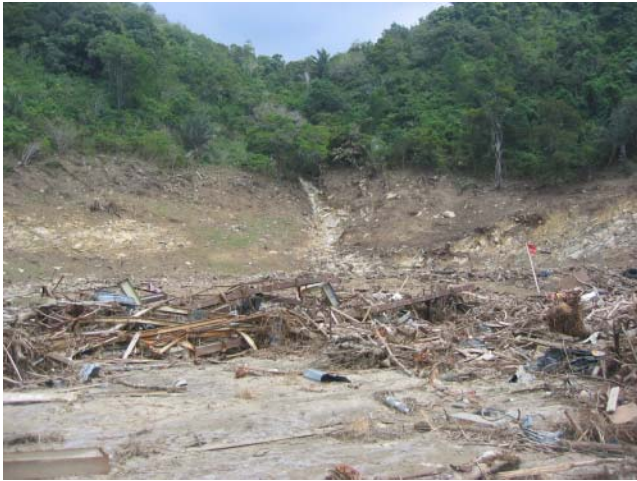
The boundary between eroded and non-eroded areas is clear in this photo. We climbed along the axis of the valley to the inundation limit, confirming that the erosion boundary was not the same as the seawater inundation limit: seawater had risen 4 to 5 m higher than the apparent erosion limit. **Fig. 6** shows the inundation limit of seawater in the

Fig. 5. Tsunami eroded valley on the west coast.

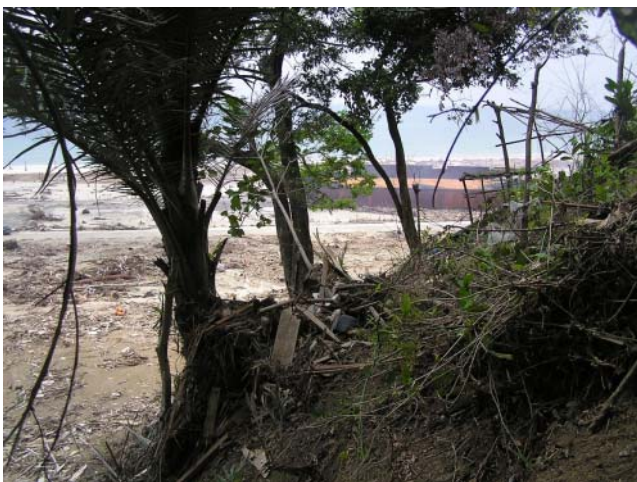
Fig. 6. Inundation limit.

valley in Fig. 5. Note the stranded oil tanker and the traces of residences once occupied by cement plant workers on the plain. Garbage carried by the tsunami is caught in the trees near the camera, which stands on a slope that is more than 33 m above MSL.

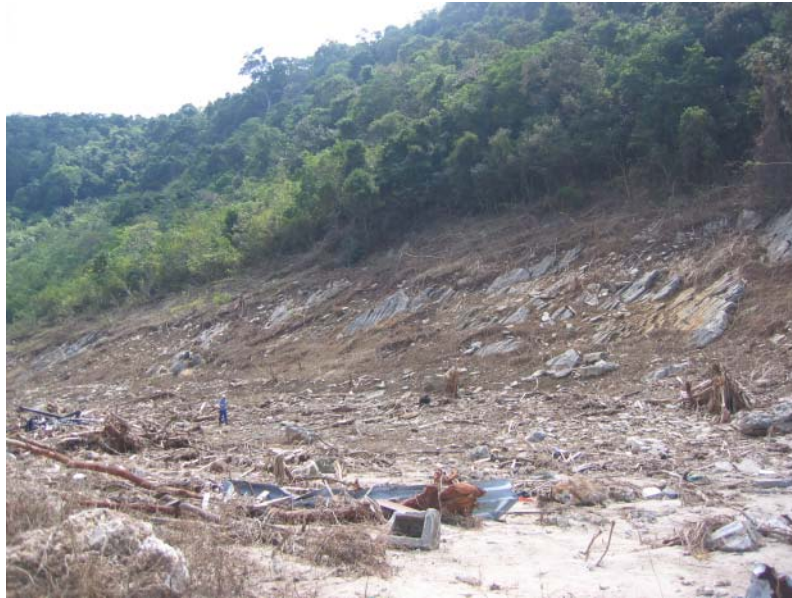
Fig. 11. Tsunami-eroded valley about 1 km south of the cement plant in Lhoknga Village. Seawater rose to 27.9 m above MSL. The limit of eroded limit on the slope is clear. Compare tsunami inundation height with human height (lower left).

30m at several villages on the west coast of Banda Aceh. Not one single resident of these villages survived. In the tsunami-eroded valley in **Fig. 11**, seawater rose to 27.9 m and all vegetation below 25 m was completely swept out to sea. Comparing tsunami erosion height and human height chillingly illustrates the existence of natural hazards that few if any of us will survive. In the Sanriku tsunamis of 1896 and 1933 in Japan, such wiped-out villages stand further testament to this fact.
