# Damage and Reconstruction at Okushiri Town Caused by the 1993 Hokkaido Nansei-Oki Earthquake Tsunami

Nobuo Shuto

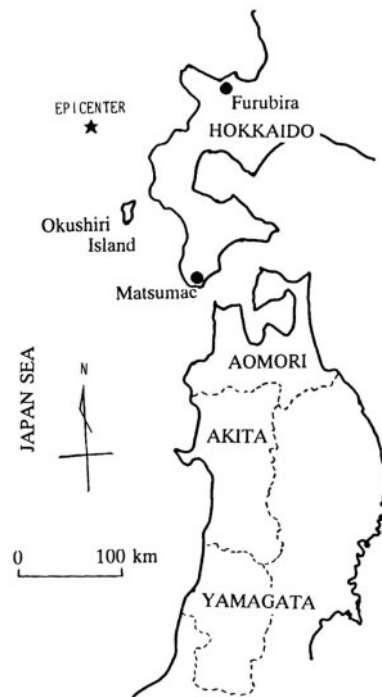
Fig. 1. Location of epicenter.

The epicenter of an earthquake of Ms 7.8 at 22:17 on July 12, 1993, off southwestern Hokkaido was located less than 100 km offshore (in Fig. 1). It originated in a fault stretching from the south to the north that partially underlies Okushiri Island. Maximum subsidence of 80 cm was observed on the southern part of the island. The tsunami caused by this fault movement hit not only Hokkaido but all areas on the Japan Sea. The tsunami's first surge reached the west coast of Okushiri Island, which was nearest the epicenter, in 4 or 5 minutes.

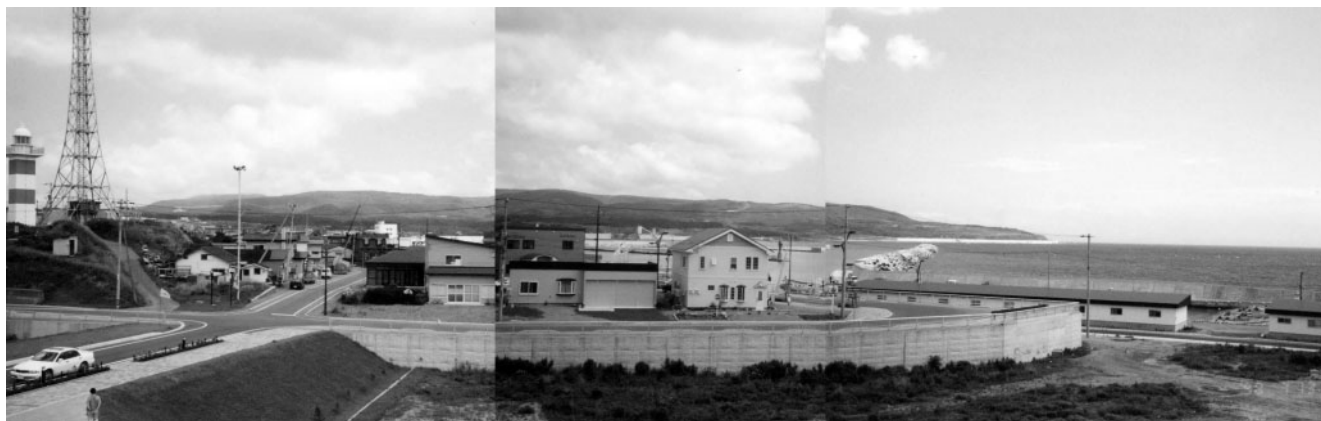
**Fig. 6.** Aonae division rebuilt by ground fill.

tificial ground”, used in developing a “disaster-resistant town”. Aonae division 5, originally located on a sandbar and totally destroyed by the first tsunami, was relocated en masse to high ground. Ground around Aonae divisions 1 to 4 was raised nearly 6 m to be higher than tsunami height and divisions were reconstructed there. **Fig. 6** shows Aonae division 4 from the south. This is the first time in Japan that a community was reconstructed by raising ground so widely and extensively.
