Survey Report:

Lessons Learned from Tokai Heavy Rainfall

Akihiro Tominaga

Nagoya Institute of Technology

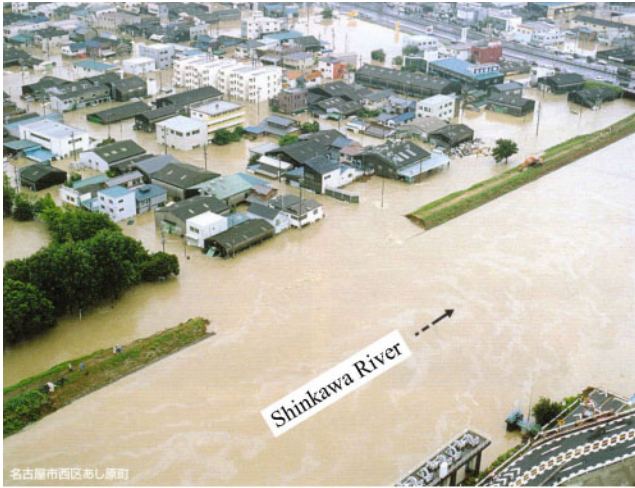
Fig. 5. Levee breach in the Shikawa River [2].

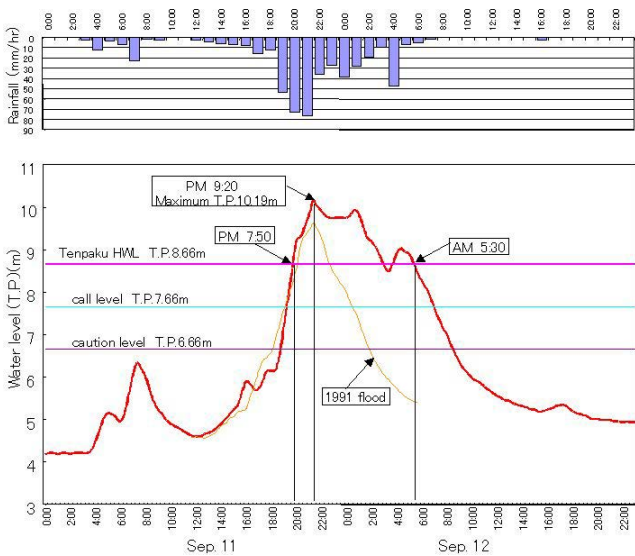
Fig. 6. Hydrograph and hyetograph in the Tenpaku River.

The bed level of the Tenpaku River was higher than the surrounding ground level, and river improvement work was not executed 4 km upstream from the river mouth. This river basin was covered by the maximum rain zone shown in Fig. 1. Fig. 6 shows the hyetograph at Tenpaku Civil Engineering Office and the water level hydrograph at Tenpaku Measurement Station in the Tenpaku River. The previous maximum hydrograph in 1991 is superposed in this figure. The water level rose very quickly and re-

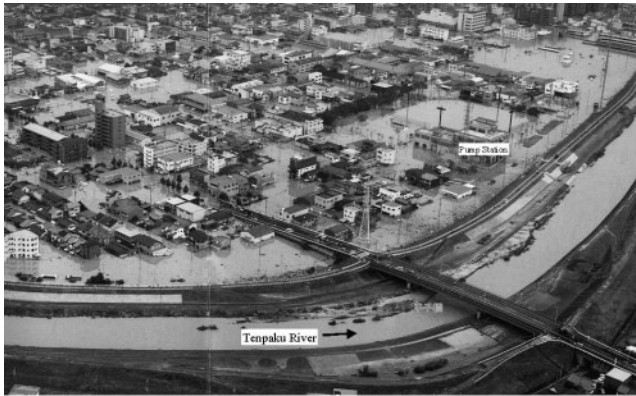
Fig. 9. Inundation at Nonami area [2].
