The Heisei Eruption of Mt. Unzen-Fugendake and Measures Against Volcanic Disasters

Hiroshi Ikeya

SABO TECHNICAL CENTER (STC)

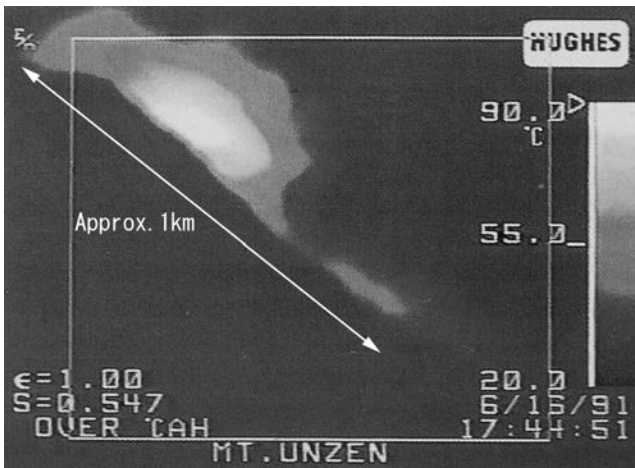
Fig. 1. Pyroclastic flow just running down along the mountain slope of Mt. Unzen-Fugendake (captured by a Thermal Infrared Camera).

During the growth of the lava dome, pyroclastic flows occurred frequently due to partial or large-scale collapses of the lava dome (**Fig. 1**). The total numbers of occurrence of pyroclastic flows were 9,432. The total volume of lava extruded during the Heisei eruption was as much as 200 million m³. About half of it still remains as a lava dome, and the remaining was flowed out as pyroclastic flows. About 170 million m³ of the deposits were piled up on the mountain slope, which became a potential source of debris flow. The volcanic activity had weakened since around October, 1994, resulting in no occurrence of a pyroclastic flow. The growth of the lava dome almost ceased in February 1995. Responding to it, the Coordinating Committee for the Prediction of Volcanic Eruptions of Japan declared the end of volcanic activity on May 25, 1995. Four and half years had elapsed from the start of eruption on Nov. 17, 1990 to the end of volcanic activity in February 1995.

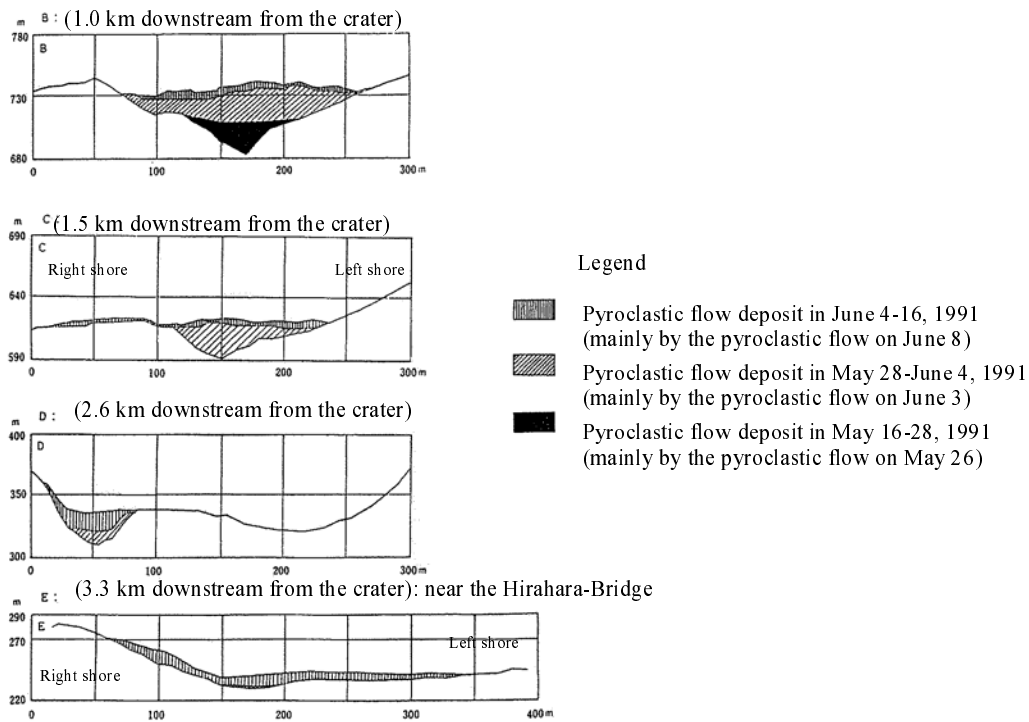
Fig. 2. Topographic change of the Mizunashi River due to accumulation of pyroclastic flow deposit (cross section) [1].

Once pyroclastic flows occurred, valleys were soon filled with the deposits and the valleys' topography was wholly changed (see Fig. 2). It is considered that the topographic modification changed the flowing direction of successive pyroclastic flows or debris flows. Therefore, every time when the topographic condition was changed, the areal data were surveyed and hazard map was remade by reflecting the results. The map was utilized for setting the evacuation area and for implementation of disaster prevention measures.

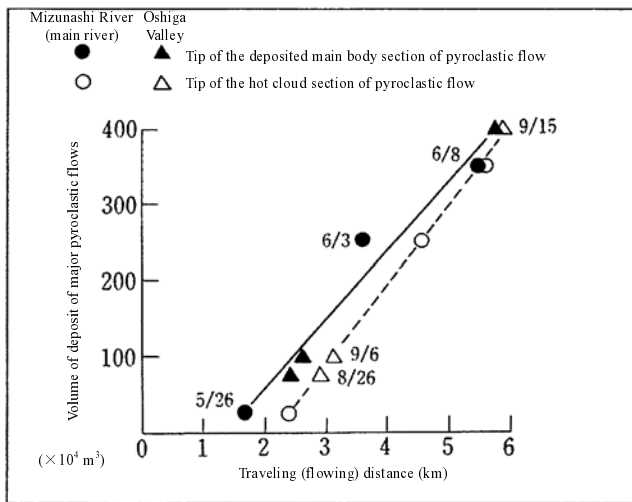
Fig. 3. Sediment volume and traveling distance of major pyroclastic flows [2].

Pyroclastic flow consists of the main body part and the overlying part of hot ash cloud. The main body part contains blocks and fragments of hot lava, and flows down along a topographically low by gravity, just like a debris flow. However, the fashion is not controlled by small topography such as a debris flow, because a pyroclastic flow has a large force of inertia due to its high speed. The hot ash cloud part grows from the movement of the main body part. It is the mixture of high-temperature gas and particularly fine volcanic ash produced by fragmentation of lava blocks. It flows farther than the main body section, because it has the property of gas and a larger force of inertia than the main body part (See **Fig. 3**).

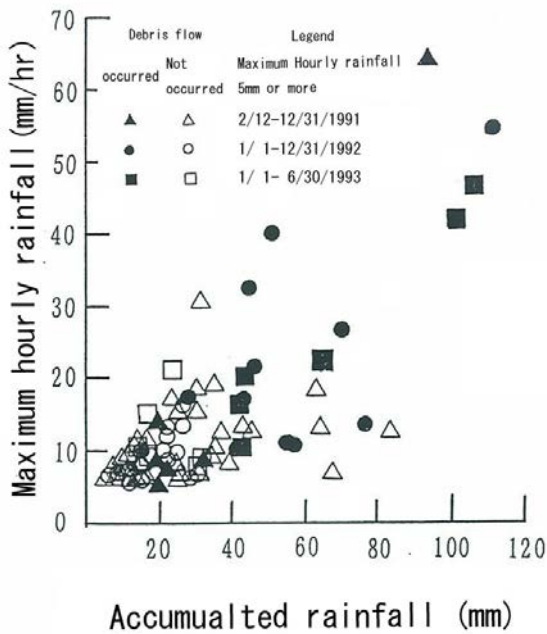
Fig. 4. Relationship between occurrence of debris flow and rainfall [3].

The Mizunashi river does not have surface water at ordinary seasons as its name implies. From the examination of the relationship between the rainfall and the occurrence of debris flows before the eruption, it is known that no debris flow occurred even when the hourly rainfall exceeds 30 mm. After the eruption started, however, debris flows occurred in almost all cases when the hourly rainfall was 20 mm or more (Fig. 4).

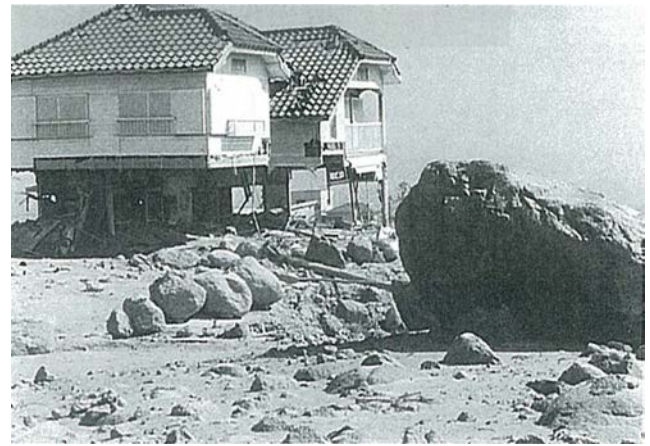
Fig. 5. A house damaged by debris flow.

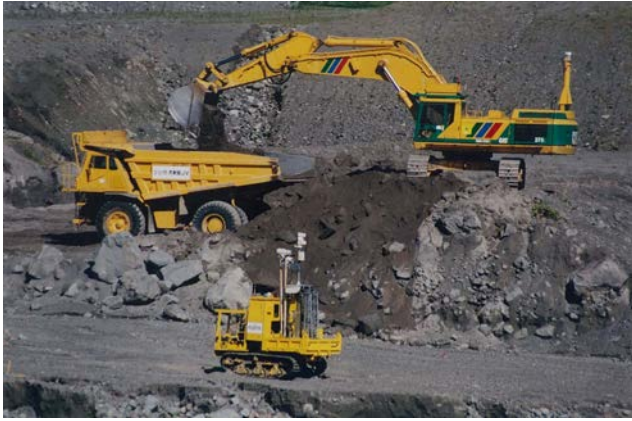
Fig. 9. Unmanned construction machinery developed ahead of the world and implemented for disaster prevention.

In early April of 1993, the national government established a new project office for preventing the Unzen volcanic disasters, and the office directly started volcanic sabo works as the permanent measures based on the volcanic sabo master plan at Mt. Unzen-Fugendake. To prevent expansion of damage by debris flows, sediment removal work was performed at the sand pockets in the hazard area by mobilizing newly-developed unmanned machinery that can ensure the safety of workers (**Fig. 9**). The unmanned construction work which started in 1994 showed the effect immediately by removing about 200m³

In addition, sediment deposited in existing sabo dams and sand pockets was removed using unmanned machinery to recover their functions.

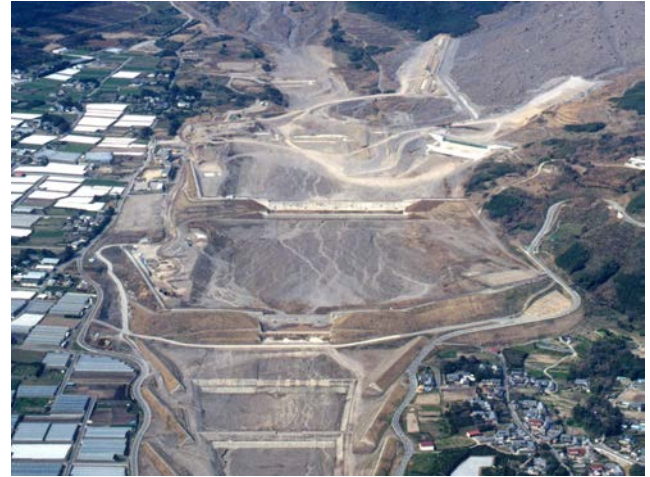
Fig. 10. Sabo dams and dikes were executed.

To prevent sediment-related disasters in the Mizunashi River, construction of the main sabo dam, the Mizunashi River No. 1 sabo dam, started in September 1995 and was completed by the unmanned construction method for the first time in Japan in February 1998 (**Fig. 10**). It is 870 m long, 14.9 m high, and has a sediment storage capacity of 1 million m³. With the completion of this dam, the safety of the area was significantly improved.

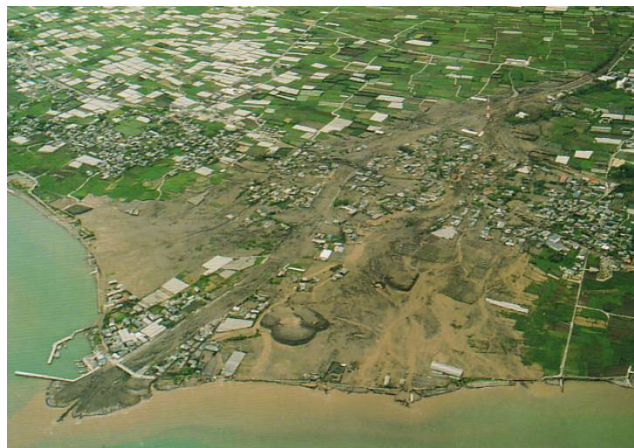
Fig. 11. Situation of disaster stricken area in Annaka district (1993).

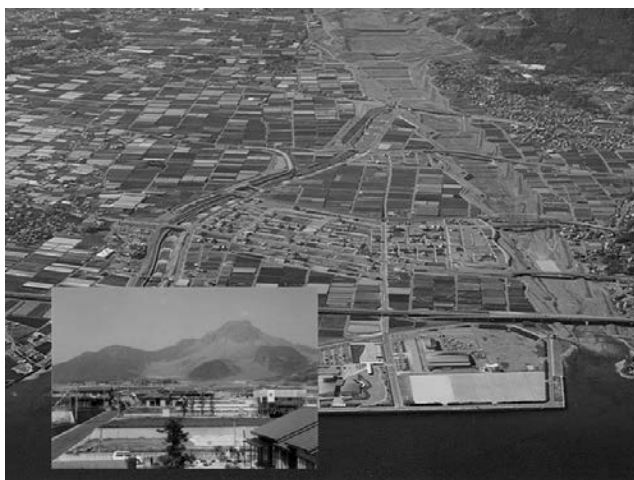
Fig. 12. A new community is creating by incorporating disaster prevention measures (2003).
