# An Overview of Disasters Resulted from Typhoon Morakot in Taiwan

Chjeng-Lun Shieh\*, Chun-Ming Wang\*\*, Yu-Shiu Chen\*\*, Yuan-Jung Tsai\*,  
and Wen-Hsiao Tseng\*

\*Department of Hydraulic and Ocean Engineering, National Cheng Kung University,  
Tainan 70101, Taiwan

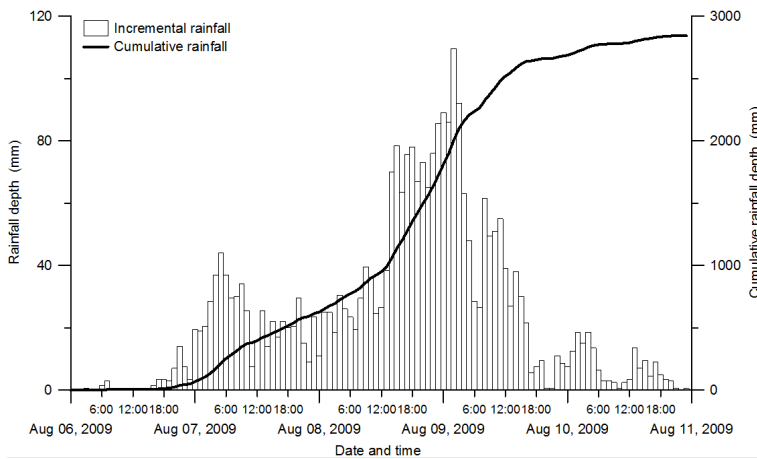
**Fig. 3.** Incremental and cumulative rainfall hyetographs at rain gauge Fenchihiu during Typhoon Morakot.

intensity. As seen in **Fig. 3**, for example, incremental and cumulative rainfall hyetographs at rain gauge Fenchihiu (**Fig. 2**) show that observed rainfall lasted 118 hours and the cumulative rainfall depth is 2841.5 mm. The greatest 1-hour rainfall intensity is 109.5 mm/hour.

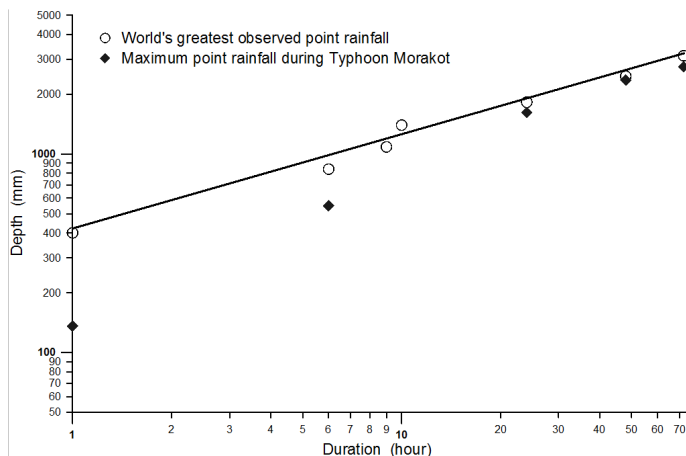
**Fig. 4.** World's greatest point rainfall record versus the maximum point rainfall record during Typhoon Morakot.

The maximum point rainfall depth records [3], extracted from Taiwan's rainfall records during Typhoon Morakot are shown in **Fig. 4**. Note that the values of the 24-hour, 48-hour and 72-hour cumulative rainfall depths approach those of the world's greatest point rainfall records [4], indicating the rainfall's high intensity.

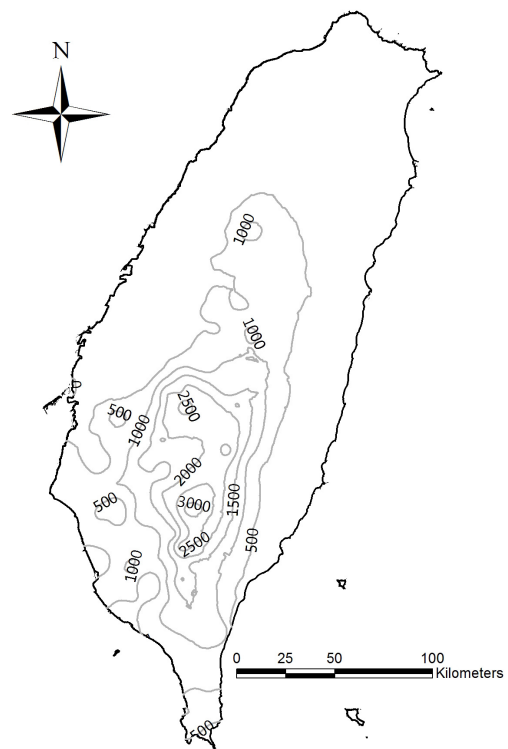
**Fig. 5.** Isohyets in Taiwan during Typhoon Morakot. Isohyets are in mm depth of total rainfall.

Cumulative rainfall depth isohyets for Taiwan during Typhoon Morakot, shown in **Fig. 5**, demonstrate how rainfall covered all of Taiwan during the typhoon, showing the rainfall's large extent. Storm centers observed in southern Taiwan as shown in **Fig. 5** are strongly related to subsequent disasters, including floods, landslides, and landslide dam formation.

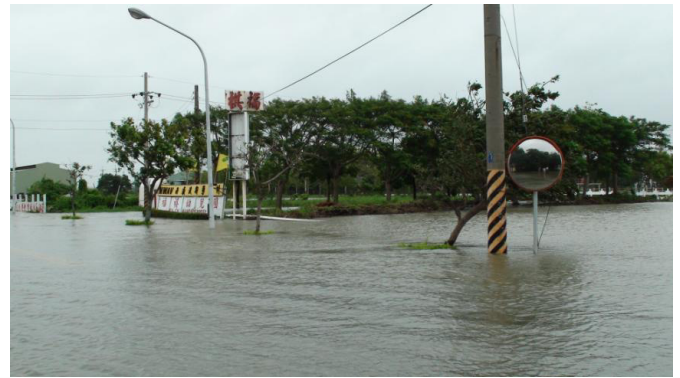
**Fig. 8.** The flood in the downstream area of the Tsengwen reservoir.

1 in **Fig. 7**) is a main supplier of water to southern Taiwan and is, in addition, Taiwan's largest reservoir. During Typhoon Morakot, massive rainfall flooded this watershed and its densely populated downstream areas, e.g., as shown in **Fig. 8**.

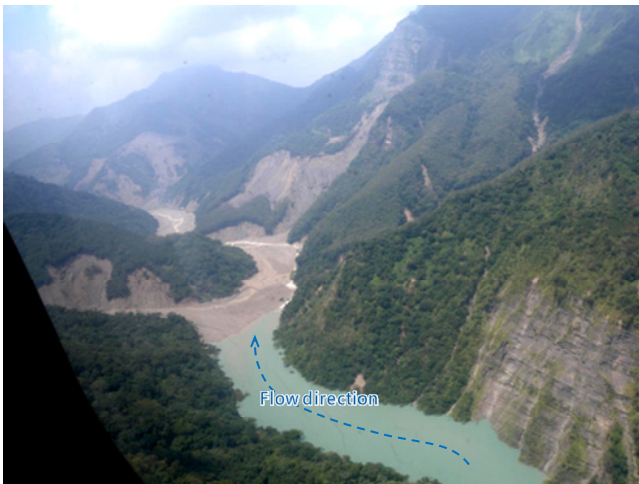
**Fig. 14.** A landslide dam photographed from a helicopter.

The 15 landslide dams forming during Typhoon Morakot were observed using satellite imageries and are located as shown in **Fig. 13**. A landslide dam photographed from a helicopter is shown in **Fig. 14**. Most of the 15 landslide dams spread around storm centers, with some being downstream from storm centers. **Fig. 15** compares landslide dam locations to isohyets. Twelve landslide dams formed in the region within which the cumulative rainfall depth is between 1,000 mm and 2,500 mm.

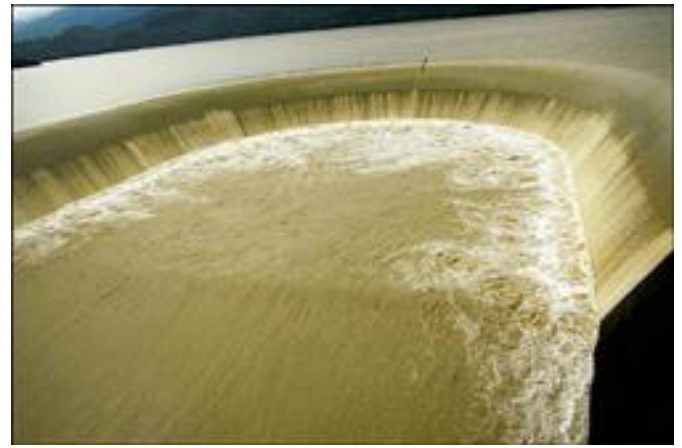
**Fig. 16.** Turbid water observed in the Nanhua reservoir during Typhoon Morakot [4].

During Typhoon Morakot, turbid water was observed in reservoirs, for example, **Fig. 16** of the Nanhua reservoir (reservoir 3 in **Fig. 7**). The water treatment plant

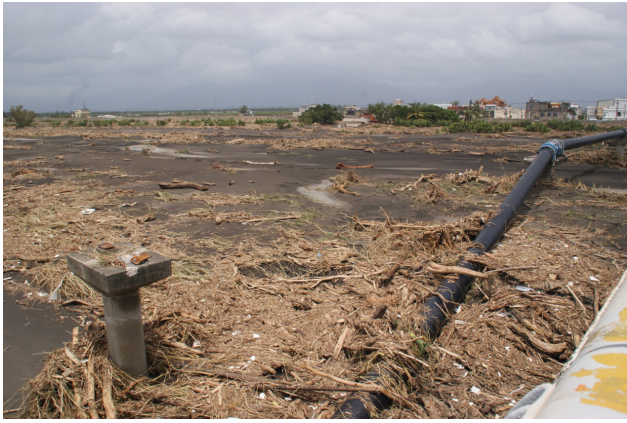
**Fig. 18.** Driftwood beside a pipe.

Our field investigation found driftwood in areas downstream from storm centers. After floods receded, for example, driftwood caught on pipes downstream from storm centers is shown in **Fig. 18** and in the Tsengwen reservoir as shown in **Fig. 19**.

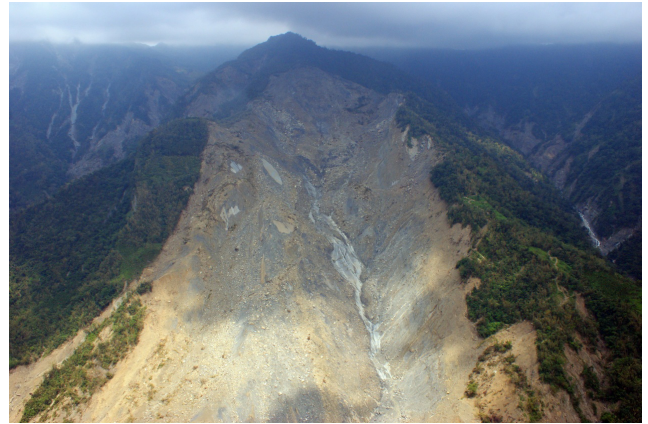
**Fig. 20.** Landslide in Siaolin village.

As stated, a landslide in Siaolin village killing over 400 persons is one example of a compound hazard. This included a debris flow, a landslide, a landslide dam formation, and a landslide dam break which itself triggered a flash flood. The landslide is shown in **Fig. 20**. A simplified map of Siaolin village shown in **Fig. 21** is provided for readers to understand the compound hazard. The incremental and cumulative hyetographs observed at the rain gauge Yuyushan (**Fig. 2**) near Siaolin village are drawn in **Fig. 22**, together with important events and corresponding cumulative rainfall depths.

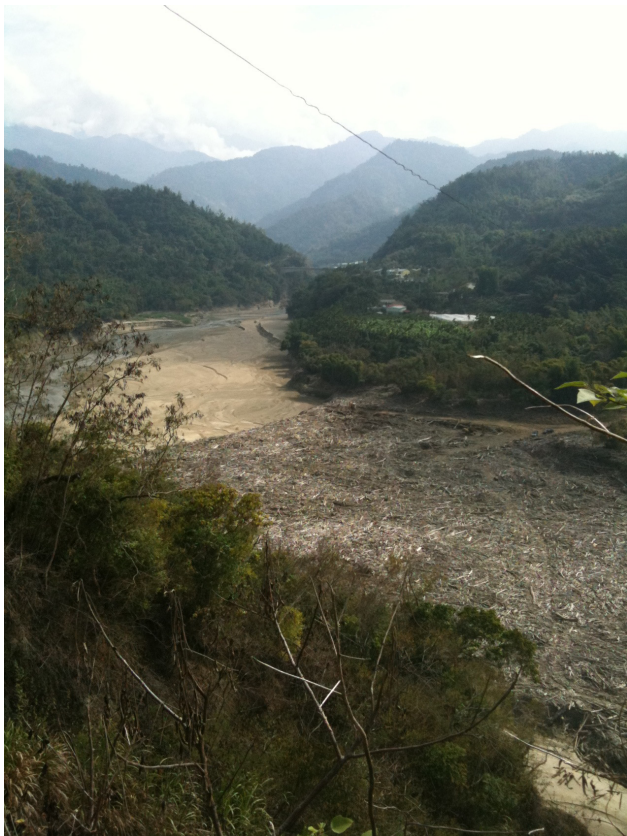
**Fig. 19.** Driftwood in the Tsengwen reservoir.
