Paper:

Large Sediment Movement Caused by the Catastrophic Ohya-Kuzure Landslide

Satoshi Tsuchiya* and Fumitoshi Imaizumi**

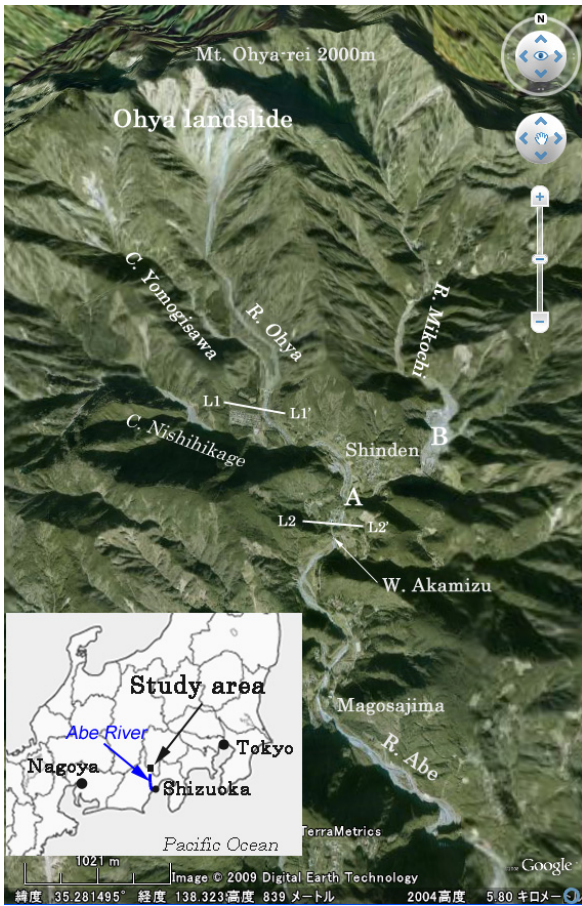
Fig. 1. Showing the around terrain of study area (using Google Earth) 'A' is the river junction of Ohya River and Mikochi River where the landslide dam was formed. 'B' shows that the pond was here in the past.

The deep Abe River rises from the Ohyarei peak 2000 m above sea level and flows 51 km almost straight down to Suruga Bay, passing north-south through Shizuoka City as shown in **Fig. 1**. The Jumaisan tectonic line [10] runs SSE-NNW along the eastern mountains of the Abe River catchment, while the Sasayama tectonic line [10] runs S-N along the vertically eroded gentle flat peaks of the western mountains of the catchment. This area forms typical steep mountainous terrain with a high relief environment of 400-500 m or more. In the west moun-

The Ohya-kuzure landslide, located in the Abe River headwater in Shizuoka Prefecture as shown in **Fig. 1**, is the largest in sedimentary rock belts in Japan. The Ohya-kuzure landslide is also one of the three major landslides in Japan at 1.8 km² in area, 800 m in slope height at the maximum, and approximately 120 million m³ in landslide volume [5] – the other two being the Tonbiyama landslide at the source of the Jyoganji River in Toyama Prefecture and the Hieda landslide in Otari, Nagano Prefecture [5]. Geology consists of a weak background of fragile weathered bedrock caught between two overthrust faults on the Itoigawa- Shizuoka and the Sasayama tec-

A large pond labeled ‘B’ in **Fig. 1** formed in the Mikochi River near the Shinden Village around 1870 [13]. Lacustrine (lake-related) and debris-flow sediments were confirmed by drilling near the pond [9]. with boring core

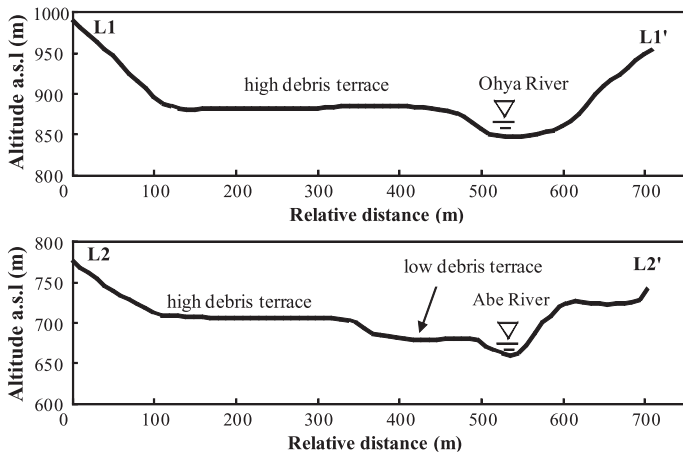
Fig. 3. Representative of cross sections of existent debris terrace in the Ohya River.

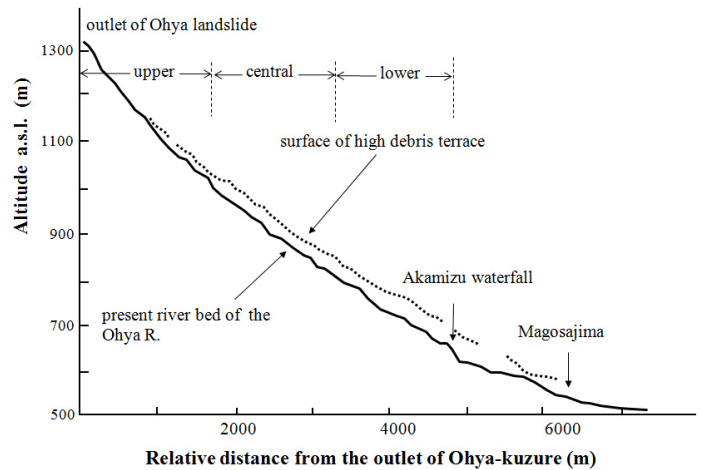
Fig. 5. Comparison of the river bed of Ohya River and surface of high debris terrace.

In the sections shown in **Fig. 5** obtained using a topographic map, comparing the high debris terrace and the river bed on the same axis in the section between the landslide and the nearby Magosajima, suggest that the surface of the high terrace is free of discontinuous geographical features, although discontinuity is seen around the Akamizu waterfall. Generally, sedimentation upstream from the Akamizu waterfall is a randomized phase, but a stratified phase appears to have been created by erosion and sedimentation between the Akamizu waterfall and Magosajima. The debris mass 5 km long originating in the landslide was thus transported through debris flow

by the cross-sectional line interval, yielding the results in **Table 1**. Upper, central, and lower sections from Ohya-kuzure to the Akamizu waterfall are shown in **Fig. 5**. As stated, accumulated sediment from the Akamizu waterfall to Magosajima is considered secondary, so debris flowing from Ohya-kuzure is estimated at 94 million m³ – 25 million m³ less than the total landslide scar volume, i.e., 120 million m³ as shown by Machida (1959) [4] And limited to from Ohya-kuzure to Akamizu where debris generated by the landslide was deposited directly. Secondary sediment accumulation was observed from the Akamizu waterfall to Magosajima.

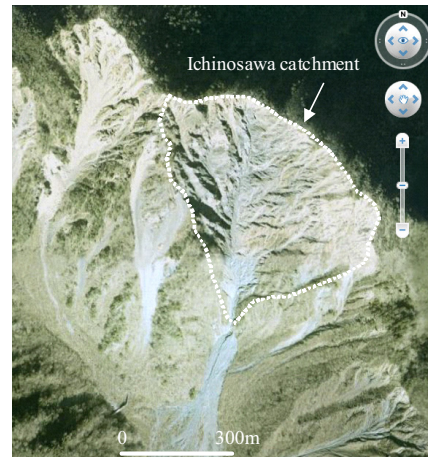
Fig. 7. Location and terrain of Ichinosawa catchment in Ohya-kuzure (using Google Earth).

As shown in **Fig. 7**, a steep valley with the highest sediment yield in the central of Ohya-kuzure is called Ichi-

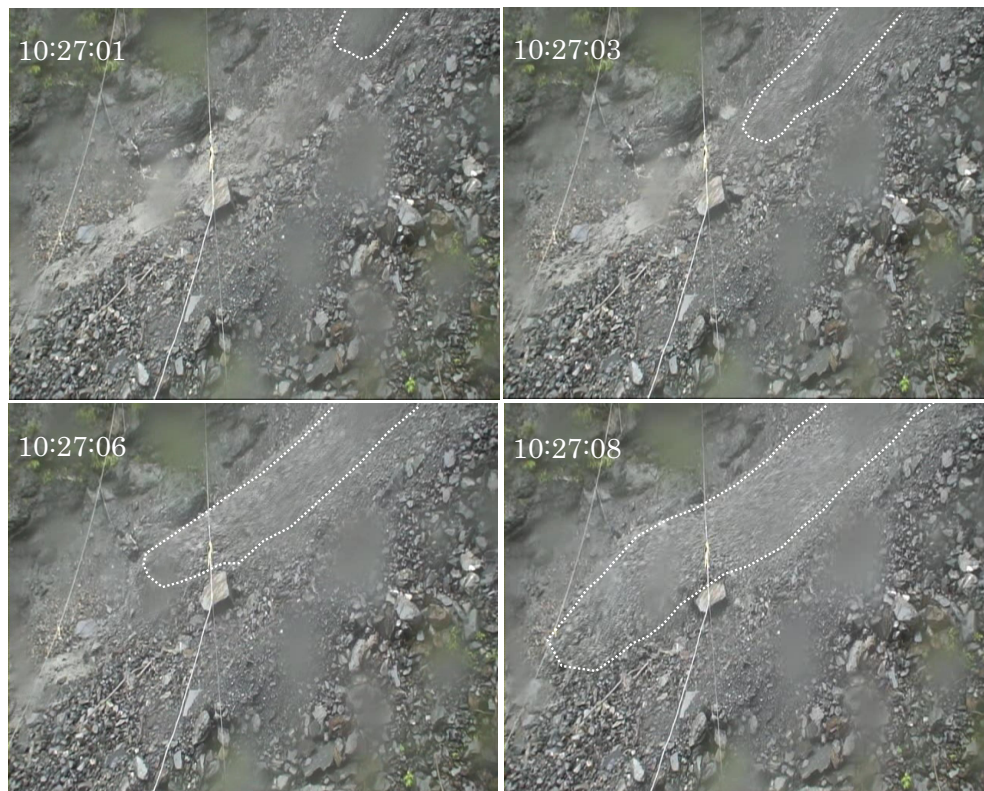
Fig. 8. Images of the debris flow on 19 July 2006. Debris is flowing down in the white frame.

Monitoring included video cameras, ultrasonic sensors, water pressure sensors, and a rain gauge installed in 1999. Continuous video imaging has been obtained since 2003, as shown in **Fig. 8** of debris flow surges on July 19, 2006. Several surge sequences occur during series of rainfall events. Normal clear, mud-free stream flows without abrupt increase in flow depth appeared between surge sequences. The typical debris flow in the upper Ichinosawa catchment is three-phase – precedent flow, main flow and subsequent flow. Precedent flow confirmed as black in video images due to high silty shale concentration appears

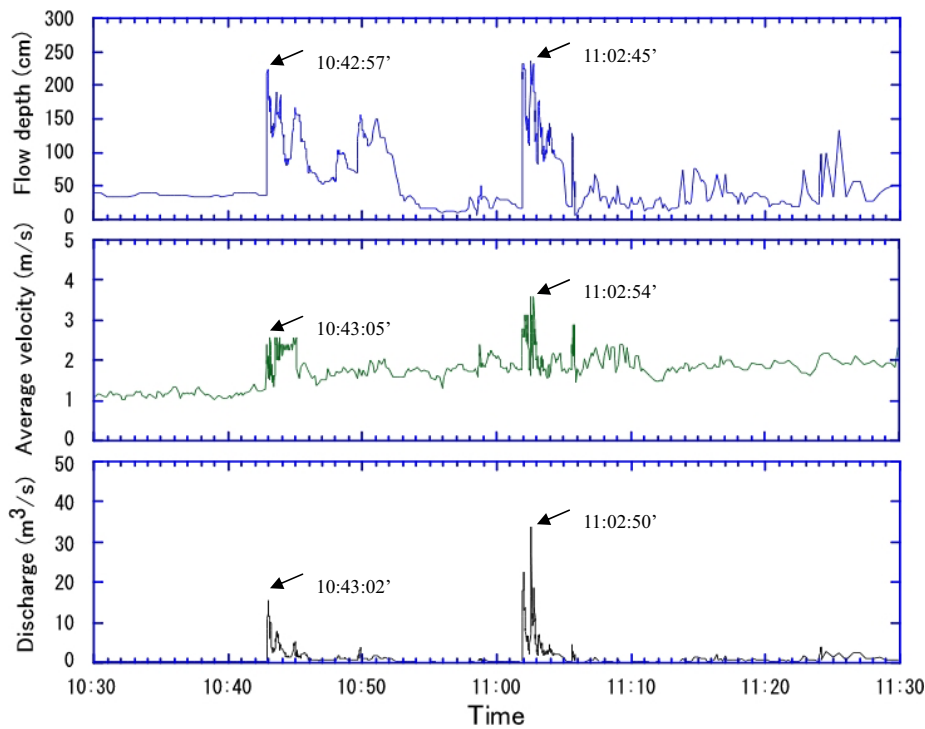
Fig. 10. Changes in flow depth, average velocity, and discharge of debris flow on 19 July 2006.

Figure 10 shows the flow depth, flow velocity, and discharge determined from video image analysis, with mean surface velocity estimated by multiplying surface velocity by 0.6, suggested by Takahashi (1977) [7, 8]. Discharge was calculated by multiplying cross-sectional debris flow area by mean velocity. As shown in **Fig. 10**, hydraulic properties peak when surges appears in the sequence of flow depth, discharge, and flow velocity. Comparable results were seen in previous studies [2, 3, 6, 8]. Debris

flow including large amounts of debris and a low average surge velocity of 2.5-3.5 m/s. Total discharge from the first-surge discharge peaking at 15 m³/s to third-surge discharge peaking at 34 m³/s was estimated at 2300 m³.

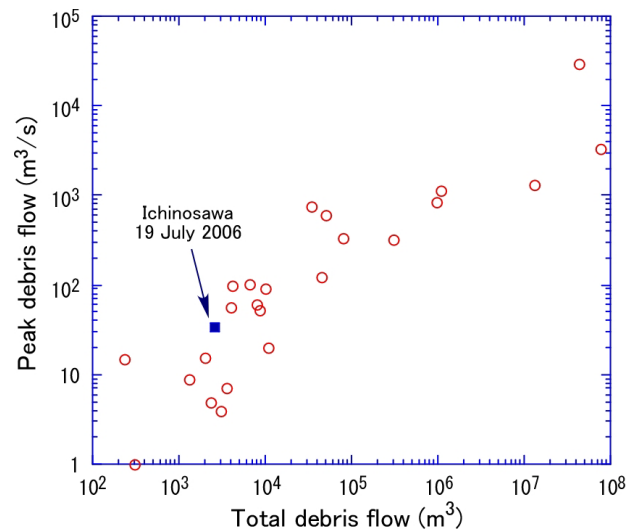
Fig. 11. Logarithmic comparison of debris flow peaks and discharges. The red circles are the data of debris flow obtained in Mt. Yakedake [1].

The peak-to-total discharge relationship during debris flow is plotted in Fig. 11 together with data from Mt. Yakedake in Nagano Prefecture, Japan [1], where stony debris flow occurs. The debris flow in 2006 is plotted in same position as Mt. Yakedake. Two or three debris flows with similar discharge by downpours in July (Baiu rainy season) and typhoons afterwards occur in each year. Excluding Ichinosawa, no noteworthy sediment production or movement is confirmed in Ohya-kuzure, so recent Ohya-kuzure sediment production is estimated to be 5000 to 10,000 m³ per year.
