Paper:

Tsunami Vertical Evacuation Buildings – Lessons for International Preparedness Following the 2011 Great East Japan Tsunami

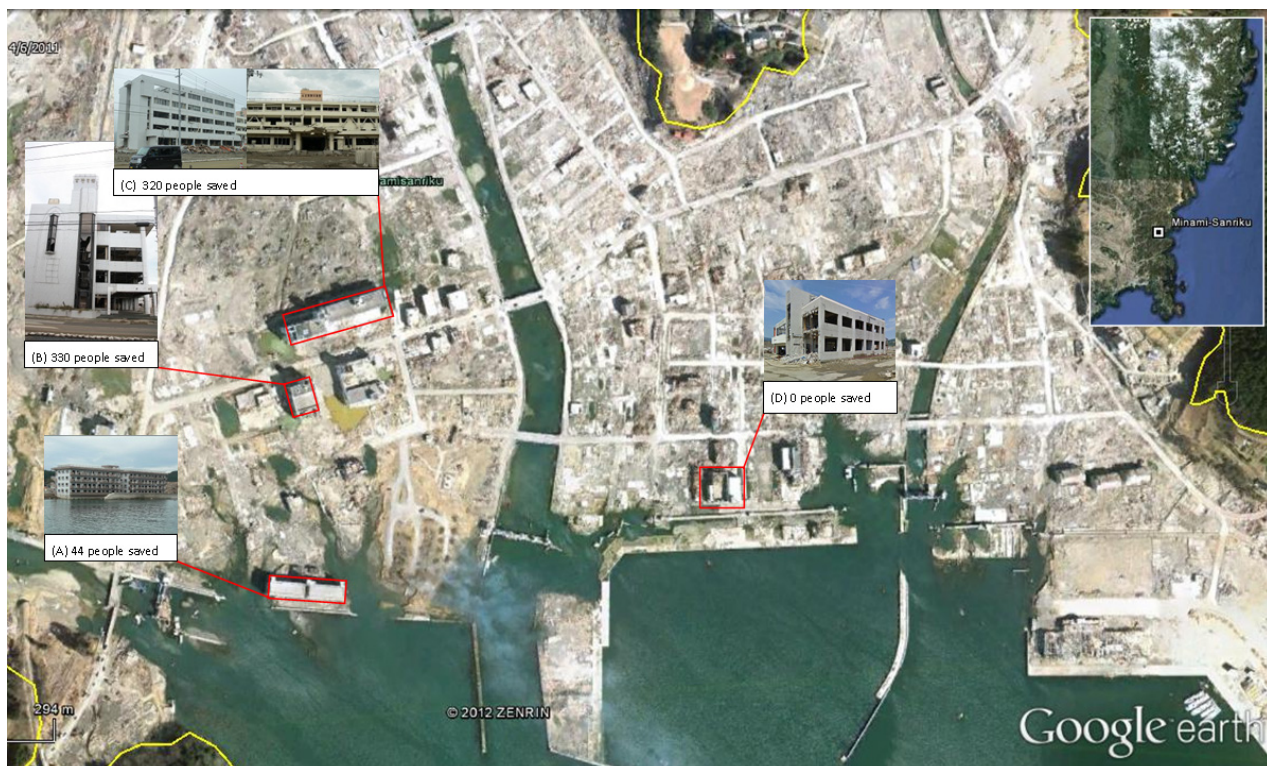
Fig. 1. Map and images of TVEB in Minami-Sanriku Town, including numbers of people saved and tsunami inundation marked in yellow [29]. (A) Matsubara apartment block; (B) Takano-Kaikan conference venue; (C) Shizugawa Hospital; (D) Fishing Cooperative.

pital in Minami-Sanriku (C in **Fig. 1**), where the shore-facing side of the buildings exhibited many broken RC columns at third storey balconies [11]. An office building at the inner harbour in Kesennuma (A in **Fig. 2**) sustained debris damage to external stairwells, but the stairwells appeared functional. Although TVEB generally sustained minor damage due to debris strike, it was not possible to confirm the type of debris that caused the observed damage. It is therefore not possible in this paper to explicitly evaluate the resistance of the observed TVEB to debris impact, for example to ascertain the level of damage in the case of a large ship striking the TVEB.

Minami-Sanriku Town had four official TVEB (**Fig. 1**), of which only the Matsubara apartment building was constructed with prior consideration of vertical evacuation functionality. Constructed in 2007, this TVEB was intended to provide refuge to large crowds at the adjacent sports ground. There were initial public concerns about the building being used for tsunami evacuation due to its port-front location, but the local community was informed that the roof level would constitute a safe elevation. It was reported during interviews that large numbers of people taking refuge in TVEB primarily comprised people who were in the building or in the immediate vicinity at the time of the evacuation warning, suggesting that people did not travel far to TVEB. At Shizugawa Hospital, 69% of the 320 evacuees were hospital staff or patients and at the Takano Kaikan building, the majority of the 330 people saved were attending a community meeting at the building.

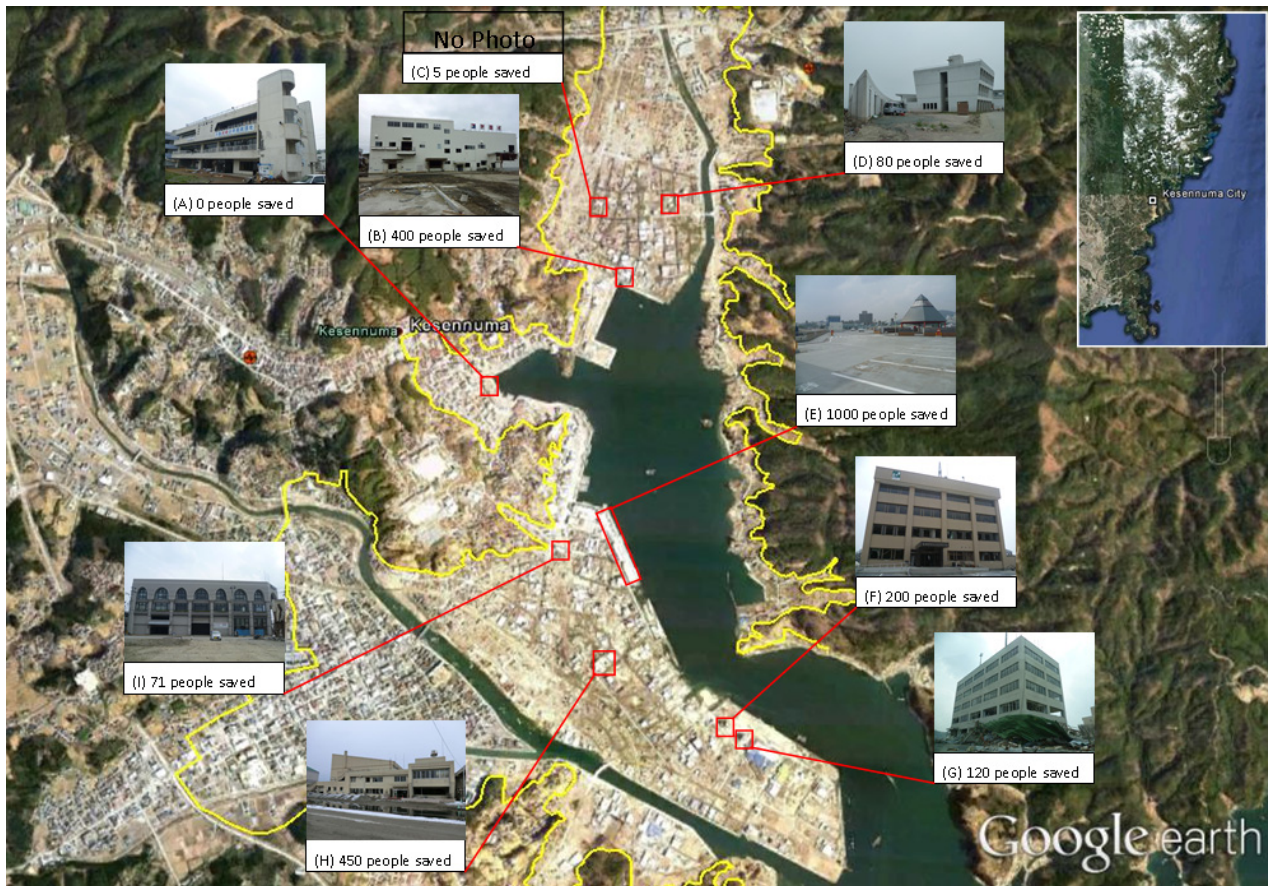
Fig. 2. Map and images of nine vertical evacuation buildings in Kesennuma City, including numbers of people saved and tsunami inundation marked in yellow [29]. These comprise office buildings (A, F, G, I); a cannery (B), a retail building (C), welfare centre (D), a car parking deck (E) and a community centre (H).

Kesennuma City had 16 officially designated TVEB relatively well distributed across the coastal areas of the city; nine are in the area shown in **Fig. 2**. With the exception of the car park deck over the fish market (E, **Fig. 2**) and the prefectural government office (F, **Fig. 2**), which

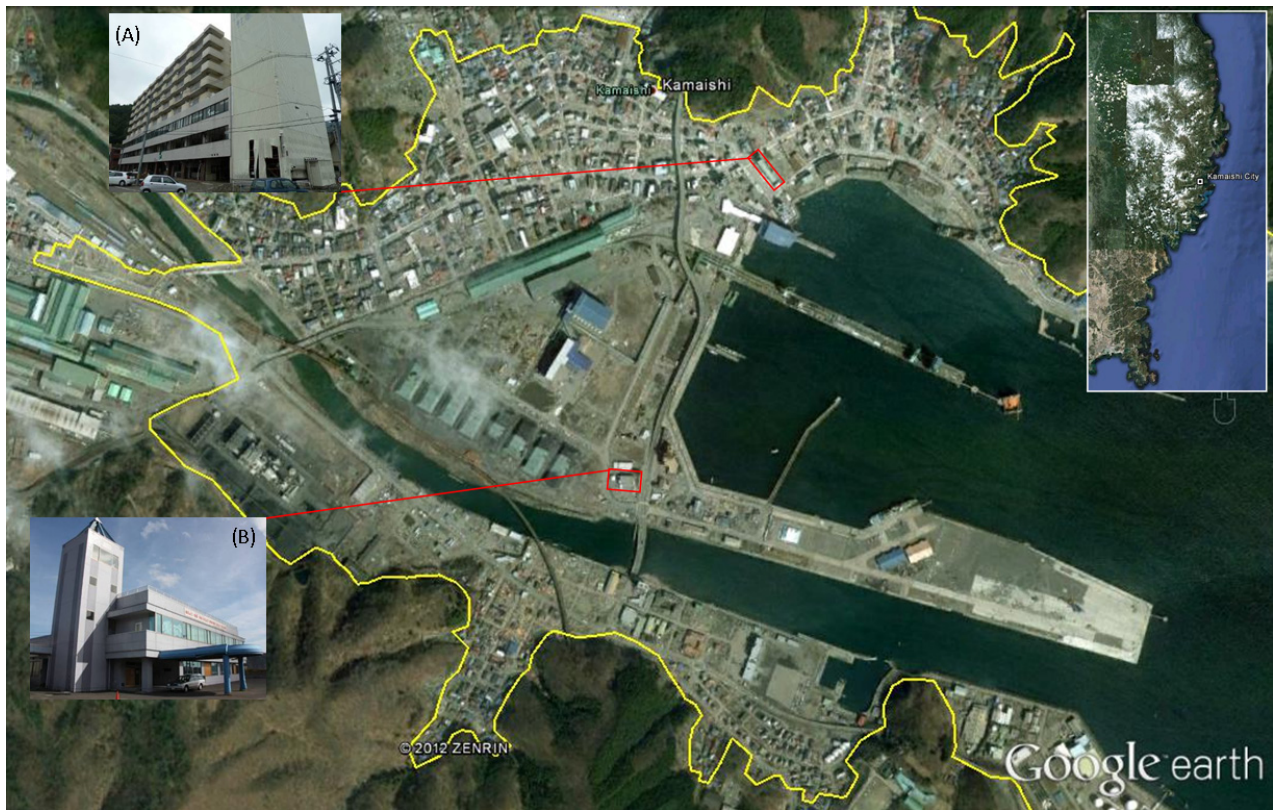
Fig. 3. Map and images of vertical evacuation buildings in Kamaishi City and tsunami inundation marked in yellow [29]. These are the Kamaishihamachō Post Office and apartment building (A) and government offices (B).

There were only two TVEB in Kamaishi City (Kamaishihamachō Post Office and a government office, **Fig. 3**). Relatively few people (50) took refuge in these buildings during the tsunami, perhaps owing to the 66.4% rate of immediate evacuation [21] and access to high ground within one kilometre of the port and industrial areas. The government office provided refuge to people who became stuck in vehicles due to traffic congestion. An additional building, the Hotel Horaikan at nearby Unosumi, was constructed with vertical evacuation in mind (see 3.8). Additional TVEB had been planned in the port area of Kamaishi, but they had yet to be constructed by March 11th.

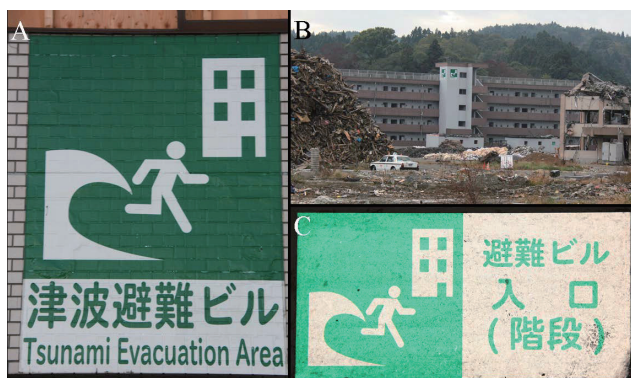
Fig. 4. Vertical evacuation signage used in Japan. (A) Sign displayed prominently on the Kamaishihamachō Post Office, (B) signage on the Matsubara apartment block in Minami-Sanriku, (C) a sign displayed above an entrance to the Kamaishihamachō Post Office (Translation: ‘Evacuation building entrance (stairways)’).

ings were observed during our field survey to have official signage: the Kamaishihamachō Post Office and Hotel Horaikan in Kamaishi, Matsubara apartments in Minami-Sanriku, the prefectural government office and the Yoyoi cannery, both in Kesennuma. The high numbers of evacuees taking refuge in designated buildings despite the absence of signage suggests that awareness of TVEB was high among people in the area at the time of the tsunami, although further research into evacuee behaviour should aim to identify any impact that signage may have had on destination of evacuees. In the meantime, consistent signage should be adopted and applied to all TVEB, including retrofitting of existing buildings that become designated. Signs should be clearly displayed at the top of each building and above entrances to clearly indicate the most appropriate access route to upper storeys. Signage should be nationally consistent with approved standards for style and messaging.
