Machine Learning Based Building Damage Mapping from the ALOS-2/PALSAR-2 SAR Imagery: Case Study of 2016 Kumamoto Earthquake

Keywords: 2016 Kumamoto earthquake, building damage mapping, ALOS-2/PALSAR-2, synthetic aperture radar, machine learning

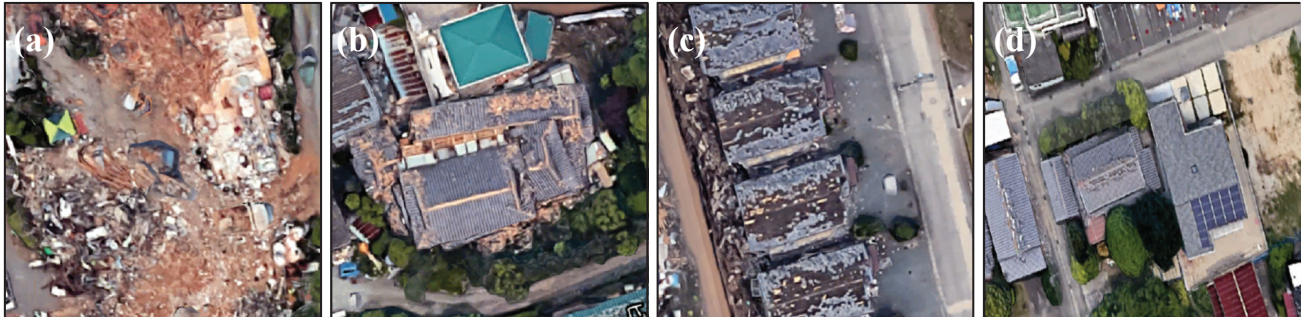
**Fig. 2.** Typical building damage patterns in the 2016 Kumamoto earthquake: (a) the buildings become debris; (b) the structure of buildings is severely damaged; (c) the roof tiles are severely damaged; (d) no significant damage can be observed.

of Mashiki is 326,000 with a density of 496.42 persons per km² as of 2003. On May 2, 2016, a reconnaissance survey was organized by Saitama University to investigate the building damage caused by the earthquake in this area. The investigation revealed that old houses suffered most of the damage, while new buildings showed almost no damage except for some shear cracks appearing on the walls.

In general, four types of buildings were observed in this area: Class 1: buildings are in ruins and present debris as shown in **Fig. 2(a)**; Class 2: the structure of the buildings is severely damaged, as in vertical subsidence or collapse of the side wall shown in **Fig. 2(b)**; Class 3: the roof tiles are damaged as shown in **Fig. 2(c)**; Class 4: no significant damage can be observed as shown in **Fig. 2(d)**. Since the ground truth data was constructed from an orthographic projection of the optical image, it is very difficult to judge the internal damage of the buildings. We therefore defined

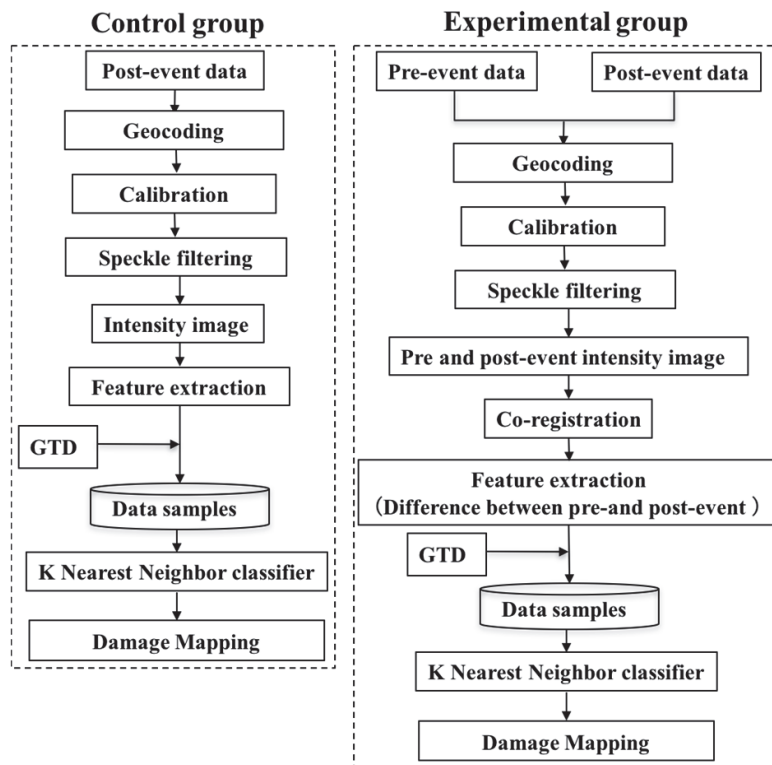
Fig. 3. Flowchart of the methodology used in this study.

processing and mapping were performed on the ArcGIS and ENVI/SARscape software [27]. A flowchart of the methodology used in this study is shown in Fig. 3.

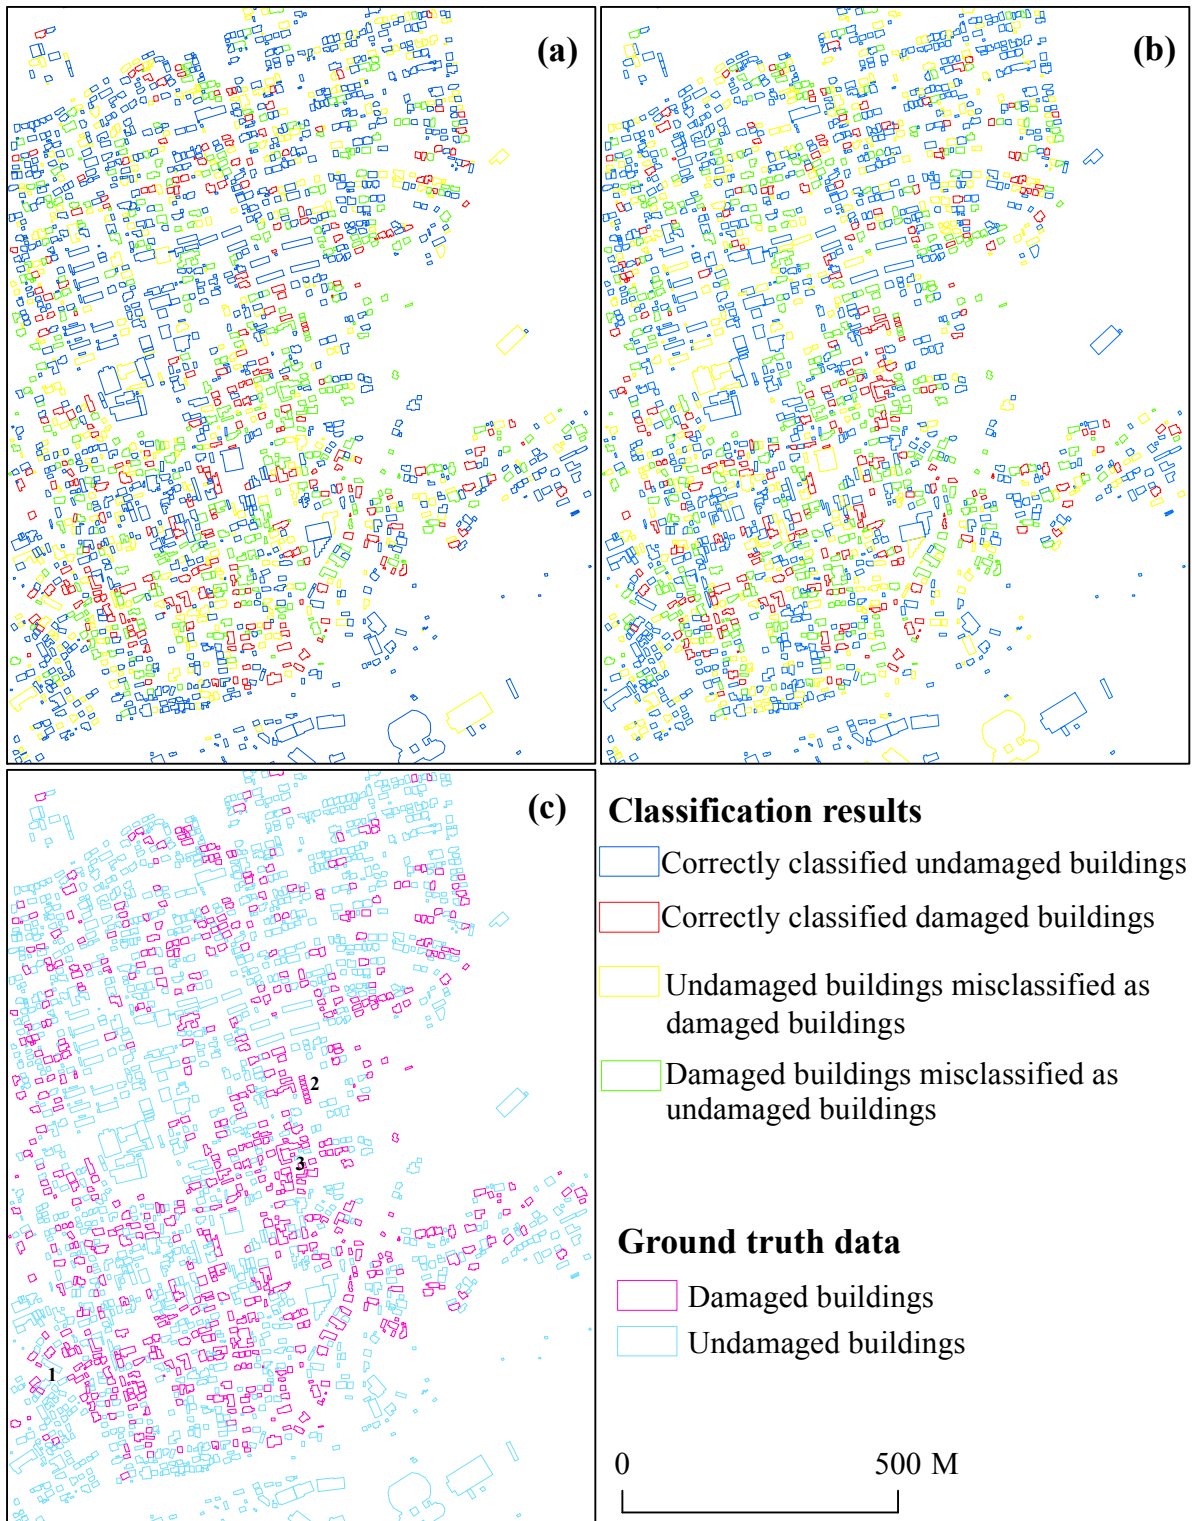
Fig. 5. Results of building damage classification using the K-Nearest Neighbors classifier: (a) damage mapping result using only the post-event SAR image; (b) damage mapping result using multi-temporal SAR images; (c) ground truth data in our study area. Note: numbers 1, 2 and 3 in **Figs. 5(c)** represent the positions of buildings in **Figs. 6(a)**, **6(b)** and **6(c)**, respectively.

The ground truth data, shown in **Fig. 5(c)**, used in this study were visually interpreted from very high resolution optical imagery provided by Google Maps [24].

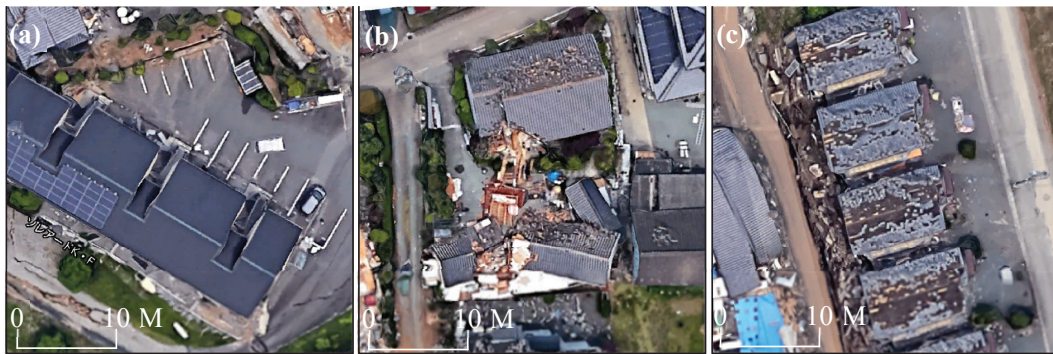
Fig. 6. Three examples of building damage patterns that caused misclassification: (a) oblique building; (b) vertical sinking building; and (c) building with tile damage.

In this study, 407 undamaged buildings were misclassified as damaged buildings. **Fig. 6(a)** shows an example of an undamaged building that was misclassified as damaged; this building has relatively bigger azimuths between the side walls and the radar sensor’s ground range direction (this building was referred to as oblique building) [34]. This is a typical case of overestimation. We can also confirm the radar azimuth direction in **Fig. 1(e)** and the building sidewall direction in **Fig. 5(c)**, which show that many buildings in our study area are oblique buildings. The building oblique buildings are represented as volume scattering [35]. Most of the randomly distributed damaged buildings are also represented by volume scattering [15]. The oblique buildings thus lead to their classification as damaged buildings.

An example of one damage pattern causing underestimation of damage is shown in **Fig. 6(b)**. This figure shows a vertical sinking building. Even though this building is severely damaged, the structure can still generate a strong double bounce reflection due to the relatively intact dihedral structure. This building will thus not show significant

To achieve a convincing conclusion, it is best to carry out a control experiment. In order to clarify the impact of the degree of tile damage on classification, four adjacent buildings with similar geometry and azimuths, as shown in **Fig. 6(c)**, were selected for analysis. The upper two buildings with minor tile damage were misclassified as undamaged buildings, while the lower two buildings with significant tile damage were correctly classified as damaged buildings. This may indicate that having a large number of damaged tiles is more likely to cause higher heterogeneity of backscattering within the roof area, and therefore such buildings are easily classified as damaged. The undulating terrain is another important reason for the low classification accuracy. According to the field survey report, the northern part of the study area is located on a mountain slope where there is significant topographic relief, causing a change in the circular polarization correlation coefficient. This in turn causes extensive misclassification in the northern buildings. In such complex situations, it is quite difficult to distinguish this kind of damage from the undamaged buildings.
