Paper:

# Full-Scale Experiment of Earthquake Resistant Embankment Using Flexible Container Bag

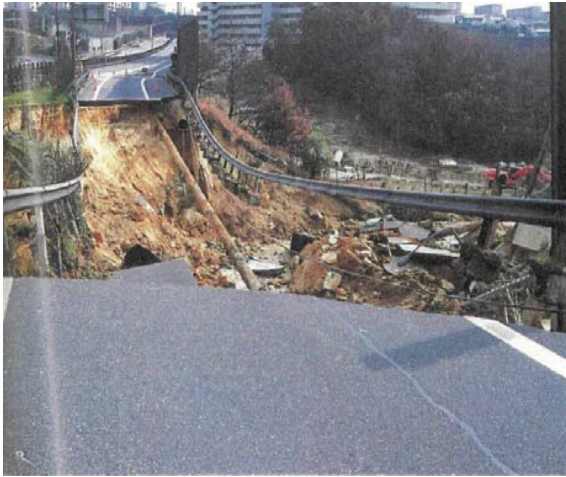
**Fig. 1.** Damage situation at Okuradani IC [1].

The Great Hanshin-Awaji Earthquake struck the southern part of Hyogo on January 17, 1995, resulting in the collapse of an embankment of height 15 m near Okuradani IC along the Daini-Shinmei Road as shown in **Fig. 1**. According to the investigation report on the Great Hanshin-Awaji Earthquake [1], this road embankment was constructed on a site where a pond had once existed, and the foundation ground was soft with the *N* value being less than 5 up to 5 m in depth. As to the failure mechanism, it is estimated that the swelling of concrete block retaining wall caused by lateral deformation and ground surface settlement, and numerous cracks in the embankment triggered the collapse. Additionally, it is pointed out that the large amount of water leaked because of a rupture in a water pipe buried in the embankment contributed to the collapse.

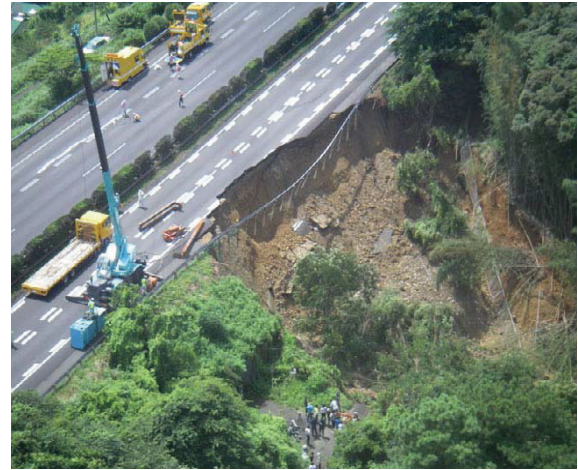
**Fig. 3.** Damaged lane of Tomei Expressway in Makinohara District [2].

An embankment slope near Makinohara Service Area of the Tomei Expressway collapsed during a 2009 earthquake with epicenter in Suruga Bay. “The Committee on Earthquake Damage in Makinohara District of the Tomei Expressway” reported on the cause of the collapse [6]. According to the report, there was slight damage in districts other than Makinohara and the damaged infrastructure was restored with relatively easy repairs. However, in case of Makinohara as shown in **Fig. 3**, a 40 m long portion of the embankment slope of the Expressway’s main lane collapsed. The above-mentioned committee was of the opinion that the slope surface collapsed because of the reduced shear strength and permeability of the structure. This was caused by the weathering of mudstone in the lower part of embankment over many years, which resulted in bad drainage and rise of groundwater because of this embankment’s construction in the catchment area. Such conditions along with the embankment’s inferior earthquake resistance triggered a sliding failure in the lower part of the embankment that gradually advanced to the upper part and finally reached the driving lane of the Expressway.

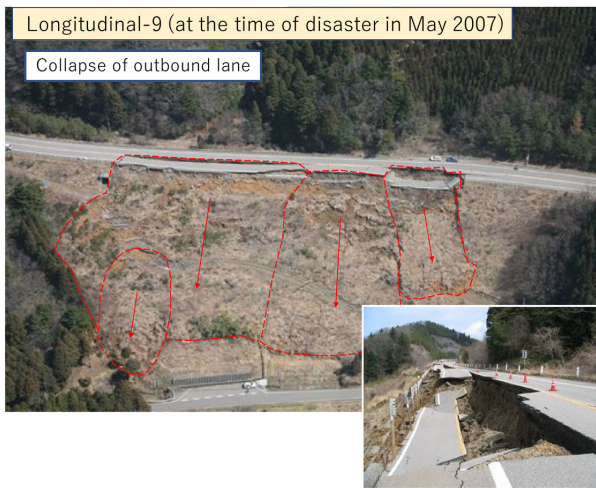
**Fig. 2.** Damage situation along the Noto Toll Road [5].

The Noto Hanto Earthquake in 2007 caused large-scale damage along the Noto Toll Road [5], following which a detailed survey was carried out to understand the tendencies of road embankment damage. The factors leading to the large-scale collapse (as shown in **Fig. 2**) are as follows: construction of high embankments in the valleys; the valleys acted as catchment areas for surface water and groundwater from hinterland and surrounding areas; at about 70% of the collapse sites, the collapsed sediment changed into mud that flows down to the lower part of a slope; performing soil boring tests, etc. It is also found out that the former geographical features remained as they were and there existed slip surface near the undersurface of embankment. These factors suggest that the shear strength of the embankment material with high moisture content rate at the top of the slope was lowered by the seismic motion, which led to collapse.

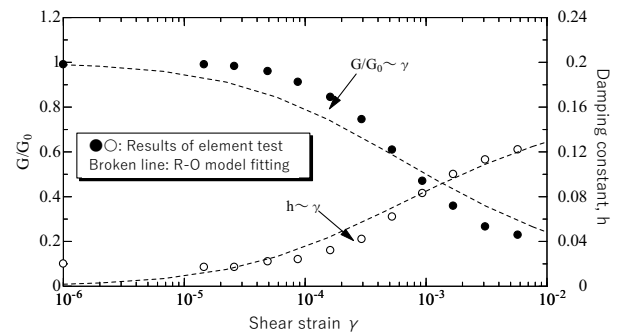
**Fig. 9.** Dynamic deformation characteristics of embankment material.

The physical and dynamic characteristics of the embankment material used for the experiment are listed in **Table 1** and its grain size distribution curve is shown in **Fig. 8**. The ground material consists of gravelly sand with fine (SF-G) with the maximum particle size of 9.5 mm and the maximum dry density of 2.15 g/cm<sup>3</sup>. The internal friction angle ( $\phi'$ ) of the ground material is around 52° compared to 30° to 35° which is generally regarded as good quality, indicating that the ground material is of superior quality. The dynamic deformation characteristics of the embankment material are shown in **Fig. 9** and are used for the prior numerical analysis as a modified RO model [11].

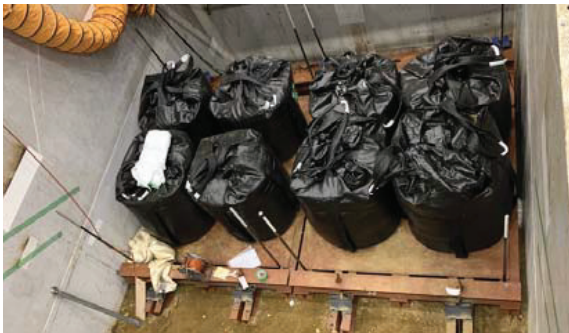
Fig. 11. Situation of flexible container bags.

**Figure 11** shows what the flexible container bags look like during the construction. The actual construction of the reinforced structure was carried out at the designated place before preparation of the embankment as described in Section 3.2.1. The construction procedure is as follows: 1) setting the foundation and anchors for fixture of the flexible container bag, 2) preparing the foundation ground for the embankment and the embankment itself,

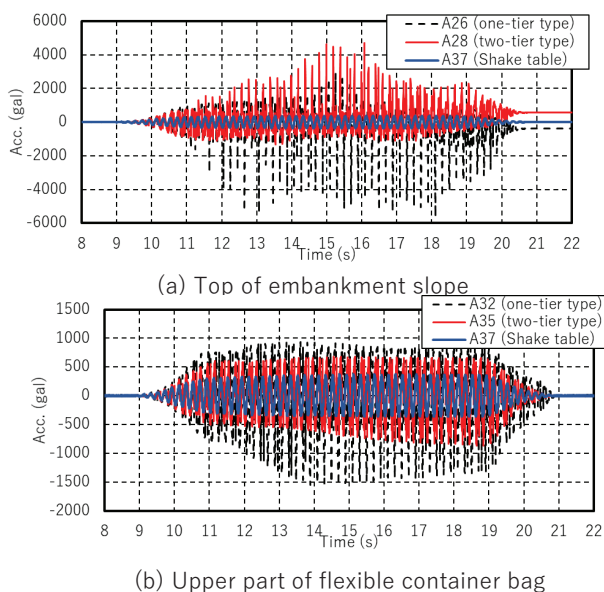
Fig. 15. Response acceleration at the top of the slope of embankment.

**Figure 14** shows the location map of the sensors. **Fig. 15** shows the time history of the results of measurement of the response acceleration at the toe of the slopes on the sides of one-tier and two-tier types (A26 and A28) in Case 3. Compared to the acceleration at the shake table (A37), an amplitude exceeding 4,000 Gal is recognized at the top of the slope corresponding to the input acceleration of 376 Gal. As for the response acceleration at the upper part of the flexible container bags (A32 and A35), there is a significant difference between one-tier and two-tier types and it is confirmed that the response acceleration of one-tier type exceeds 1,500 Gal and that of two-tier type marks 886 Gal. A possible reason behind such large amplitude of the response acceleration in the embankment could be that the predicted value of natural period of the model was about 6 Hz, while the preliminary value determined by the actual random wave was about 8 Hz, which was possible that the dynamic characteristics of the embankment was close to resonance due to damages with repeated shake tests. This possibility remains a conjecture as of now and should be examined further in detail.

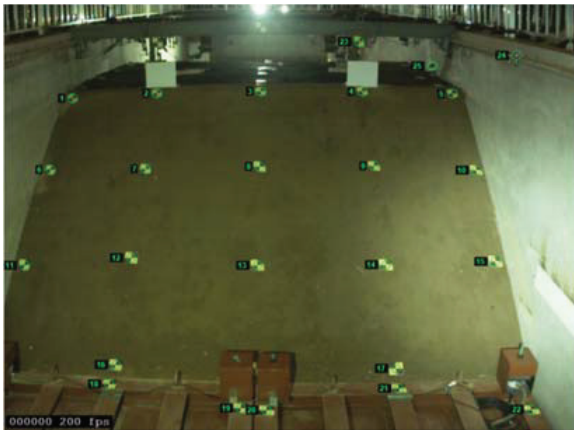
(a) Layout drawing for shooting

(b) Target arrangement (one-tier type)

(c) Target arrangement (two-tier type)

**Fig. 16.** Measurement of 3D dynamic displacement sensor.

**Figure 16** shows the layout drawing for shooting and the arrangement plan of targets. The camera was set at a depression angle of  $70^\circ$  to the direction of shaking, and the angle between the slope surface of embankment and the surface of imaging element of the camera was  $36.1^\circ$ .  $D_{yp}$  in **Fig. 16** indicates the vertical component of the gauge mark ( $P_{nm}$ ). The high speed camera used for shooting had an earthquake resistant structure with an image resolution of  $1,600 \times 1,200$  pixels and shooting speed of 1,000 frames per second. The position of the target and the displacements generated in the direction of shaking were traced and the vertical direction was summarized as time history.

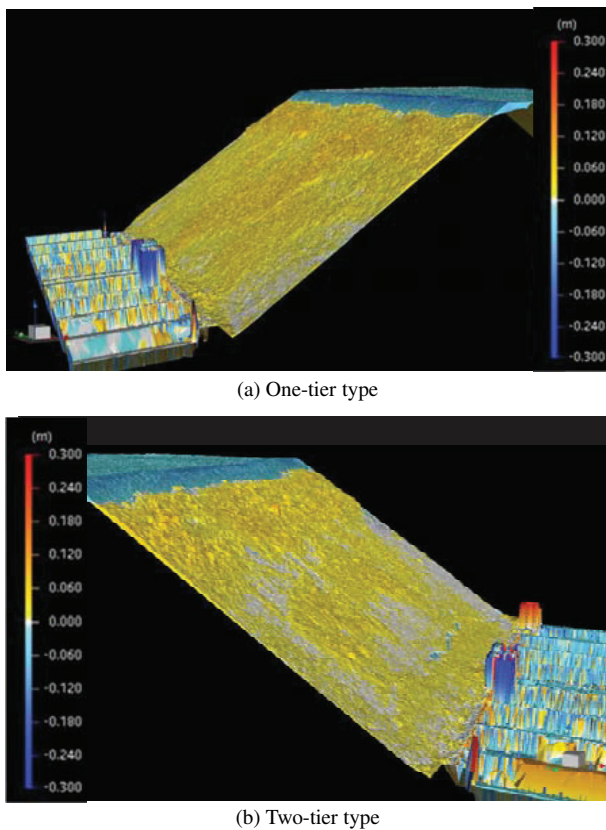
**Fig. 19.** Results of measurement of 3D dynamic displacement sensor.

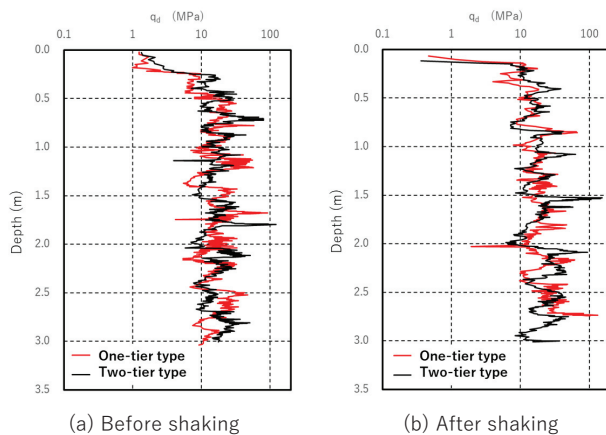
Fig. 22. Simple dynamic cone penetration test.

The abovementioned measurement results concerned the configuration of the embankment surface. Results of the handy dynamic cone penetration test [13], carried out both before and after the shaking, are shown in Fig. 22 and the damage caused to the embankment can be confirmed. The survey locations were already shown in Fig. 21. As the asphalt pavement model imitating road is placed on the crest, the survey was conducted at the shoulder of the slope. The cone penetration resistance  $q_d$  shows the periodical peaks from the ground surface, irrespective of before or after the shaking and the type of flexible container bag structure. Such peaks indicate the rolling compactions during the construction. As the values of  $q_d$  was about 10 Mpa, both before and after the shaking, for both structure types and there was no significant difference in the tendencies, sliding surface cannot be estimated at the cone penetration points.

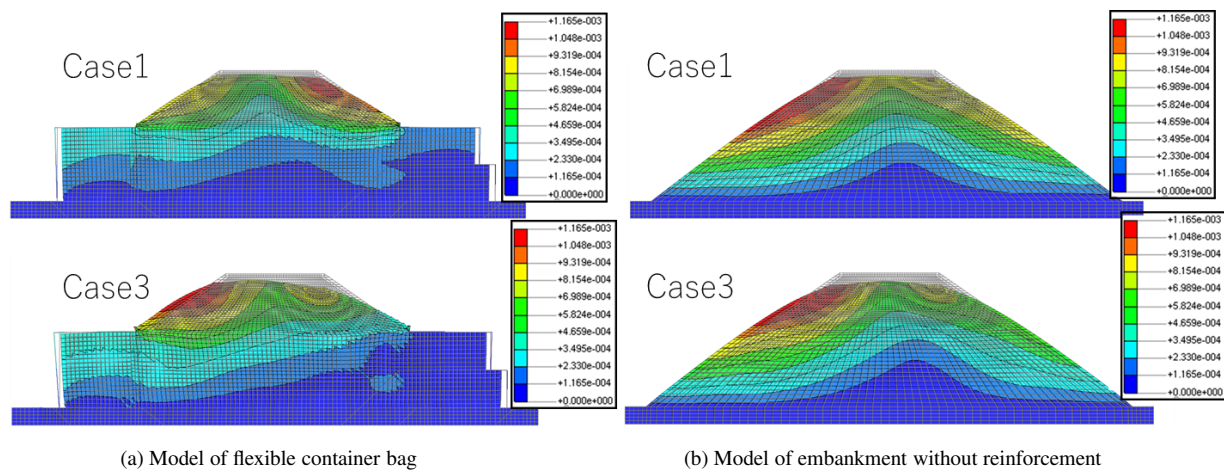
**Fig. 24.** Residual deformation diagram (Unit: m, deformation rate of 200 times).

As the condition of analysis, the input wave which was measured actually was used in each case shown in Table 2. Fig. 24 shows the residual deformation diagrams of the model of flexible container bag and that of embankment without reinforcement under the condition of shaking in Cases 1 and 3 as the representative results of the analysis. The contour color indicates the lateral displacement. Since the deformation volume is small, the results of analysis are explained based on deformation mode only. In the case of embankment without reinforcement, the overall settlement occurs with the swelling of the slope surface. In the case of model with flexible container bag, the structure of one-tier type deforms and a swelling due to the large horizontal displacement of the slope on the same side is recognized. However, for two-tier type, there is no such displacement as one-tier type but the settlement becomes larger at the top of slope. This

is thought to be caused by the fact that the flexible container bag of one-tier type is more vulnerable to deformation than that of two-tier type.

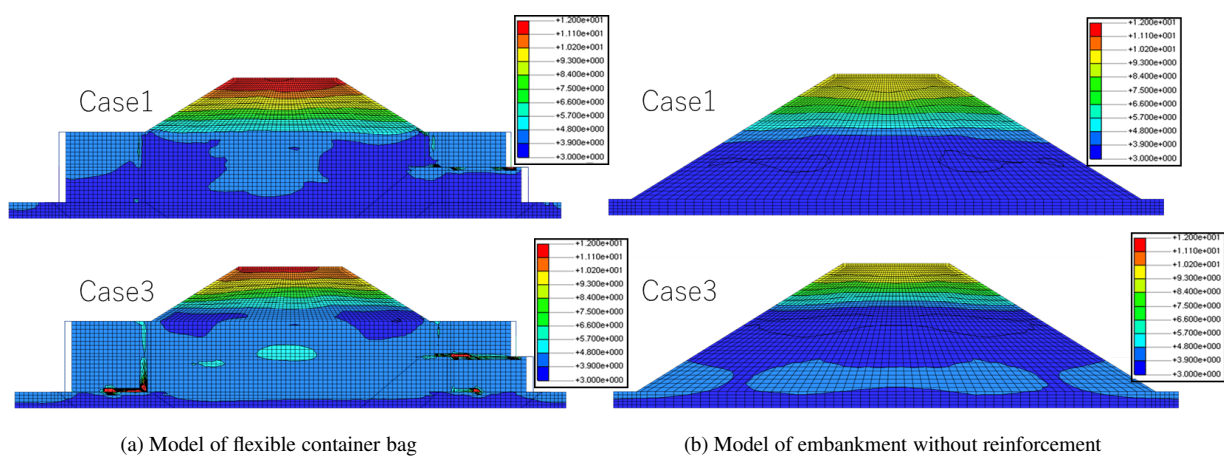
**Fig. 25.** Distribution diagrams of the maximum acceleration (Unit:  $\text{m/s}^2$ ).

The distribution diagrams of the maximum horizontal acceleration in Cases 1 and 3 are shown in Fig. 25. Although the acceleration distribution generated in the embankment without reinforcement is a little complex, it can be seen how it amplifies upward laterally. In the case of model with flexible container bag, a large acceleration generates at the joint elements between the flexible container bags and the flexible container bags has a slightly rigid structure, therefore, this model shows a larger acceleration in the upper part of the flexible container bags compared to that in the embankment without reinforcement.
