Paper:

Stability Analysis of Slopes with Terraced Topography in Sapa, Northern Vietnam: Semi-Infinite Slope Assumption with Specific Lengths for Slope Failure

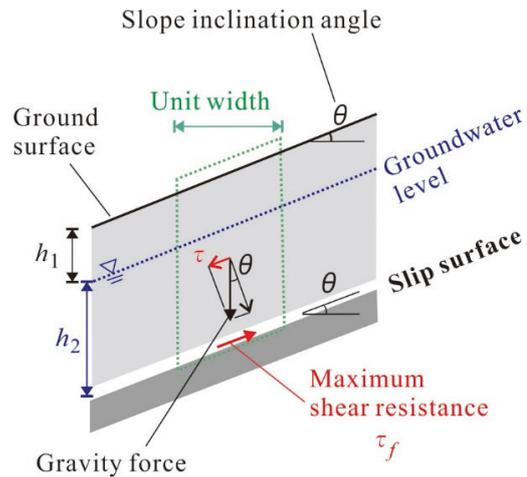
Fig. 1. Slope stability analysis for shallow failures assuming a semi-infinite homogeneous slope.

Once the groundwater level is obtained, the stability of the slope is evaluated by the total factor of safety F_s , implying instability when it is lower than 1.0. By using this index and based on the result of the seepage analysis, the slope stability evaluation can be achieved. As shown in **Fig. 1**, F_s for shallow slope failures assuming a semi-infinite homogeneous slope is defined as

$$F_s = \frac{\tau_f}{\tau} = \frac{c' + \{\gamma \cdot h_1 + (\gamma_{sat} - \gamma_w) \cdot h_2\} \cdot \cos^2 \theta \cdot \tan \phi'}{(\gamma \cdot h_1 + \gamma_{sat} \cdot h_2) \cdot \sin \theta \cdot \cos \theta}, \quad (1)$$

where τ is the shear stress due to the sliding direction component of the gravity of soil, and τ_f is the shear strength of soil, that is, the maximum shear resistance. γ is the wet unit weight of soil, γ_{sat} is the saturated unit weight of soil, γ_w is the unit weight of water, h_1 is the depth from the ground surface to the groundwater level, h_2 is the depth from the groundwater level to the slip surface corresponding to the surface of the base layer, θ is the slope inclination angle, c' is the cohesion of soil, and ϕ' is the angle of shear resistance of soil.

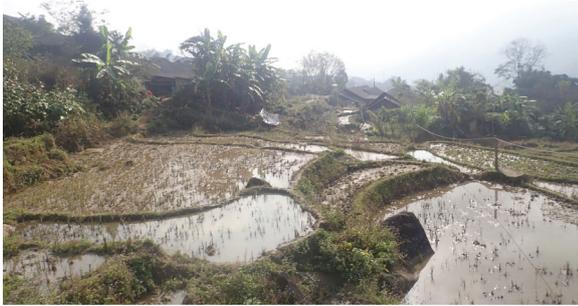
(a) Typical terraced rice field

Fig. 3. Rice terraces in study area in Sapa Town, Lao Cai Province, Vietnam.

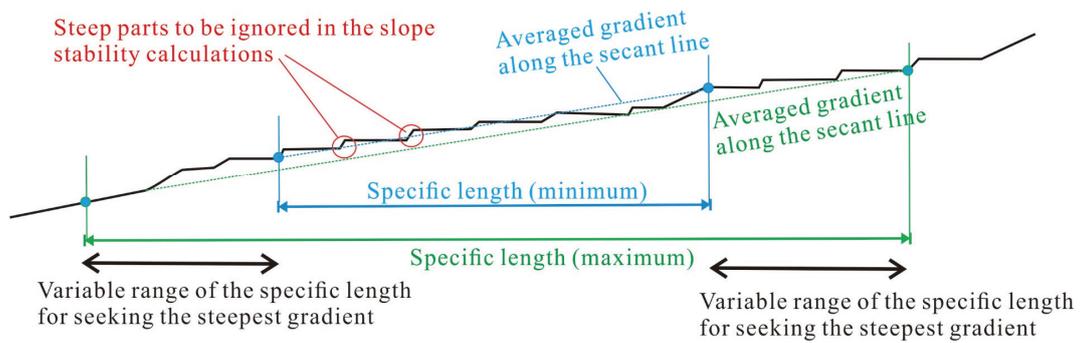
Fig. 5. A schematic diagram of the proposed concept to give a representative length within the specified length range.

Here, the specific lengths concept is proposed to address the problem that theoretically, the edge-like steep part of each rice terrace will always cause the first slope failure. **Fig. 5** is a schematic diagram of the proposed specific lengths concept, elucidating the representative length given within the specific lengths range. The averaged slope gradient is defined by focusing on the secant lines between each topographical grid. The averaged slope gradients defined outside the specific lengths range, for example, local cliff angles, are ignored in the slope stability calculation. As described in **Fig. 1**, the value of the slope inclination θ used for the slope stability analysis can be given as the maximum value of the averaged slope gradients within the specific lengths range. **Fig. 6** is a plan view to show the proposed specific lengths range concept. The central intersection point indicates the position where the representative gradient value is defined. The topographical information of the slope is generally organized as grid data defined in latitude and longitude. The specific lengths are expressed as the diameter of the specific circles in the plan view, providing us the range of possible averaged slope gradients of the representative gradient.

The proposed concept defines not only the lower limit of micro-topography – similar to the resolution of the topography data – but also the upper limit of the calculated length of landslides. As seen in the above points, the pro-

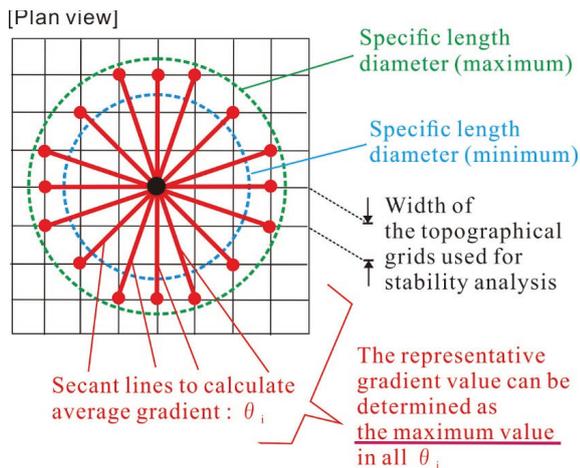
Fig. 6. Plan view of the proposed specific length concept to define the representative gradient used for the stability analysis.

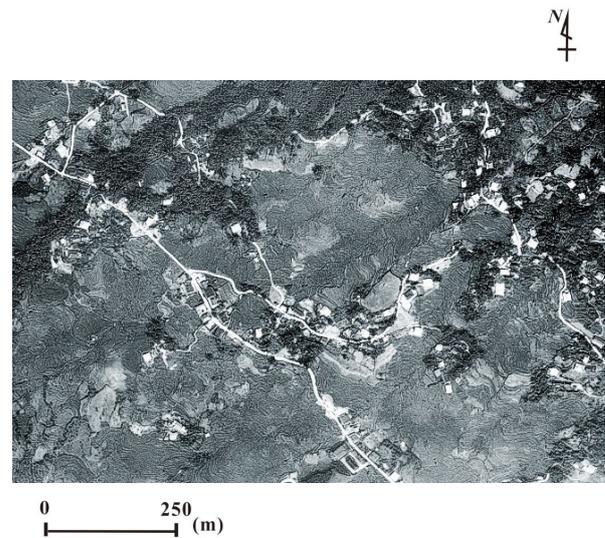
Fig. 7. Aerial photo of the target area of the analysis.

The aerial photo of the target area is shown in **Fig. 7**. The finer folds in the image may correspond to the terraced terrain. **Fig. 8** shows the steepest downward slope at each point, which can be defined as the maximum ground inclination from each pixel to one of its eight neighboring slopes, either adjacent or diagonal. The digital elevation model was provided by the AW3D, a global digital 3D map with 1-m resolution. A pixel here is defined as a point in the grid corresponding to the resolution of the topography. The elevation value of the ground surface at each pixel has been estimated from the satellite data.

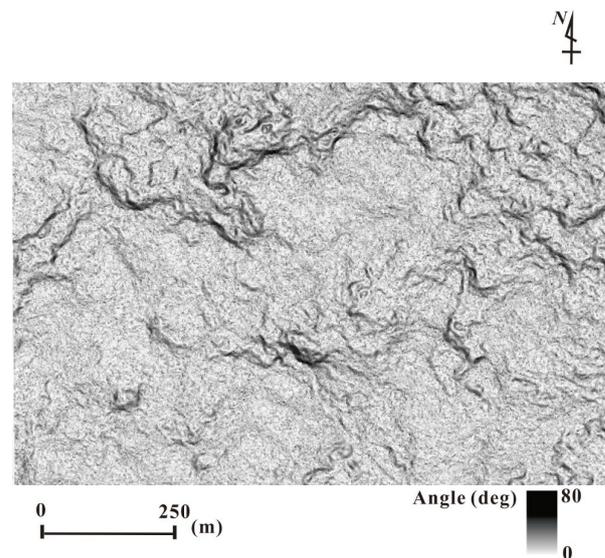
Fig. 8. Distribution of the steepest downward slope angle at each point in the target area based on AW3D.

In the figure, the darker the color, the greater the angle. If such a simple method is adopted, extremely large angles would be obtained at the edges of individual rice terraces, with the angle inside the rice terraces estimated as approximately zero. Apart from such a simple definition, other methods for defining the slope angle have been comprehensively described in [9]. Examples of detailed

In this analysis, the slope inclination angle θ , previously shown in Fig. 8, was used to calculate the total factor of safety at each point. This is the maximum ground inclination from each pixel to one of its eight neighboring grids with 1-m resolutions, either adjacent or diagonal. This is regarded as a conventional method for defining the slope inclination angle. All analytical parameters used in the slope stability analysis are summarized in Table 2.

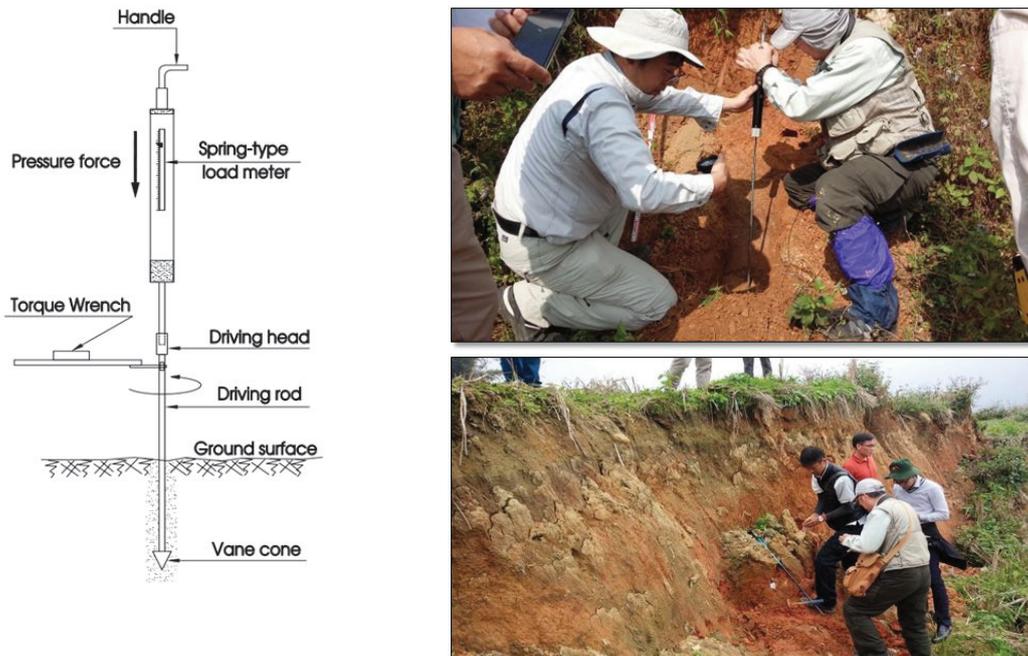
Fig. 9. Vane cone shear test device, named “Dokenbou,” and its operation in the field investigation.

To understand the nature of typical shallow failures in this area, a simple field investigation at a slope failure was performed in December 2019, as shown in Fig. 3(b). The shear strength parameters of the topsoil were estimated by a convenient and simple device (Fig. 9): the soil-layer-strength measuring instrument (in Japanese, Dokenbou). This device was developed by the Public Works Research Institute of Japan. This instrument has a soil inspection rod, wherein a vane cone is attached to the tip of the rod. The vane cone shear test is conducted by pushing the penetration vane cone to a target depth, with pressure force at a constant value, and shearing the soil by rotating it with a torque wrench. Next, press force and rotation torque values are checked. During each trial, the pressure force was kept constant in a certain level of load. From the measured values, the soil cohesion c' and soil friction angle ϕ' can be easily estimated from the relationship between shear strength and normal stress of soil.

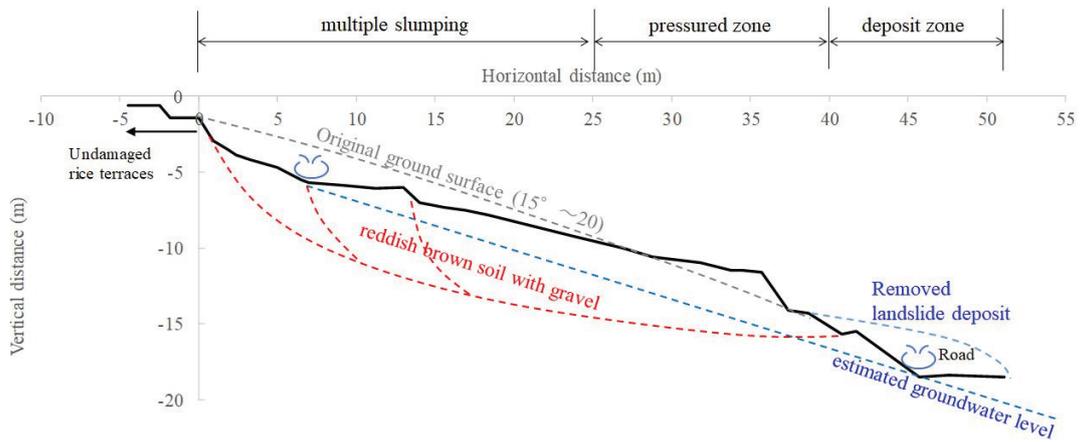
Fig. 10. Residual shape of the collapsed slope surface in the longitudinal section.

The estimated values are depicted in Table 1. The residual shape of the collapsed slope surface in the longitudinal section is shown in Fig. 10. The depth from the original ground surface to the exposed slip surface H was estimated to be about 5 m. Further studies are required on the effectiveness of such a field investigation.

is almost consistent with the observed size of an actual slope failure shown in **Fig. 10**. Contrariwise, in **Case C**, the large values of the specific lengths are adopted to capture larger size failures. This assumption may be more suitable for assessing landslides with deeper slip surfaces, for example, 10 m or more.

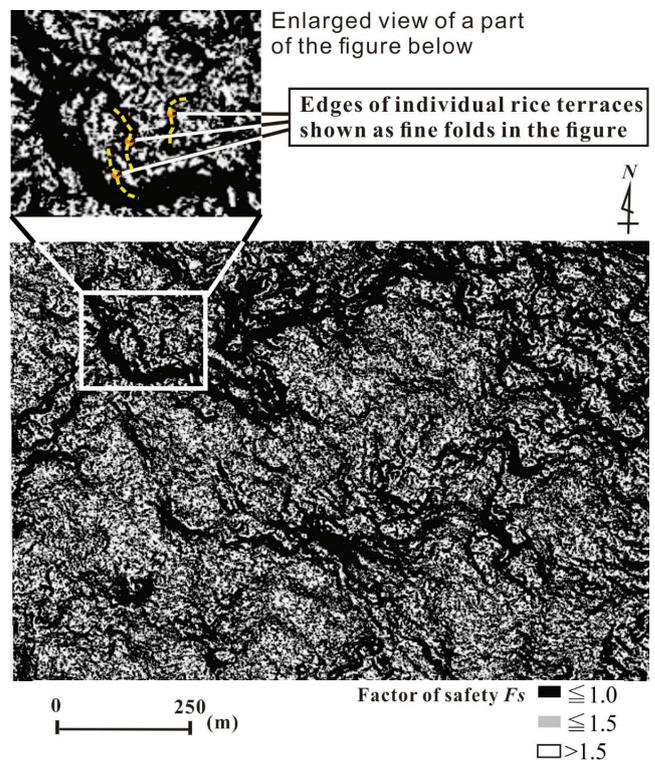
Fig. 11. Distribution of the calculated total factor of safety F_s based on the slope angle θ estimated from the conventional definition as the maximum ground inclination from its eight neighboring grids in 1-m resolution.

Figure 11 shows the distribution of calculated total factor of safety at each point. In the figure, the darker the color, the smaller the factor of safety, implying instability. Similar to the tendency in Fig. 8, the dark-colored portions are distributed in a shape like fine folds corresponding to the edges of individual rice terraces. Such a detailed information distribution may not be useful for disaster prevention purposes because collapses of the edges of terraced rice fields do not attract much attention. As demonstrated in Fig. 10, the size of the phenomenon recognized as a slope failure would be more than 10 m at least.

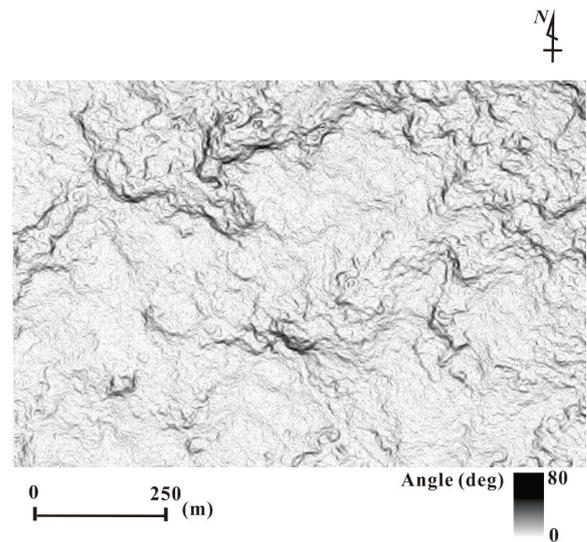
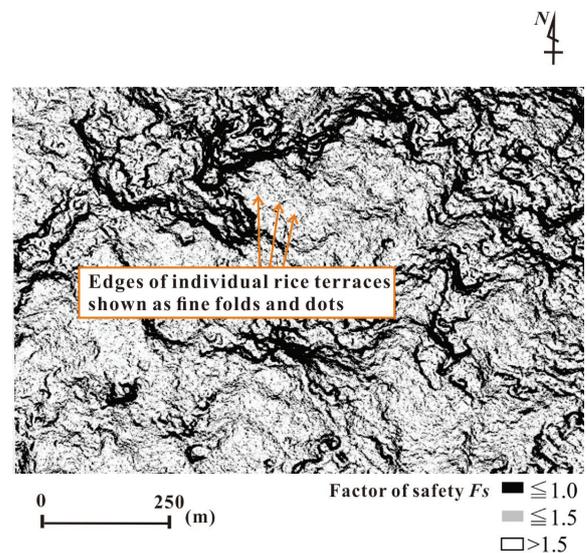
(a) Distribution of slope inclination angle

(b) Distribution of total factor of safety

Fig. 12. Calculated results in **Case A** (where the specific lengths range was assumed to be from 0 m to 2 m).

Figure 12 shows the calculated results in **Case A**. The slope inclination angle was obtained as **Fig. 12(a)**, similar to **Fig. 8**. This is because both assumptions are numerically almost equal. Therefore, **Fig. 12(b)**, obtained based on this inclination angle, tended to be similar to that of **Fig. 11**. As indicated before, under such an assumption, an extremely small total factor of safety was obtained at the edges of individual rice terraces. However, the total factor inside the rice terraces was estimated to be very large. These assumptions may not be desirable.

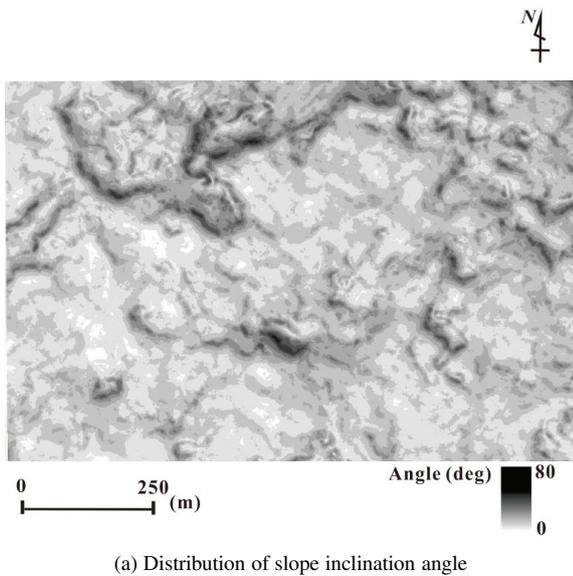
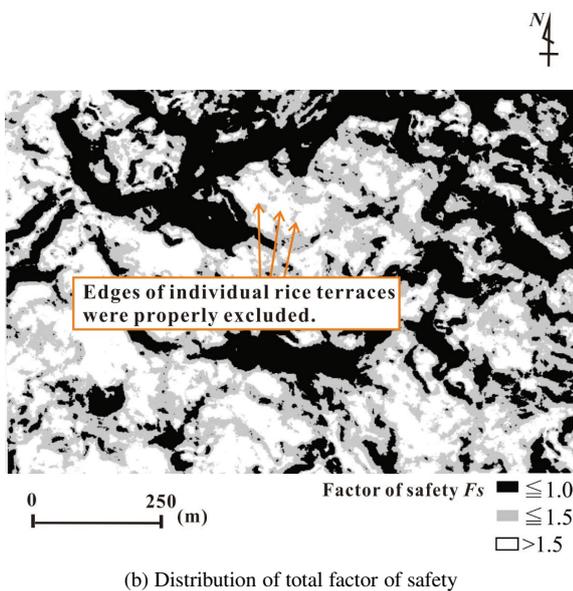
Fig. 13. Calculated results in **Case B** (where the specific lengths range was assumed to be from 10 m to 40 m).

Figure 13 shows the calculated results in **Case B**, where the specific lengths are assumed to be the values consistent with the observed size of an actual slope failure shown in **Fig. 10**. As seen in **Fig. 13(a)**, fine folds with darker color are excluded and only more comprehensive slope shapes are visible. Such modeling seems to be optimal from the engineering point of view, especially when many small-terraced topographies are included in the slope. The calculated result of the total factor of safety shown in **Fig. 13(b)** may also be valid for disaster prevention for shallow slope failures.

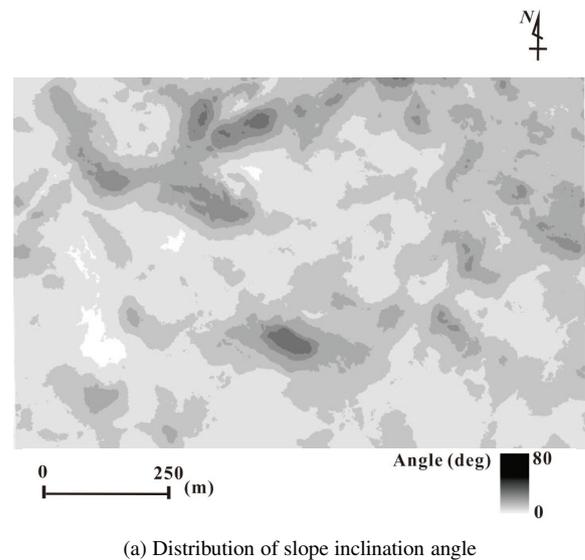
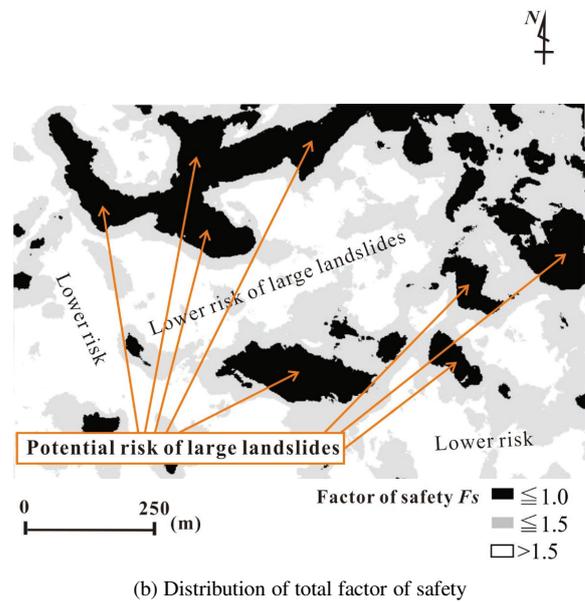
Fig. 14. Calculated results in **Case C** (where the specific lengths range was assumed to be from 40 m to 100 m).

However, the danger of large landslides should also be recognized. **Fig. 14** shows the calculated results in **Case C**, where the values of specific lengths may be larger than those in **Case B**. As seen in **Fig. 14(a)**, such a rough pattern characterized with darker colors implies that the target slopes under consideration became larger. **Fig. 14(b)** reminds us which places are more dangerous if a larger landslide occurs. Using these assumptions properly considering the geological structure in the target slope confirmed that by changing the assumed values of the specific lengths of slope failure, various slope objects can be appropriately evaluated.
