# Identification, Monitoring, and Assessment of an Active Landslide in Tavan-Hauthao, Sapa, Laocai, Vietnam – A Multidisciplinary Approach

**Keywords:** landslide, slip surface, resistivity inversion, numerical model, surface moving monitoring

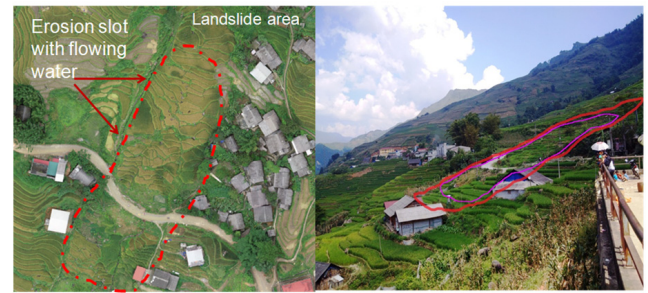
**Fig. 21.** Study of the sliding block in Tavan-Hauthao (July 2020).

**Figures 20 and 21** show the sloping topography of the study area with a dip toward the river valley bottom. An erosional gully along the western side of the slide was formed with time, which acts as a drainage and seepage path for saturating adjacent groundmass, including sliding soil block. The presence of anomalous weak zones was identified at depth from geotechnical investigations in conjunction with the ERT. These weak zones suggest that the groundmass has low shear strength and high permeability. A curvilinear sliding plane was identified through sub-surface exploration. Seepage of water through agriculture activity and rainwater appears to be the main cause of this landslide besides removal of toe support due to progressive erosion of the river valley slope. Initially, the landslide appears to have started as a translational type, but subsequently developed into a concave rupture plane in groundmass near the contact of soil and rock and formed as a mixed type rotational slide.
