## Survey Report:

# Fukuchiyama Line Train Derailment

Prepared by Editorial Office

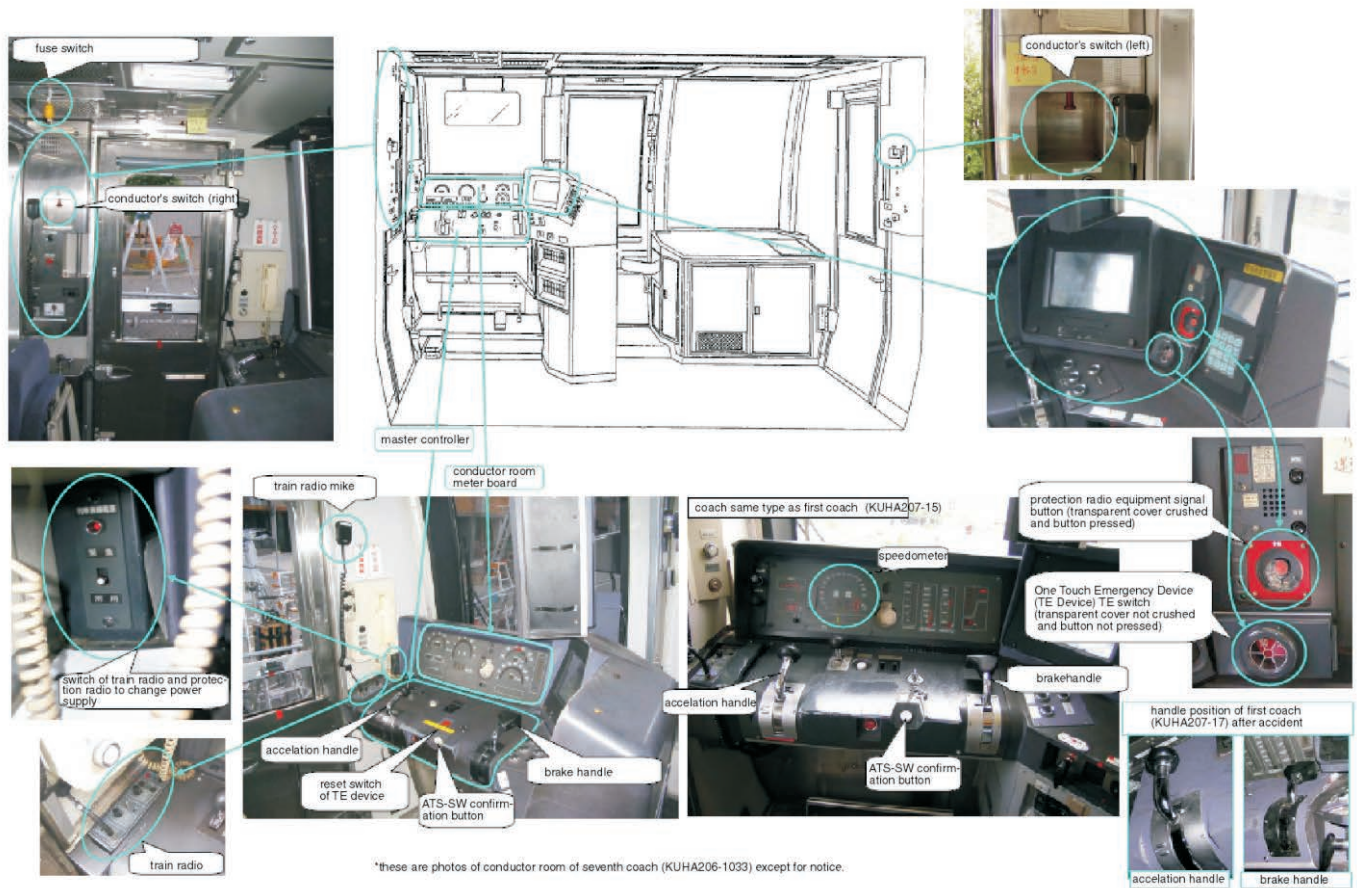
Fig. 9. Equipment arrangement in operation room.

Inspection of the main controller just after the derailment showed nothing abnormal (Fig. 9).

Based on the above result, calculating in trials the error under the condition of the wheel diameter that would cause the maximum error, using the same speedometer as in the first coach, the speedometer indicates speed lower by about 4 km/h than the actual train speed (Fig. 9).

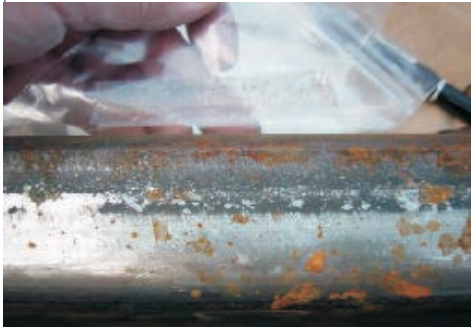
| No. | sample | gathered at | appearance | analysis overview | anticipated material | anticipated matter | situation on gathering |
|---|---|---|---|---|---|---|---|
| 1 | rail white powder | head of up line rail, left, between rail road ties 88 and 89 | white powder | SiO <sub>2</sub><br>Fe <sub>2</sub> O <sub>3</sub><br>Al <sub>2</sub> O <sub>3</sub><br>Na <sub>2</sub> O<br>K <sub>2</sub> O<br>CaO<br>quartz<br>feldspar<br>mica<br>clay minerals | granite | ballast | |

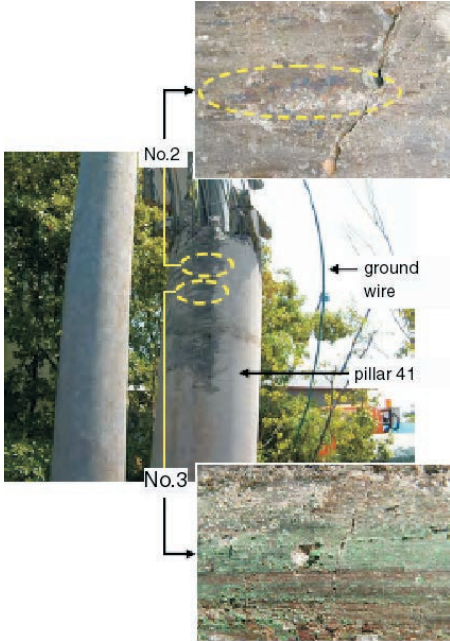
| No. | sample | gathered at | appearance | analysis overview | anticipated material | anticipated matter | situation on gathering |
|---|---|---|---|---|---|---|---|
| 2 | scratches on pillar | pillar 41 (1k814m on up line) | miscellaneous scratches (metallic luster) | Fe<br>Cr<br>Si<br>Ca<br>Al<br>Ni | stainless steel | coach | |

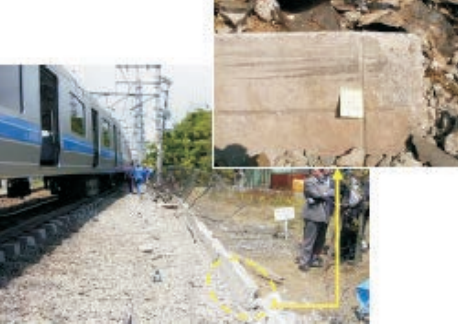
| No. | sample | gathered at | appearance | analysis overview | anticipated material | anticipated matter | situation on gathering |
|---|---|---|---|---|---|---|---|
| 4 | miscellaneous matter on pillar | pillar at rail road tie 108 | miscellaneous matter on pillar | same spectrum of coach roof cloth | — | coach roof cloth | |

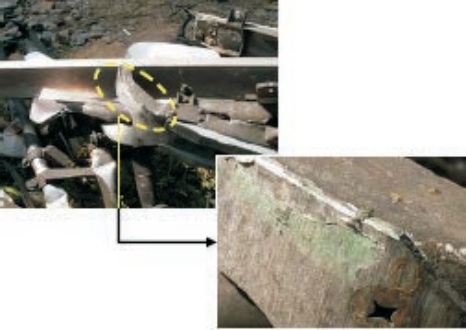
| No. | sample | gathered at | appearance | analysis overview | anticipated material | anticipated matter | situation on gathering |
|---|---|---|---|---|---|---|---|
| 9 | miscellaneous pantograph matter | rear pantograph of second coach fallen by pillar 41 | miscellaneous green matter (sheet like) | same spectrum of the cover vinyl of ground wire of pillar 41 | — | vinyl cover of ground wire of pillar 41 | |

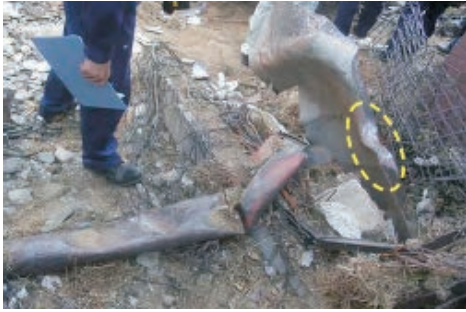
| No. | sample | gathered at | appearance | analysis overview | anticipated material | anticipated matter | situation on gathering |
|---|---|---|---|---|---|---|---|
| 10 | miscellaneous skirt matter | left depression in skirt of first coach | miscellaneous white matter | Ca(OH) <sub>2</sub><br>CaCO <sub>3</sub><br>quartz<br>feldspar<br>mica | cement, aggregate | concrete | |
