Damage in Ports due to the 2011 off the Pacific Coast of Tohoku Earthquake Tsunami

Takashi Tomita*, Taro Arikawa*, and Tadashi Asai**

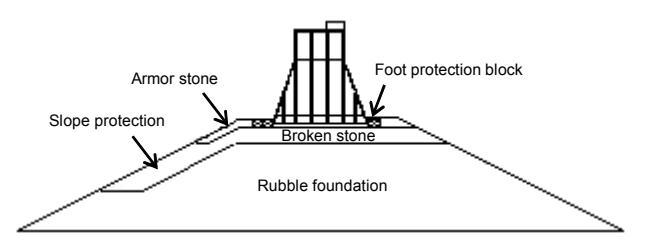
Fig. 6. Standard cross section in the deep water section of the north breakwater in Kamaishi Port.

the difference in water level between the front and back of the breakwater was considered to be 2.8 m. The 2011 tsunami, however, was over 11.8 m high and the water level difference between the front and back of the breakwater was over 6 m, resulting in heavy damage of the breakwater.

The 990 m north breakwater in Kamaishi consisted of trapezoidal caissons (**Fig. 6**) of about 36,000 tons in the deep water section and rectangular caissons in the shallow water section. Among caissons in the 670 m south breakwater, three caissons were the trapezoidal caissons and the rest were rectangular caissons of about 32,000 tons (**Fig. 7**). The height of the breakwater crest was D.L. +6.0 m (T.P. +5.14 m). Along a 300 m long opening between the north and south breakwaters, a submerged breakwater was installed that consisted of caissons whose crown height was D.L. -19.0 m.

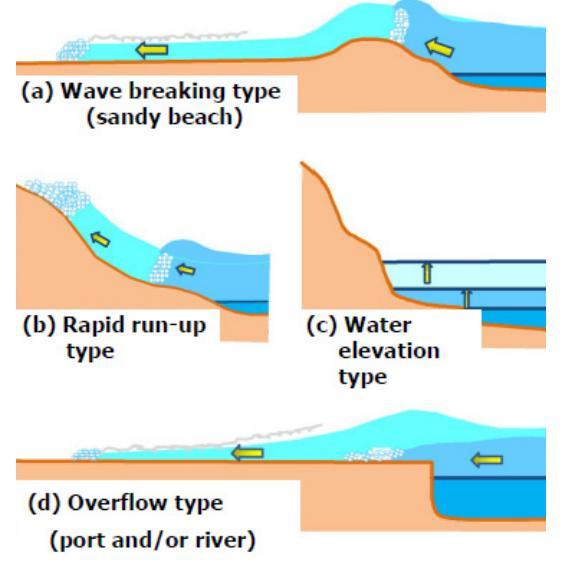
Three types of breakwater failure mechanisms were found from damaged breakwaters in Kamaishi and Hachinohe ports that the tsunami overflowed severely: i) strong horizontal force due to water surface level differences between the front and back of breakwater caissons, ii) re-

Fig. 14. States of the tsunami overflowing.

duced rubble foundation bearing capacity due to scouring by overflowing water, and iii) reduced rubble foundation bearing capacity around the breakwater head due to the strong tsunami current. Breakwater failures in other ports are explained by these failure mechanisms, as is also supported by experimental analysis and calculation of damaged caisson stability by the Tohoku Regional Bureau of MLIT against the tsunami impact [5].

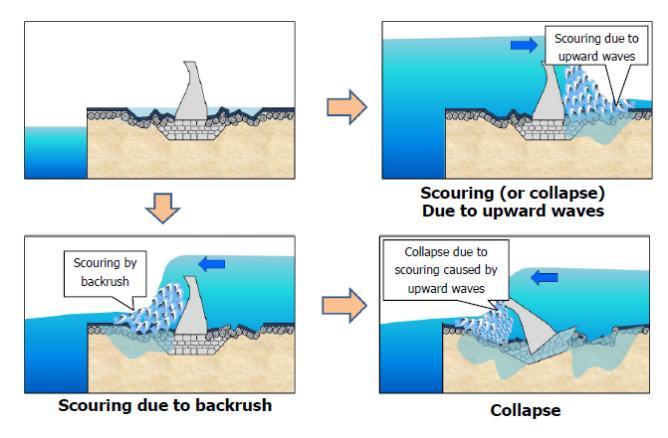
Fig. 15. Failure mechanism of seawall in ports.

Types of seawall damage in ports and harbors were as follows: i) seawall breaching, ii) seawall parapet scattering, iii) seawall surface cracks, iv) local damage due to tsunami debris collision, and v) breakage along seawall surface joints [6]. Scoured foundations were found at the front or back of many breached seawalls (**Fig. 13**). No seawall breakdowns were found in ports, but scouring occurred around damaged seawalls. Typical tsunami damage at ports is shown in **Figs. 14(c)** and (d). Although no wave breaking of tsunamis occurred in sea areas because of the water depth, tsunamis overflowed rapidly onto quays at 10-30 km/h with or without breaking. These

rapid tsunami waves caused no breakdown in main seawalls, which they overflowed, causing scouring failures at seawalls. Failures occurred both during the rushing tsunami phase and during the receding tsunami phase, as shown in **Fig. 15**.

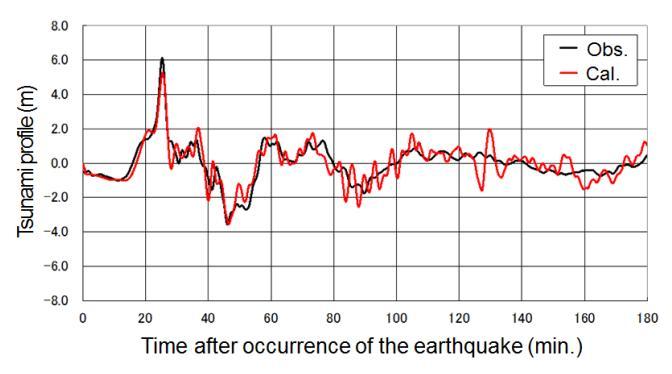
Fig. 24. Tsunami profiles observed with the GPS-mounted buoy located off Kamaishi Bay (black line) and calculated profile (red(gray) line).

Figures 24 and **25** show the tsunami profiles calculated at GPS-equipped buoys off Kamaishi Bay and the seaward point of the north breakwater head. Circles in **Fig. 25** indicate water surface elevation analyzed using photos and video footage. Calculated results agree well with the results of photoanalysis. Based on calculation in the case where there was no breakwater, the tsunami height was approximately 12 m along the north breakwater. This height exceeds the crown of the breakwater by about 7 m, as shown in **Fig. 2**. The breakwater was not designed to withstand the force of such a high tsunami, resulting in the failure of the breakwater.

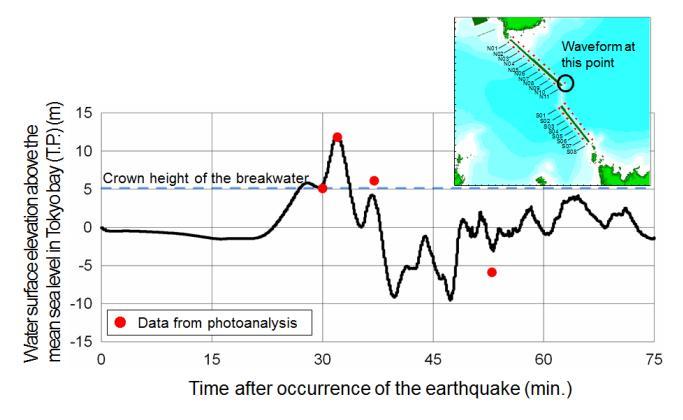
Fig. 25. Calculated tsunami profile (line) and water surface elevation analyzed from photos (circles) at the head of the North Breakwater in Kamaishi Bay.

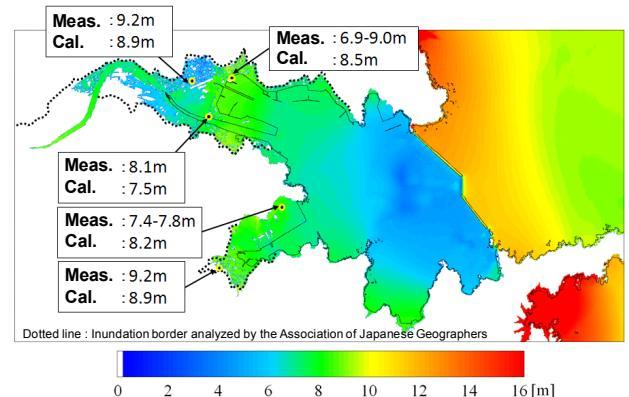
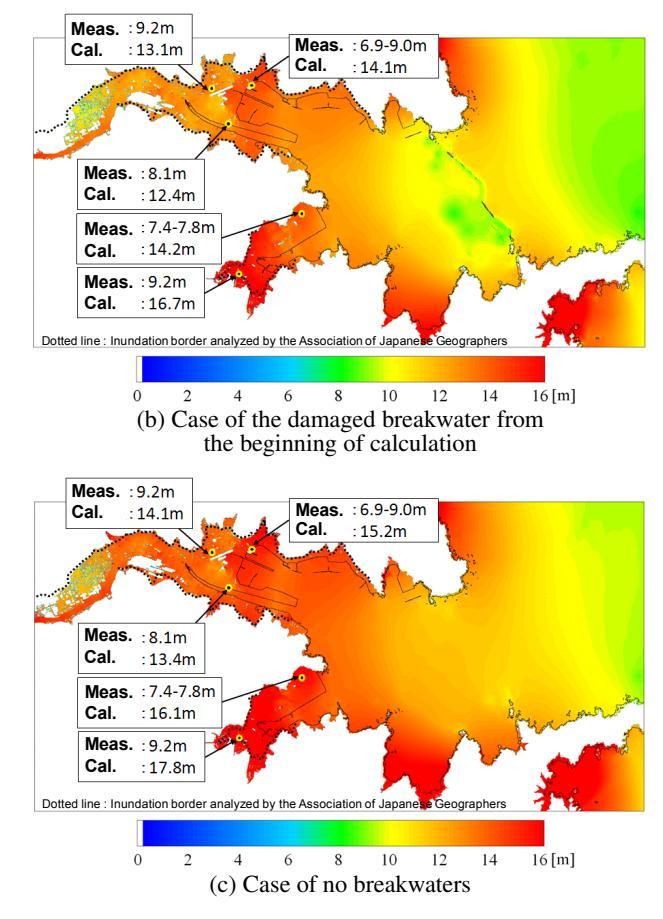
Figure 26 shows the spatial distribution of the calculated maximum tsunami height at sea and inundation height on land with tsunami watermark heights measured in posttsunami field surveys. In case (a) of breakwaters without failures, calculated inundation heights are 30-60 cm lower than heights of watermarks measured. This reduction could be because the breakwater failure that occurred when the first tsunami wave struck the breakwater was not introduced into calculation. In case (b), where broken breakwaters were set as the initial calculation condition, crown height distribution was determined from

Fig. 26. Distribution of the maximum tsunami height in the sea and inundation height on land, depending on the situation of the breakwaters.

measurements of actual damaged breakwaters. Calculated inundation heights are 4 m or higher than measured watermark heights. Indeed, **Fig. 2** shows the tsunami around the peak of the first positive wave, which is the highest tsunami wave in Kamaishi Bay, where the tsunami overflowed the breakwater has a long crest line of the same height. This indicates that no serious breakwater failure occurred until this moment, so measured tsunami inundation heights lie between cases (a) and (b) and comparably near case (a). This indicates that the breakwater probably resisted the force of the tsunami until the peak of the first tsunami wave, resulting in the reduction of tsunami

intrusion flux and impact on the port. Note that the damaged breakwater reduced tsunami inundation height by 40% around the coast inside the port because the calculated inundation height is about 14 m in case (c), which was calculated under the condition of no breakwaters, and measured watermark heights are about 8 m. According to calculation, inundation areas are 3.38 km^2 , i.e., areas with an inundation depth of 2 m or deeper are 76% of the total inundation area in case (a), 4.57 km^2 (90%) in case (b), and 4.87 km^2 (90%) in case (c), confirming that breakwaters reduced the area of inundation.

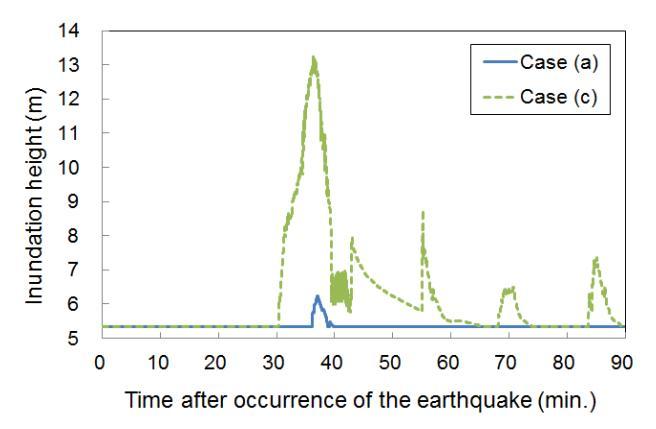
Fig. 27. Time of the start of inundation around the point where the inundation heights of 6.9-9.0 m were measured.

Figure 27 shows the time inundation started around the point where inundation heights of 6.9-9.0 m were measured in **Fig. 26**. In case (a) of breakwaters without failure, the tsunami overtopped the seawall along the coast and inundation started 36 minutes after the earthquake occurred. If, however, there were no breakwaters, i.e., case (c), inundation started 30 minutes after the earthquake, so breakwaters had an effect on the time delay in the start of inundation and on the reduction of tsunami height.

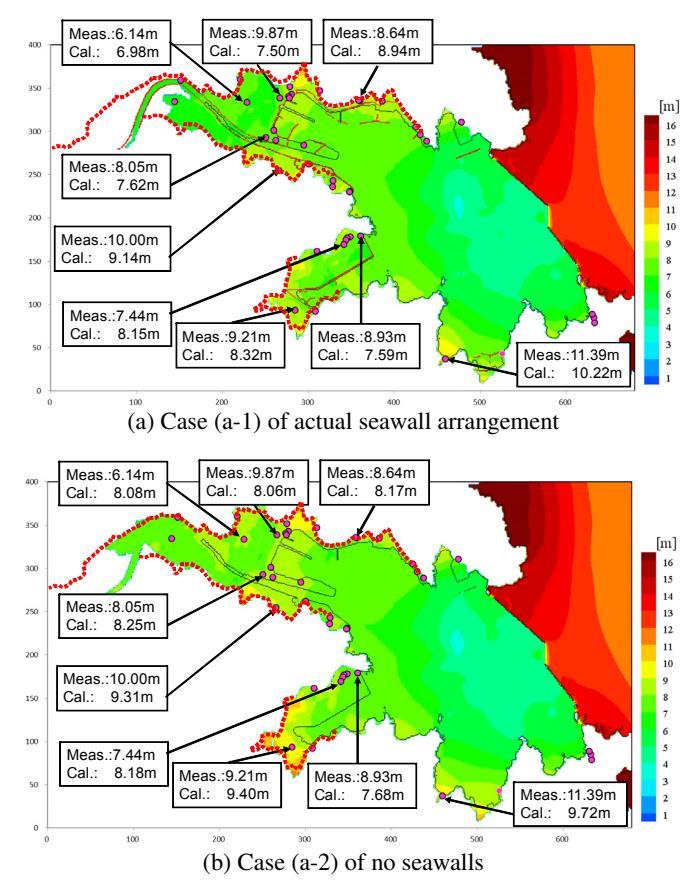
Figure 29 indicates the spatial distribution of maximum tsunami height at sea and inundation height on land and the inundation heights measured in posttsunami field surveys. Both tsunami and inundation heights for case (a-2), i.e., no seawalls, are several tens of cm to 1 m higher than those for case (a-1) with the actual seawall arrangement. Calculated areas of inundation are 3.26 km^2 (inundation area with an inundation depth of 2 m or more: 2.55 km²) in case (a-1) and 3.33 km^2 (2.62 km²) in

Fig. 29. Distribution of the maximum tsunami height in the sea and inundation height on land depending on the seawalls along the coast.

case (a-2). The seawall has a limited effect on reducing tsunami inundation because a tsunami 8 m in height struck the coast, overtopped the seawall by 4 m and inundated a narrow low-lying flat area.
