Flooding Along Oda River Due to the Western Japan Heavy Rain in 2018

Keywords: flood, inundation, Oda River, Western Japan heavy rain

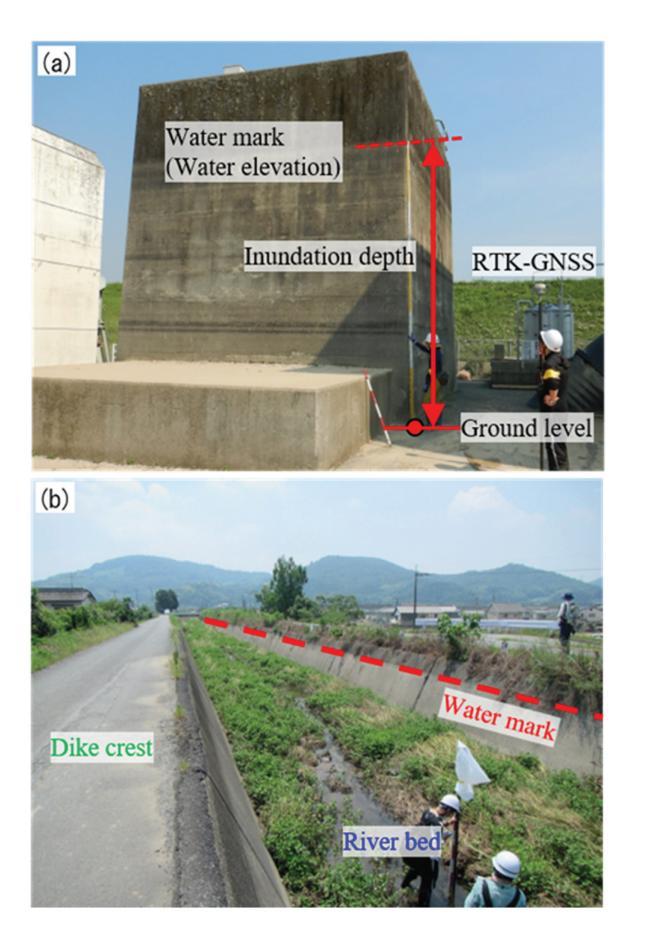
In survey 1, the inundation height and depth were measured based on flood marks such as mud and vegetation deposits on houses in the flooded area around Oda River (**Fig. 4(a)**). In this survey, the ground level of a location where any flood mark was found was measured using RTK-GNSS (R6/R10, manufactured by Trimble Co., Ltd.), or the inundation height was directly measured if the flood mark was at a low level. The height from the ground to the flood mark (inundation depth) was measured to determine the inundation height (flood level) by adding inundation depth to ground level. This survey covered the entire flooded area on the left and right sides of Oda River, and the number of survey points was 170.

In survey 2, the flood mark, riverbed height, and height of the dike crest within the river channels were measured using RTK-GNSS and by leveling staff, as shown in **Fig. 4(b)**. The rivers surveyed were Oda River and its tributaries, Suemasa River, Takama River, Madani River, and Uchiyamadani River.

Fig. 4. Survey on flood marks in flooded area (a) and river channel (b).
