Survey Report:

Landslide Process Revealed by Mineralogical Properties of Landslide Deposits in the Sa Pa District, Vietnam

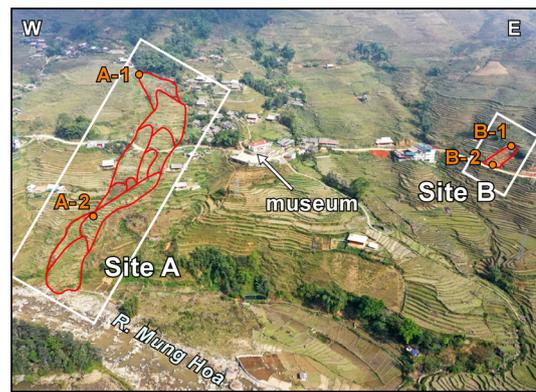
Fig. 3. Landslides and sampling locations for the survey (A-1, A-2, B-1, and B-2). Red solid lines indicate landslide blocks of landslides to be surveyed. Photograph was taken on December 1, 2019.

The field surveys were conducted of two landslide sites in Hau Thao Village (**Fig. 3**). Site A is located in Ta Van District in the village. As seen from **Fig. 3**, the landslide

body of the landslide is made up of multiple landslide blocks; its slope length is 400 m and the maximum width is 60 m. In the field survey, fresh cracks were confirmed on this landslide body. Site B is located about 350 m in the eastward direction from Site A and is made up of a single landslide, which occurred in 2019 along the road. Its scale includes a slope length of 50 m and a maximum width of 20 m. In the field survey, the deposits found in the landslide body at these sites were observed and samples were taken for the mineral composition analysis. Each sample was taken from the flank of the upper main scarp within the scarp located at the head of Site A (location A-1 of **Fig. 3**), the toe of the landslide body in Site A (location A-2 of **Fig. 3**), the main scarp in Site B (location B-1 of **Fig. 3**), and the toe of the landslide body in Site B (location B-2 of **Fig. 3**). The mineral composition analysis was conducted using desktop XRD MiniFlex of Rigaku Corporation, which is owned by Japan Conservation Engineers & Co., Ltd. In addition to powder X-ray diffraction using the random orientation method, and the preferred orientation analysis was also conducted to examine the clay mineral.
